CK-2134

STS'AILES (WEST) 23.5km

2020 Inspection

| Crossing Name | Hale Creek | | |

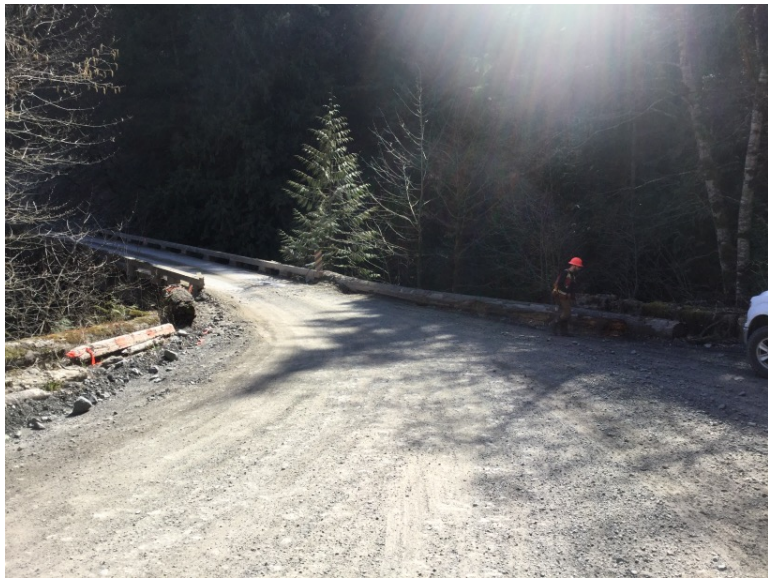
Approach from Left Bank when facing downstream

Neither approach allows for lowbed access without a high probability of guardrail strikes. The fill slopes at the downstream left bank are continually eroding leaving the gabions undermined. The upstream right bank fill slope immediately in front of pipe column has eroded.

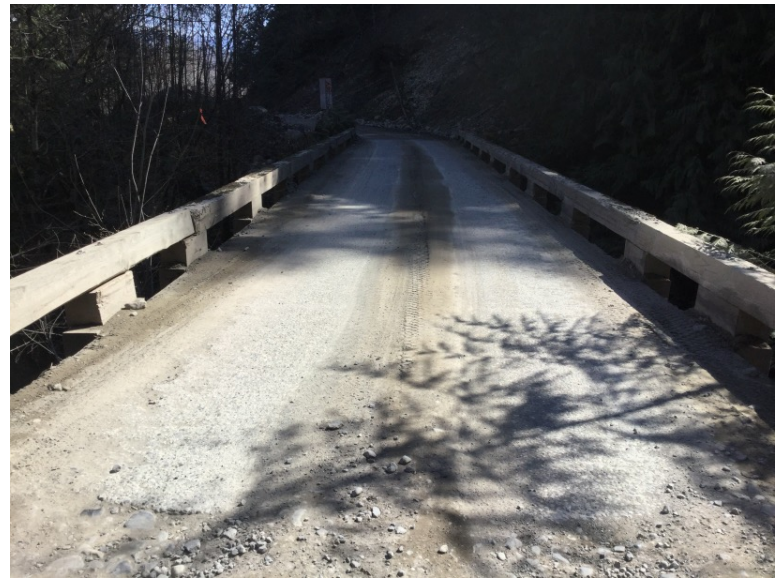
Concrete Deck Fair Minor damage noted to wheel path - likely due to tracked equipment

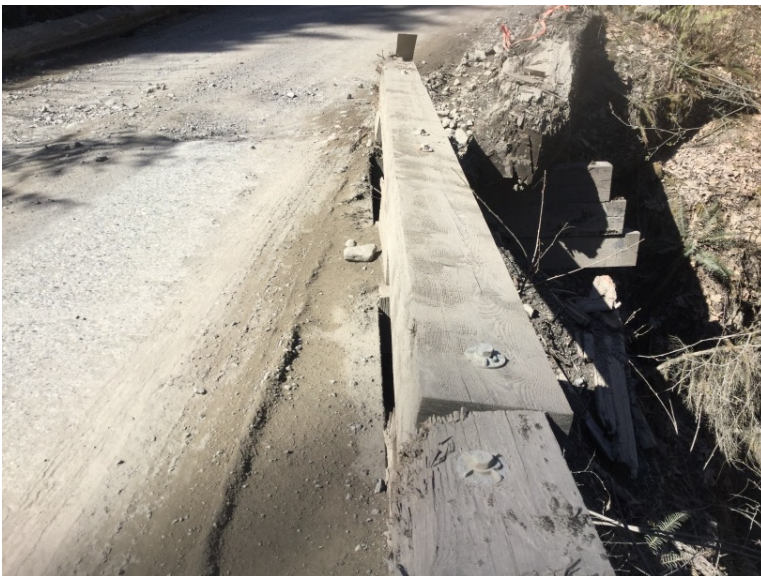
Curb Rail/Blocks/Posts Fair damage noted to downstream rail at approaches - poor tracking

Downstream left bank guardrail condition

| 1 | Medium | Replace damaged guardrail sections at downstream location |

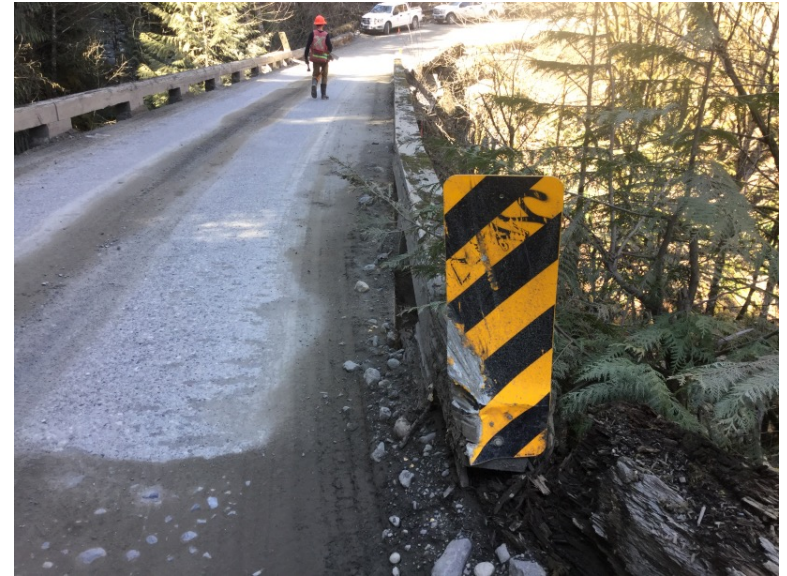
Downstream right bank guardrail condition

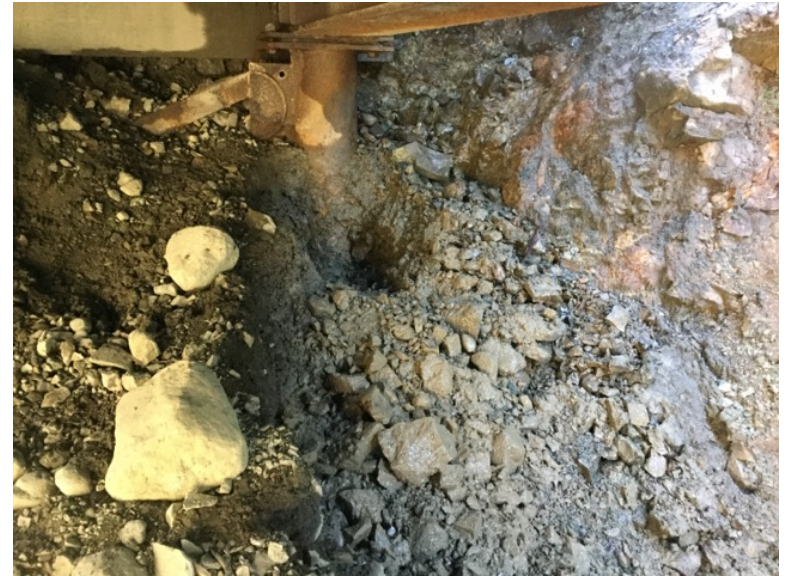
Upstream right bank fill condition

| 1 | fill erosion noted at downstream left bank and in front of upstream right pipe column | Annual |

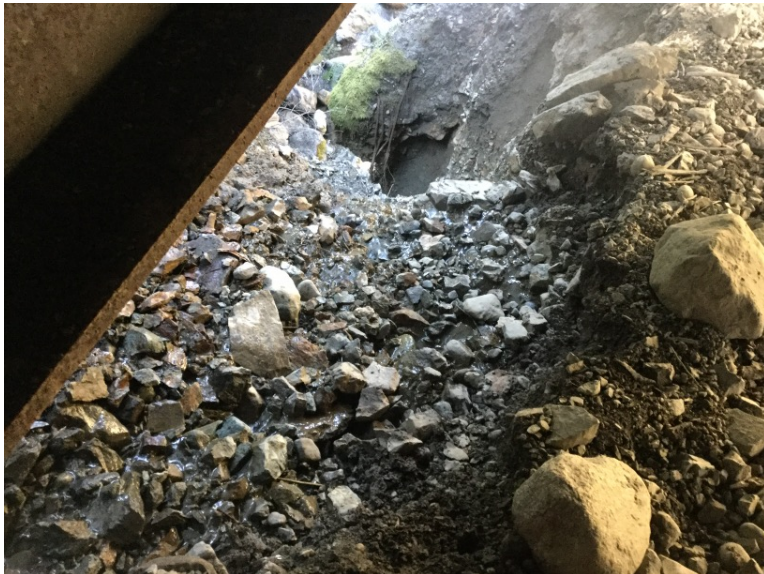
Upstream right bank fill condition

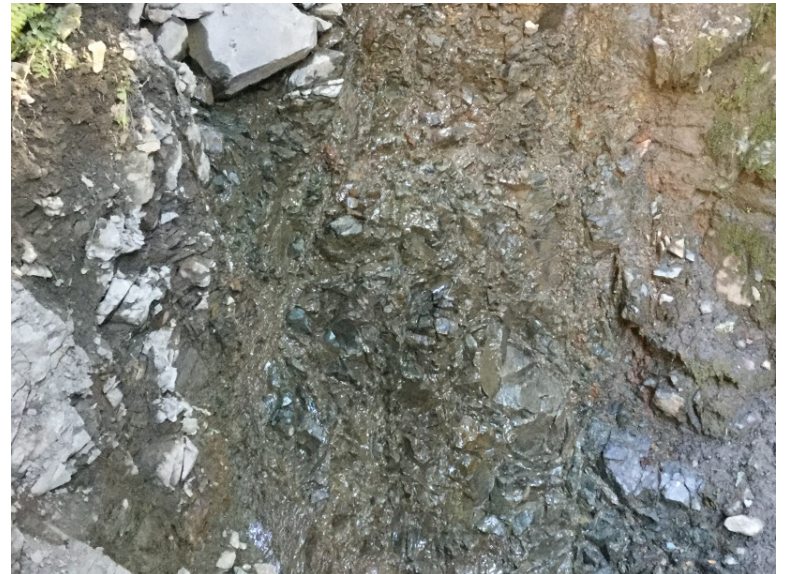
Parent material below upstream right bank pipe column

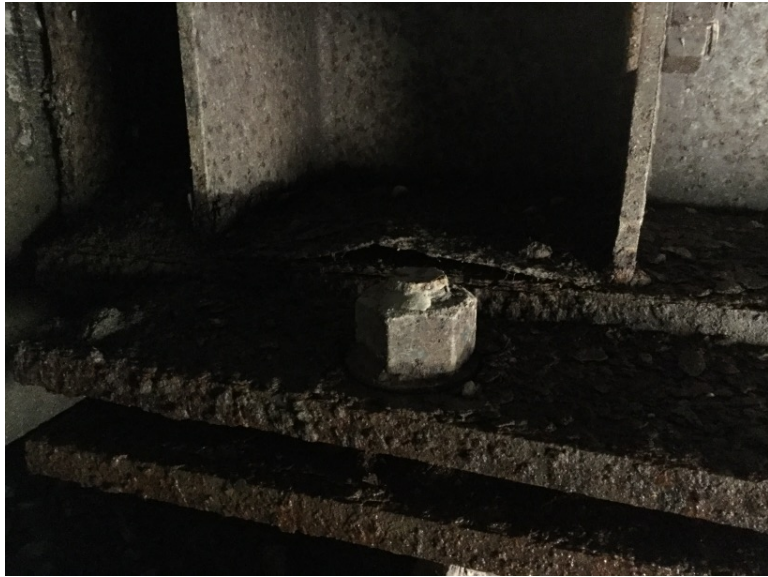
columns at right bank do not appear to have been coated

Right bank steel delamination

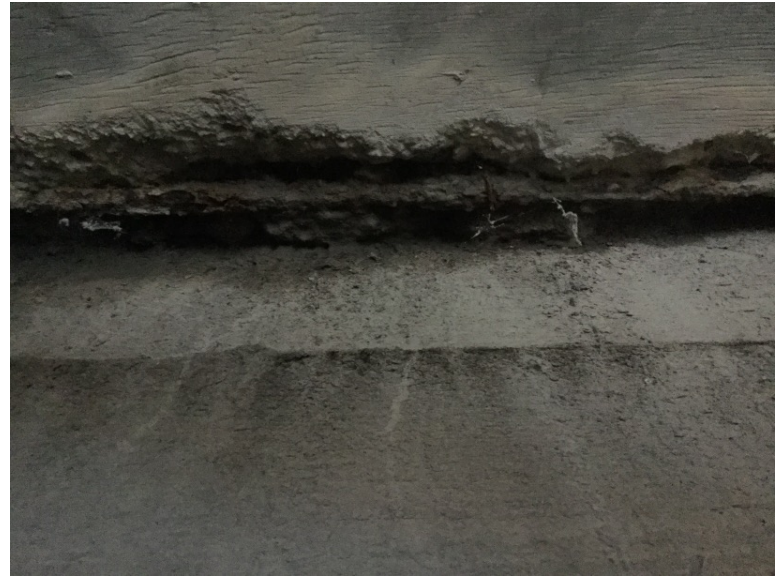
Underside of deck panel 1 at right bank

| 3 | Medium | Repair the damage noted to the underside of deck panel 1 at right bank |
