CK-2141

STS'AILES (WEST) 49.1km

2020 Inspection

Crossing Name Trio Creek

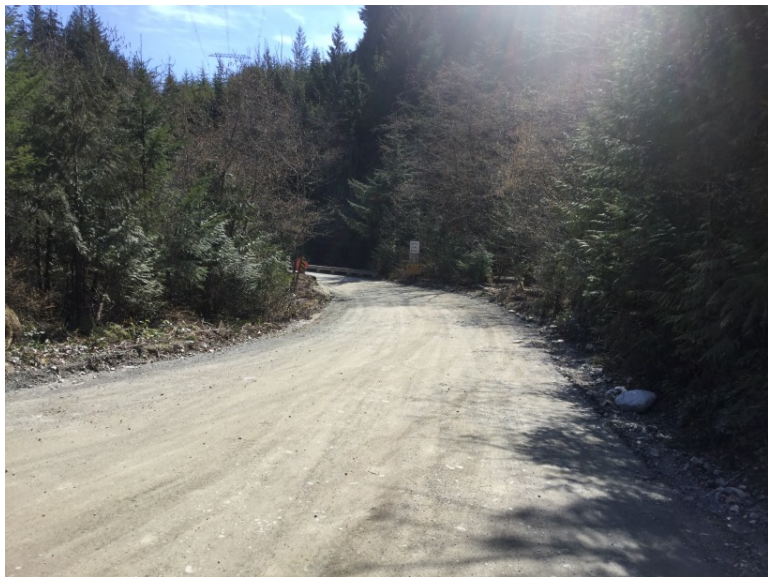
Approach from Left Bank when facing downstream

Alignment Fair HC left bank

| 1 | Medium | Brush approaches to improve sightlines |

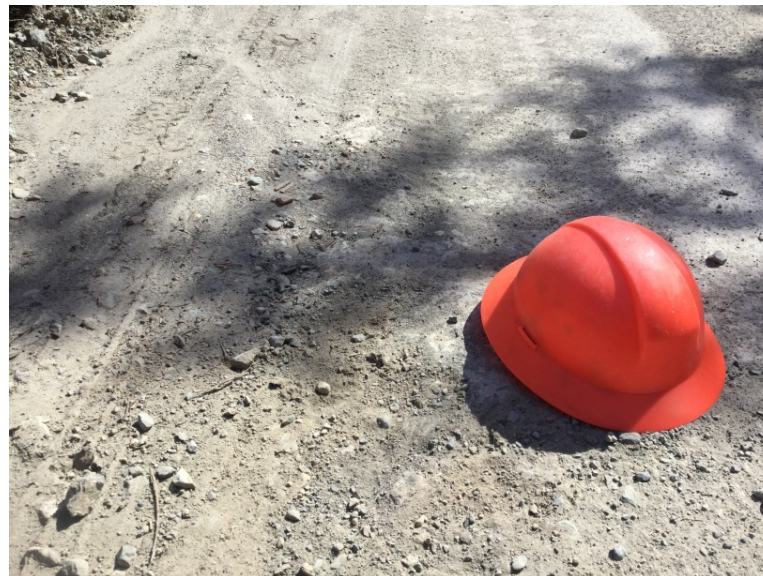
Concrete Deck Fair Wear noted at surface along wheel path

Wear noted to deck along wheel path

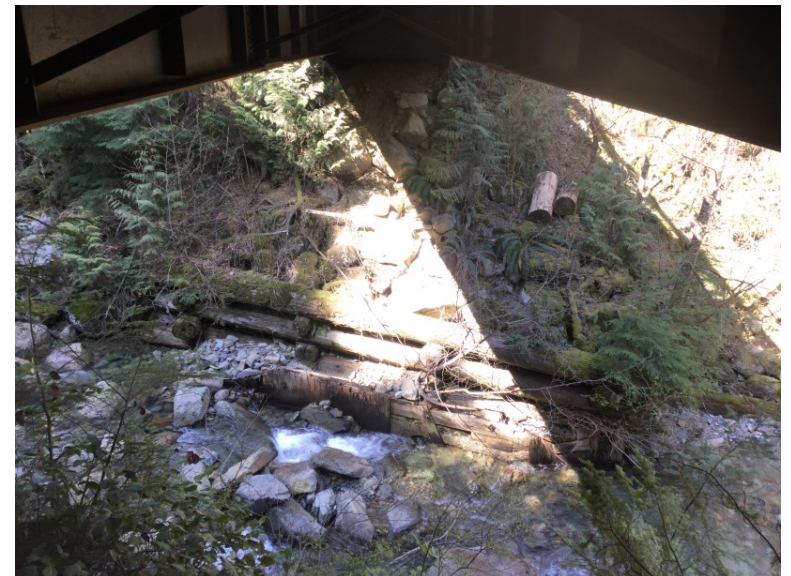
Left Bank Abutment when facing downstream

Piles or Posts Good Left bank

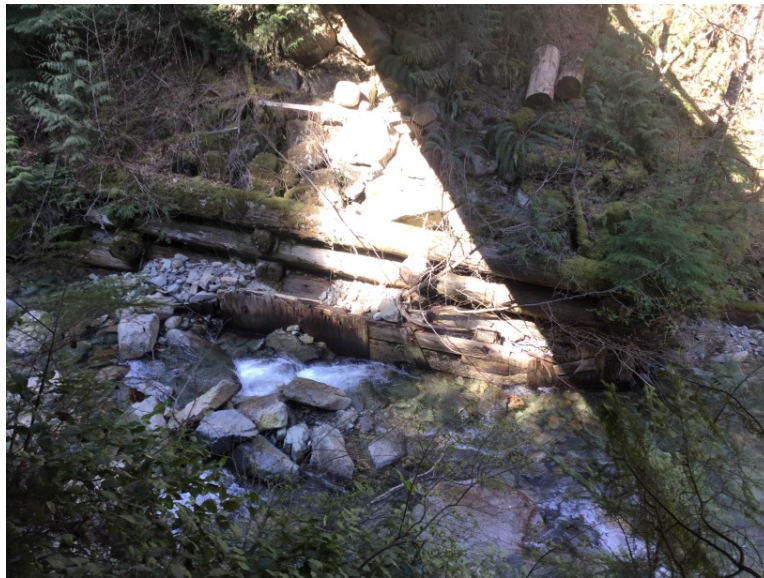
Partial old log crib still in tact at left bank

| Item | Monitor Description | Frequency |
|---|---|---|
| 1 | Old log crib condition | Routine Inspection |

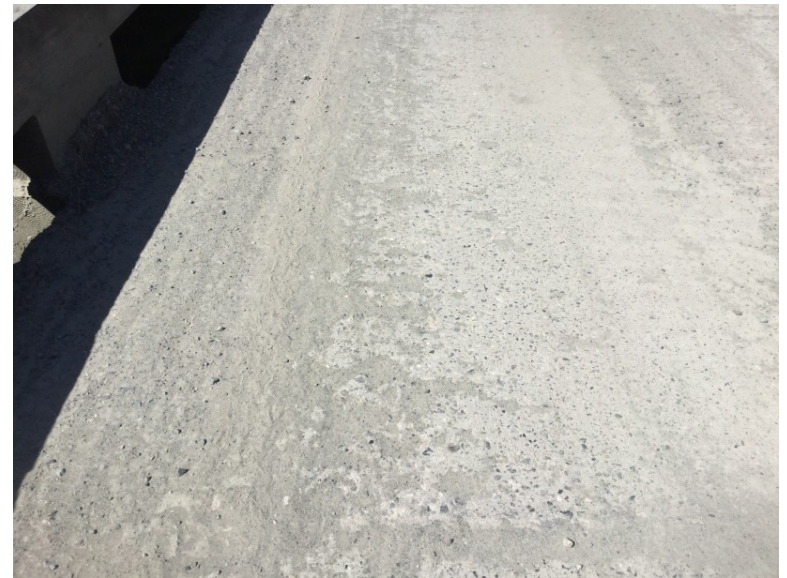
Panels wearing across deck on wheel path

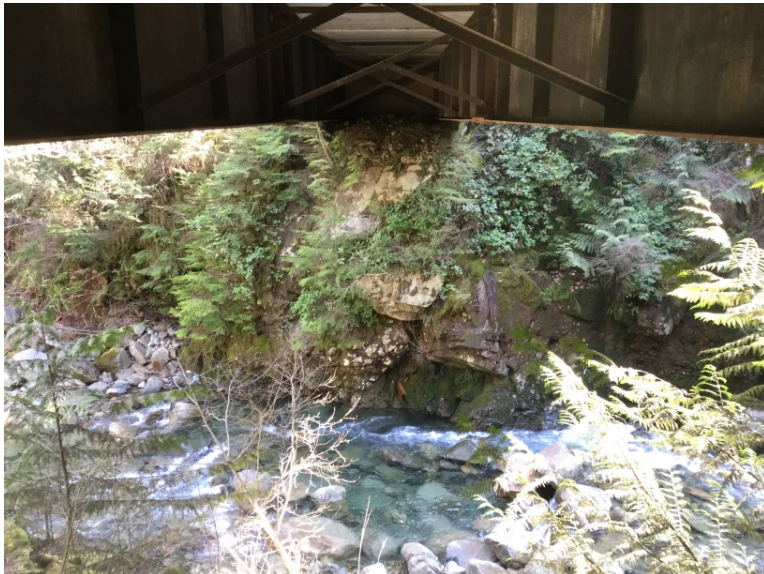
Right Bank Abutment when facing downstream

Concrete Good Right bank
