CK-2143

STS'AILES (WEST) 55.4km

2020 Inspection

| Crossing Name | Doctors Creek | | |

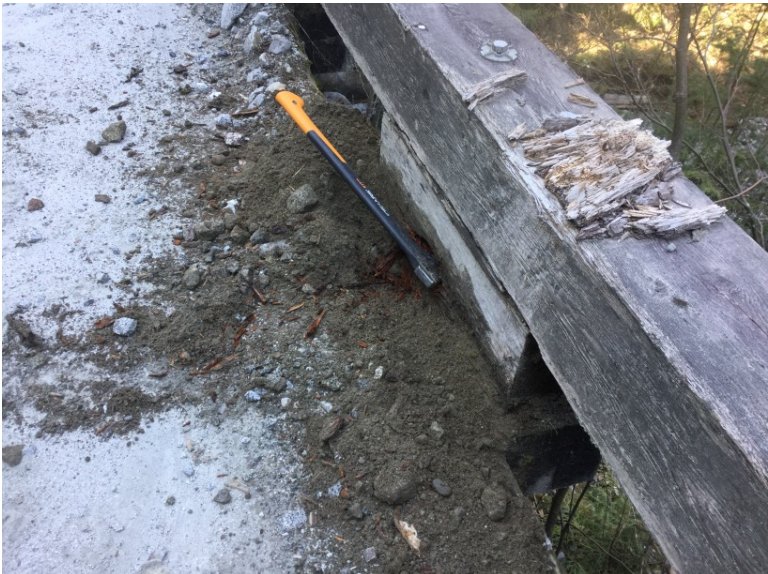
Guard Rail

Curb Rail/Blocks/Posts Poor Rotten

Hardware Poor Loose rail bolts

Overall Deck Condition Poor Due to rail condition

| 1 | High | Replace guardrail, risers and blocks |

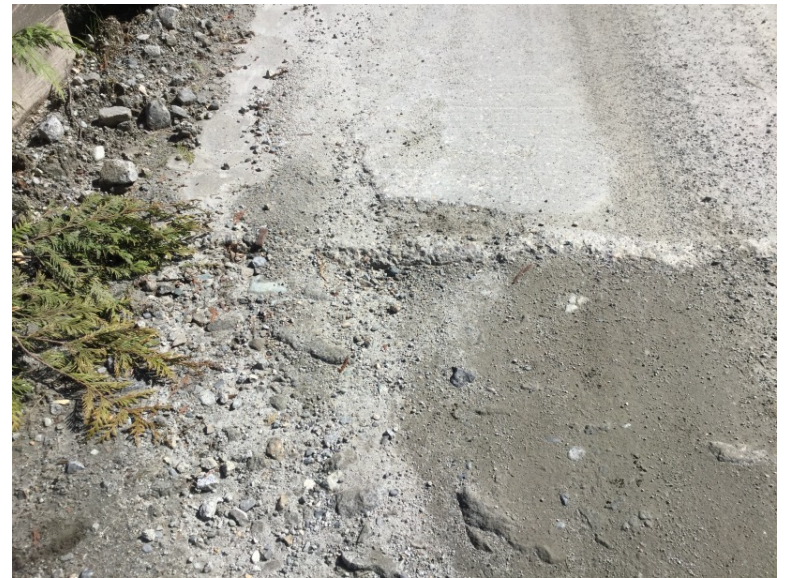
Ballast Wall Fair Minor damage at surface noted

Damage noted to ballast wall and deck panel on wheel path

| 3 | Medium | Repair damaged concrete |

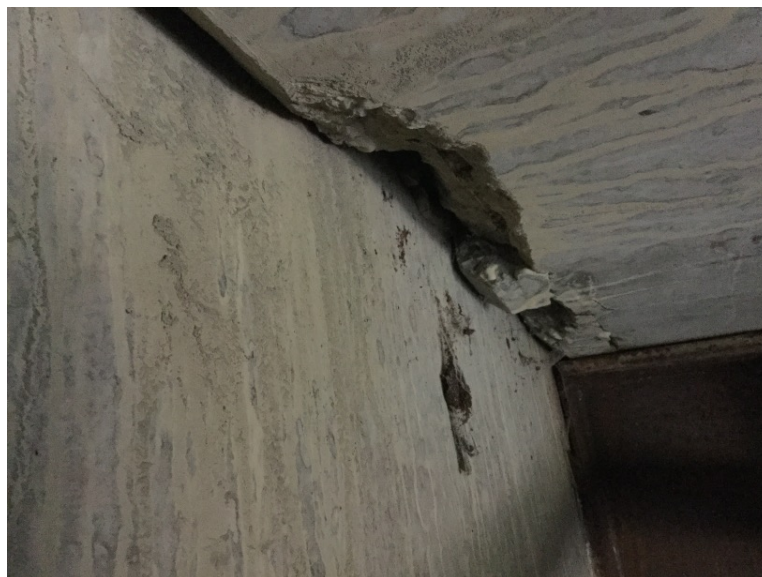
Concrete Deck Fair damage noted underneath on panel 1 at right bank

Damage to underside of panel 1 right bank

Repair the damage noted to the top of the ballast walls and to the underside of deck panel 1 at right bank consistent with the Concrete Repair Guide for Concrete Bridge Components MoFLNRO (2017). Replace the guardrail, risers and blocks. Brush approaches and remove sediment from deck. The current load rating of CL-625 or 63 tonnes to continue. Update the load rating signs.
