CK-2144

STS'AILES (WEST) 56.3km

2020 Inspection

| Crossing Name | Bremner Creek |

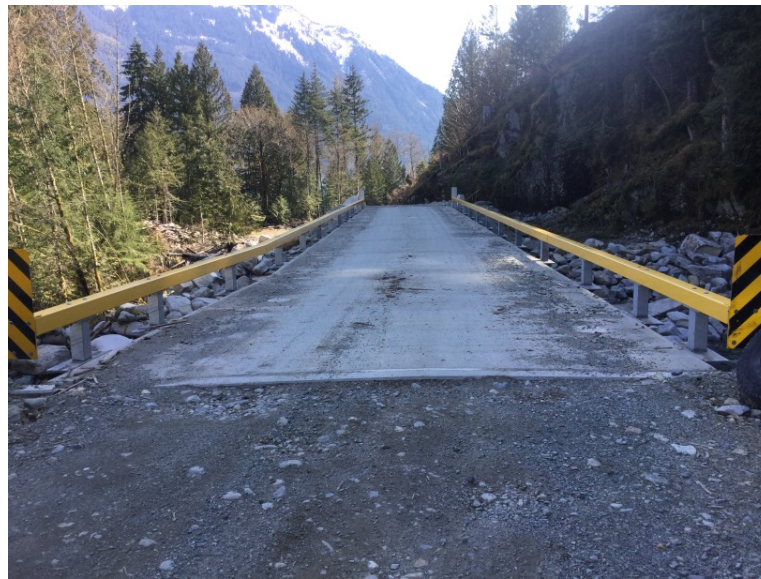
Overall Deck Condition      Good

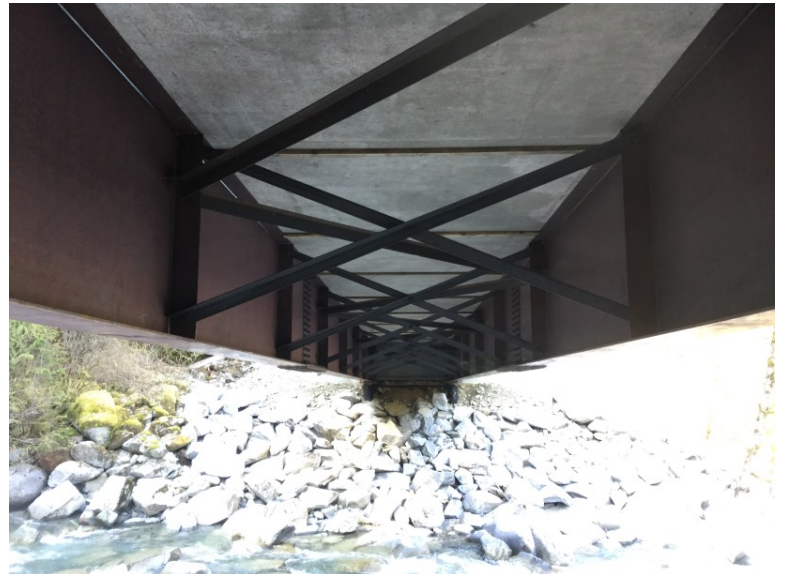
Superstructure

Girders Good
