CK-2146

STS'AILES (WEST) 64.4km

2020 Inspection

| Crossing Name | Coon Creek | | |

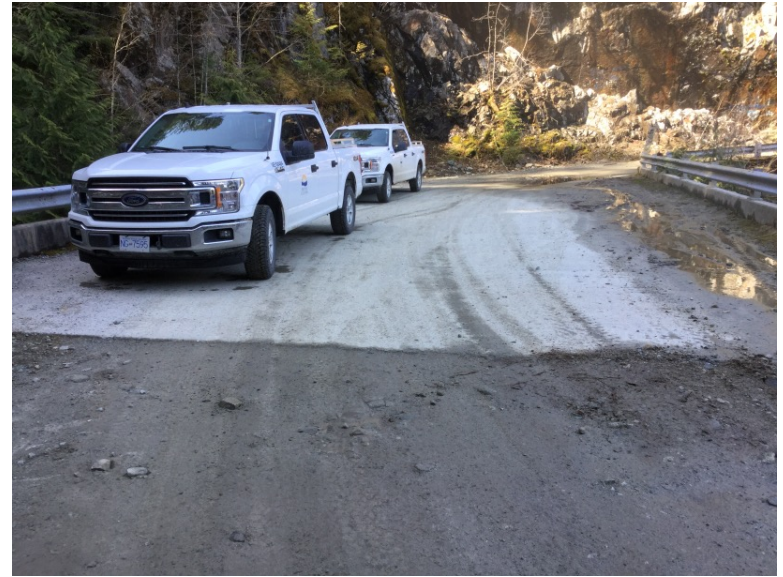
Deck

| Running Surface | Fair | Sediment accumulating on deck |

| 1 | Medium | Clean sediment from deck |

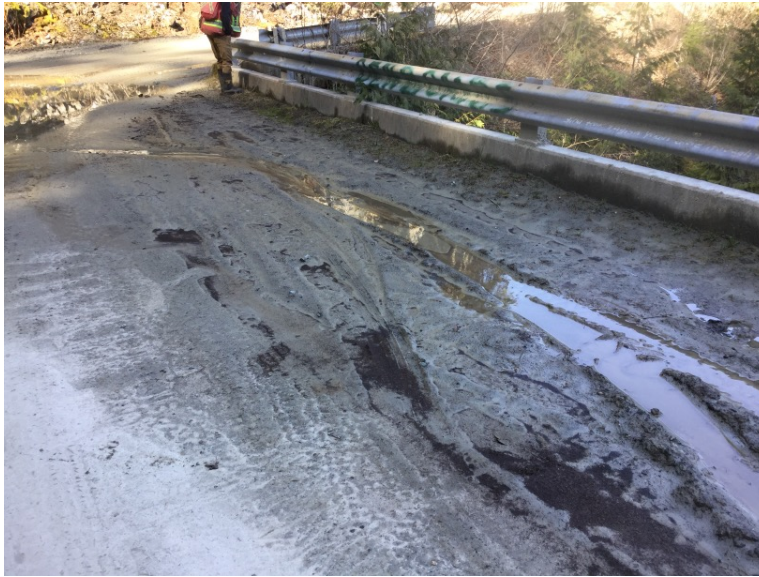
Sediment on deck

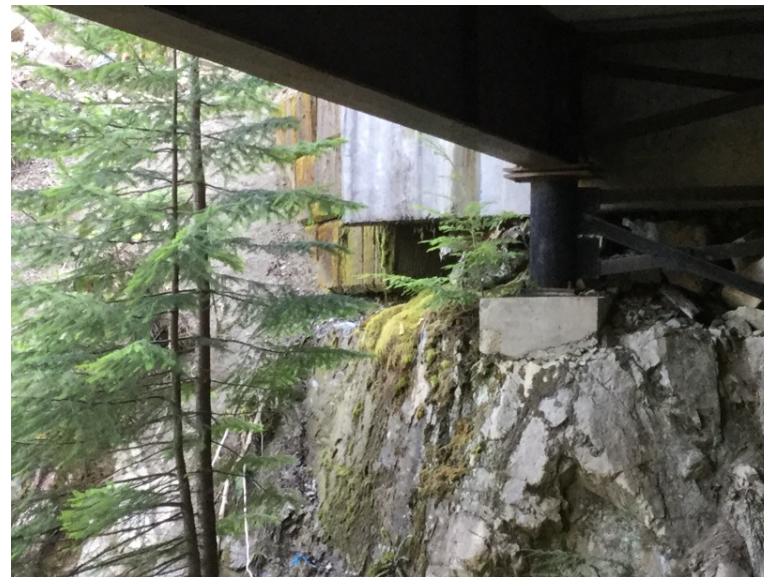
Minor erosion noted under tight bank base lock block, no settlement noted

Downstream right bank is susceptible to erosion

Downstream right bank wingwall undermined

| 1 | downstream right bank fill slope | Routine Inspection |
