CK-2157  
CK-2157

HUNTER 2.2km

2020 Inspection

| Crossing Name | Hunter Creek |

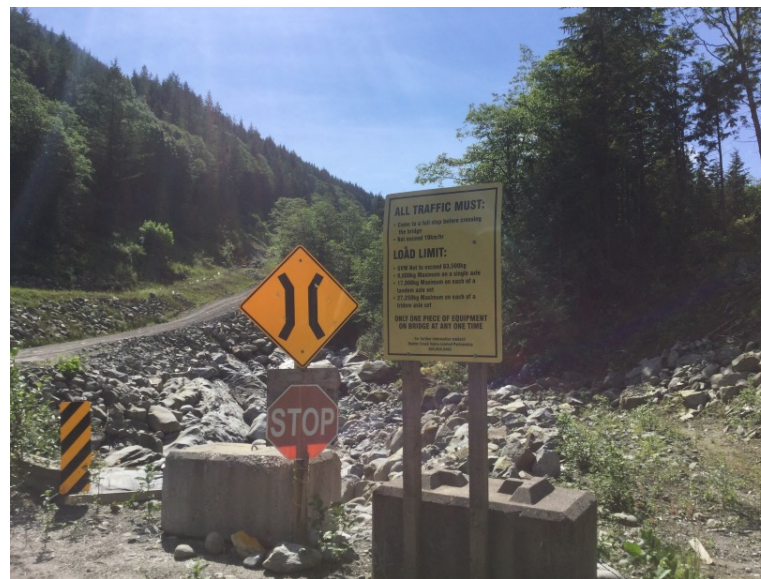
### Load Rating Sign

Posted Load Rating 63500

See picture

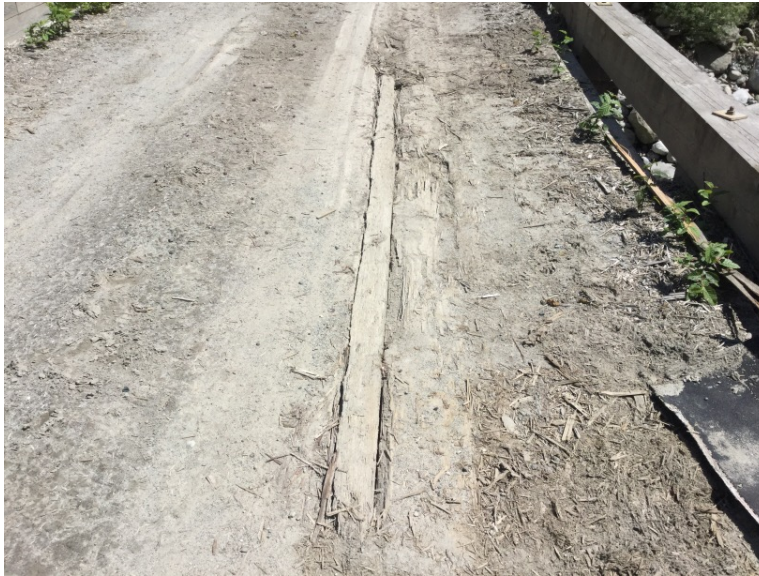
Poor

Rotten

Starting to protrude through planks

Due to plank condition

Plank condition

Replace the wear planks and thoroughly inspect the subdeck at that time - replace poor subdeck materials. Replace the downstream right approach boulders with a log fender, min 6m length x 600mm diameter.

| Repair Item | Repair Description |
|---|---|
| 1 Structure. Minor redecking (wearing surface). m.<br>Priority:High | Replace wear planks |

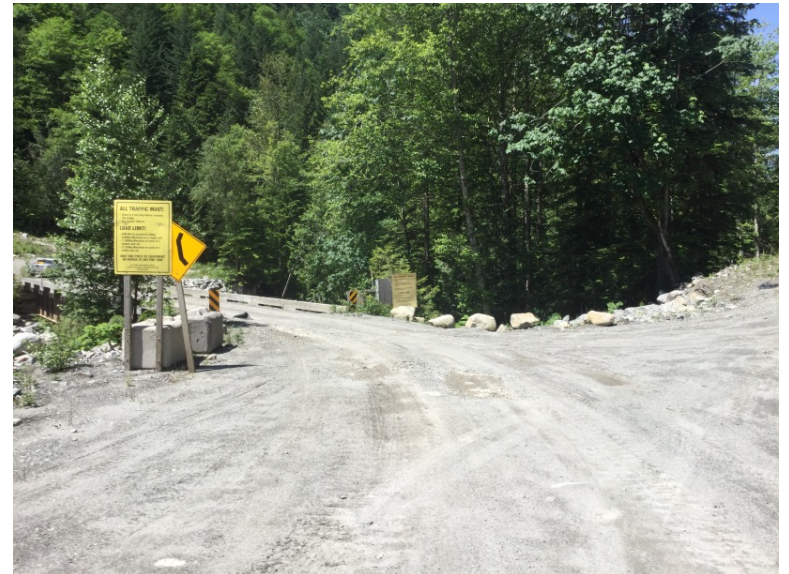
Approach from Right Bank when facing downstream

Fender Condition Fair

Combination of lock blocks, rock and logs

| Repair Item | Repair Description |
|---|---|
| 2 Approach. Approach fenders (install). # of units.<br>Priority:Low | Replace downstream right approach rocks with 6m length x 600mm fender |

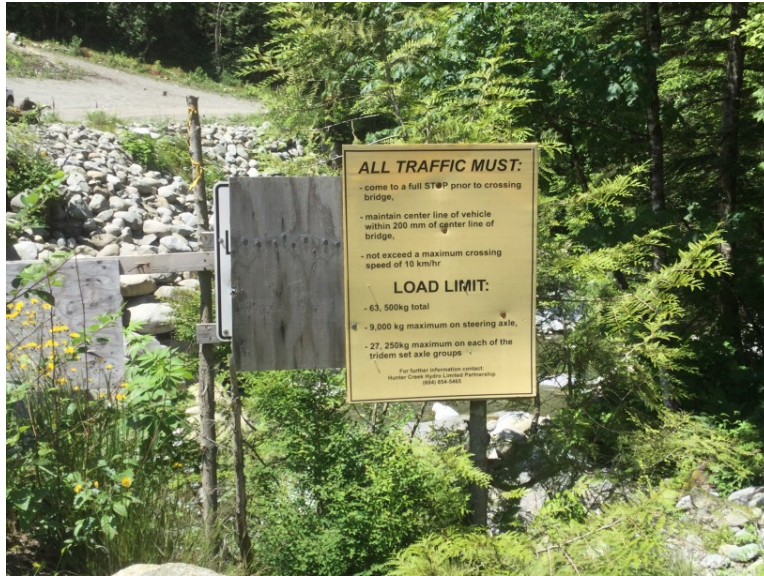
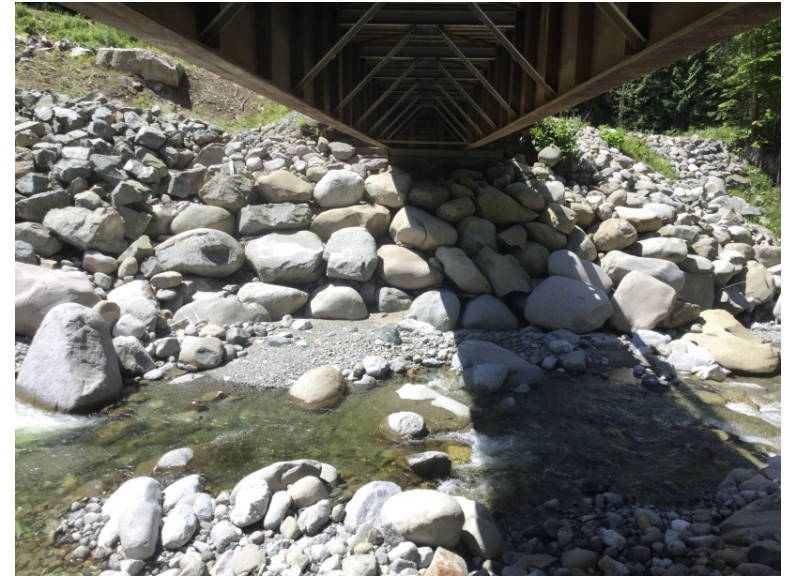
Left Bank Abutment when facing downstream

Only 2 face logs visible both banks with up to 40mm sap rot

Large round rock used at left bank, 1:1 slope

The log crib is 35 years old and nearing the end of its industrial life - monitor its condition and plan for a replacement structure soon. The current load rating of BCL-625 or 63 tonnes to continue, with the following restrictions: only 1 piece of equipment on the bridge at a time; 9,100 kgs maximum on a single axle; 17,000 kgs maximum on each tandem axle set; 27,250 kgs maximum per tridem axle set; full stop before driving onto bridge; maximum driving speed is 10km/hr; and centerline of the trucks is no more than 200mm off center of bridge.

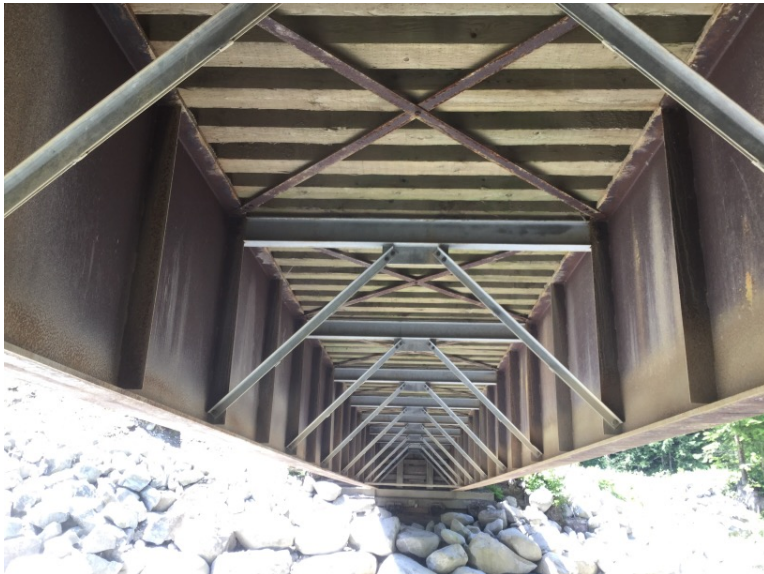
Superstructure

Minor sag in both girders

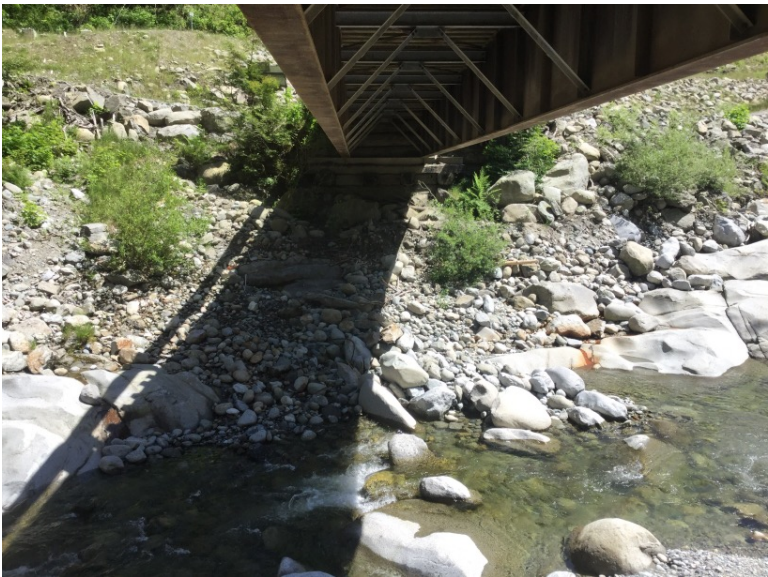
Right Bank Abutment when facing downstream

End splitting - Tiebacks under girders appear in fair condition, tiebacks outside of girders in poor condition
