CK-2167  
CK-2167

## LOST CREEK 8km

2020 Inspection

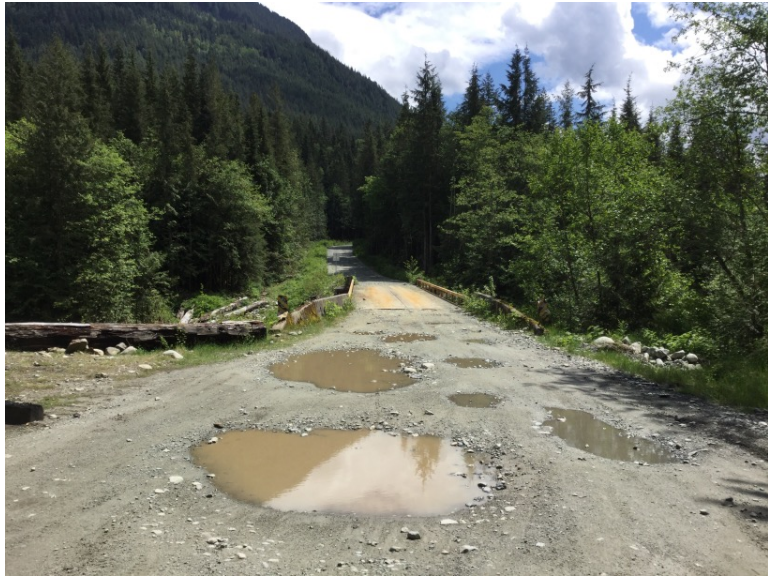
Approach from Right Bank when facing downstream

Road Surface Poor Potholes at both approaches

| Repair Item | Repair Description |
|---|---|
| 2 Approach. Approach surfacing grading. m.<br>Priority:Medium | Grade approaches |

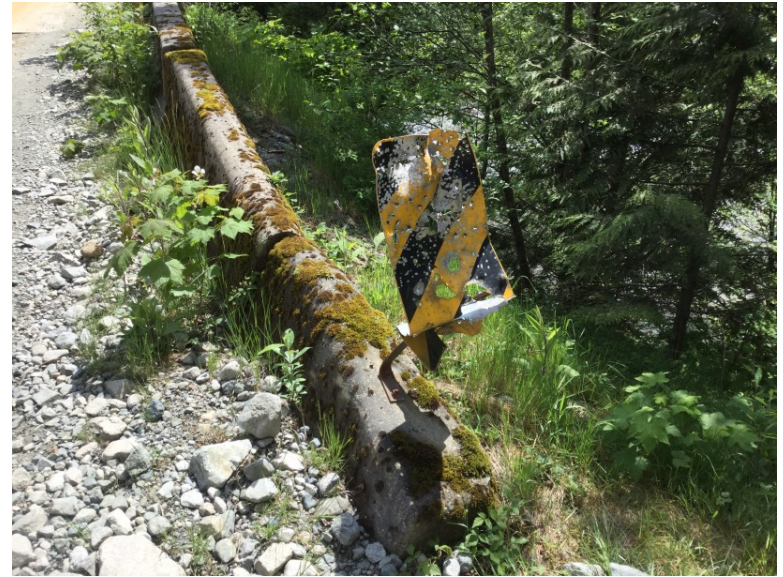
Existing delineators

| Repair Item | Repair Description |
|---|---|
| 1 Structure. Delineator maintenance. .<br>Priority:Low | Replace all delineators |

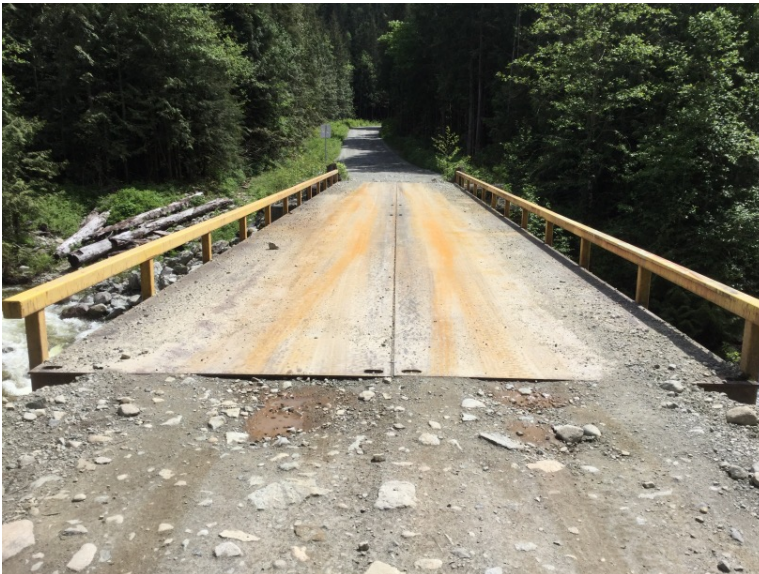
Steel Deck Plate      Fair      Minor damage on wheel path and all anti skid worn off

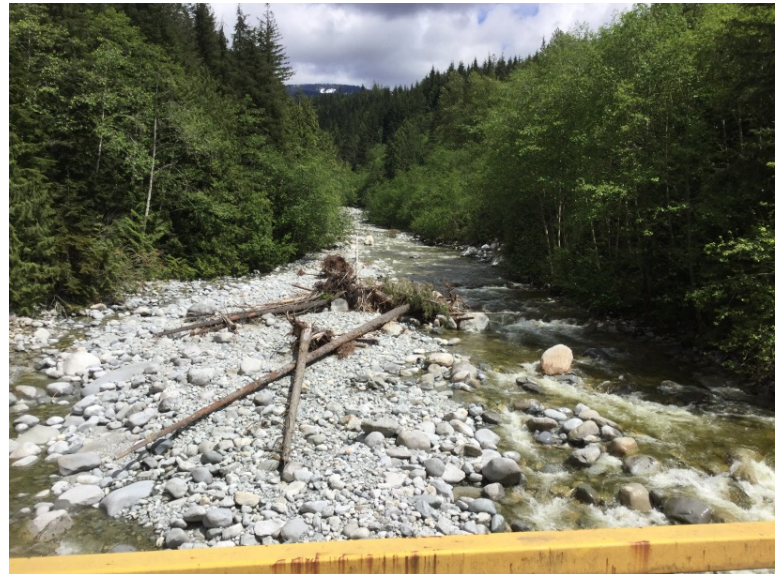
Upstream from Crossing

| Item | Monitor Description | Frequency |
|---|---|---|
| 1 | debris accumulations upstream | Routine Inspection |

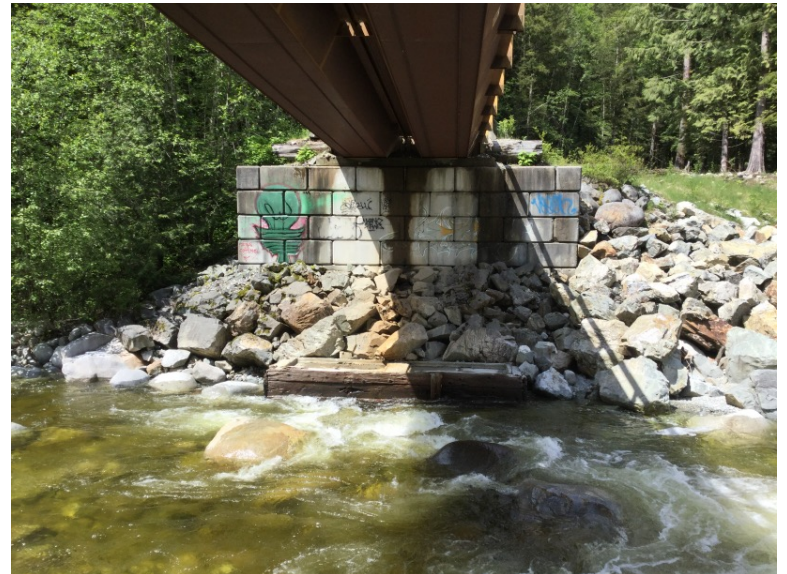
Right Bank Abutment when facing downstream

Concrete Good 5 rows of lock blocks visible
