CK-2171  
CK-2171

## LOST CREEK 17.8km

2020 Inspection

| Crossing Name | Kenyon Creek |

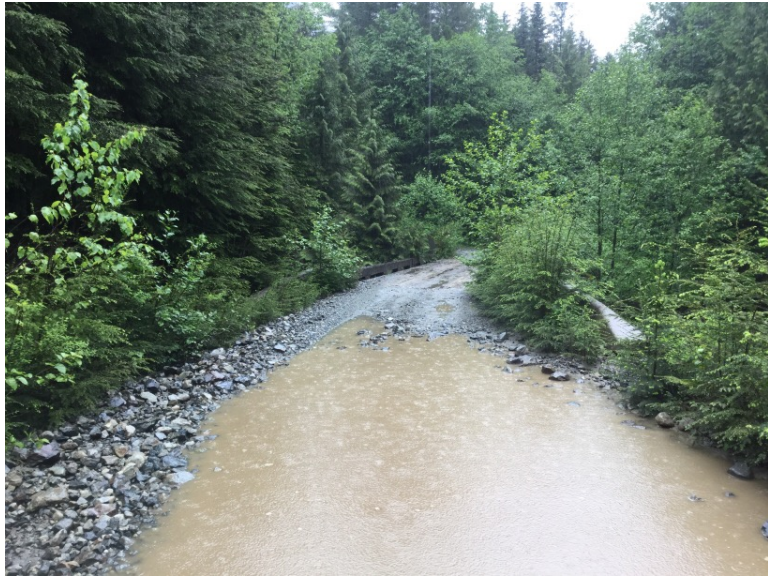
Approach from Right Bank when facing downstream

Road Surface Poor

Large potholes at both approaches

Replace the entire timber deck and guardrail system. Replace the missing delineators, brush and grade approaches and post bridge ahead signs. Take the additional CRB at both downstream approach locations and add them to the upstream ones. Limit loading to 5 tonnes, post load rating signs.

| Repair Item | Repair Description |
|---|---|
| 1 Approach. Approach surfacing grading. m. Priority:Medium | Grade approaches |

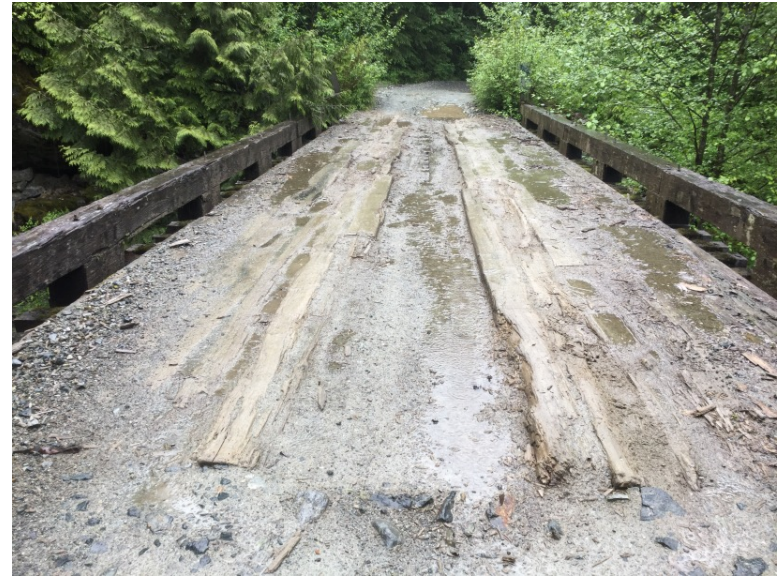
Overall Deck Condition      Poor      Rotten

| Repair Item | Repair Description |
|---|---|
| 3 Structure. Major redecking (crossties or laminated deck). m. Priority:High | Replace timber deck |

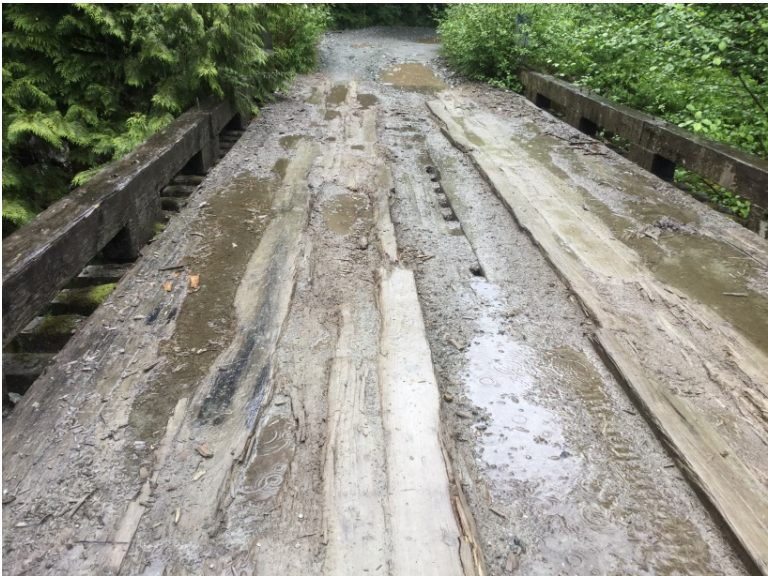
Plank condition

Running Planks      Poor      Rotten

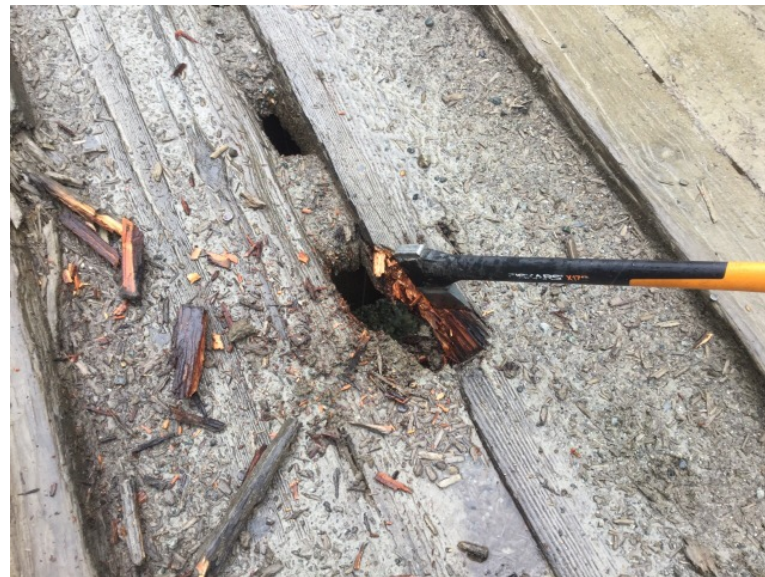
Subdeck condition

Sub Deck      Poor      Rotten

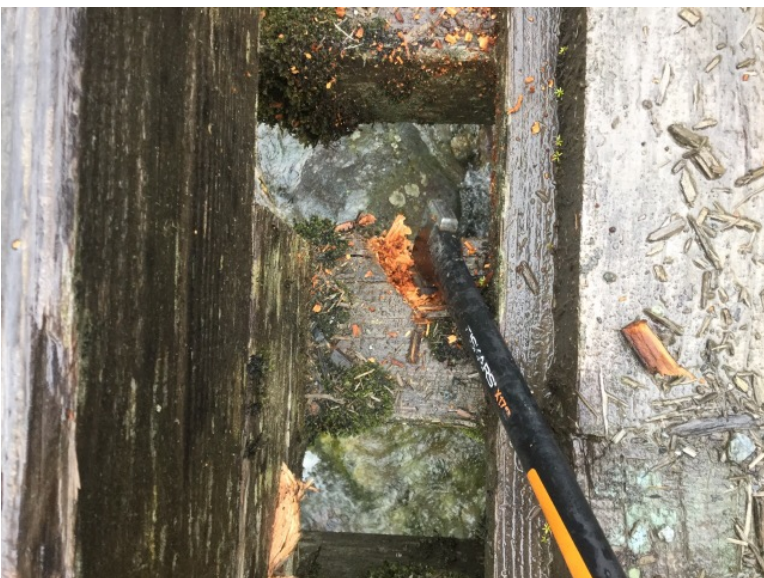
Tie condition

Ties      Poor      Rotten

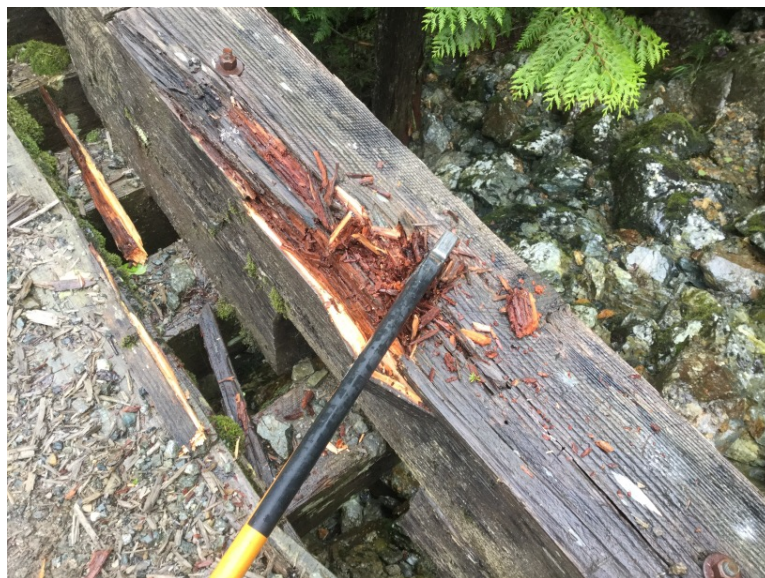
Guardrail condition

Curb Rail/Blocks/Posts      Poor      Rotten

Hardware      Poor      Loose rail bolts

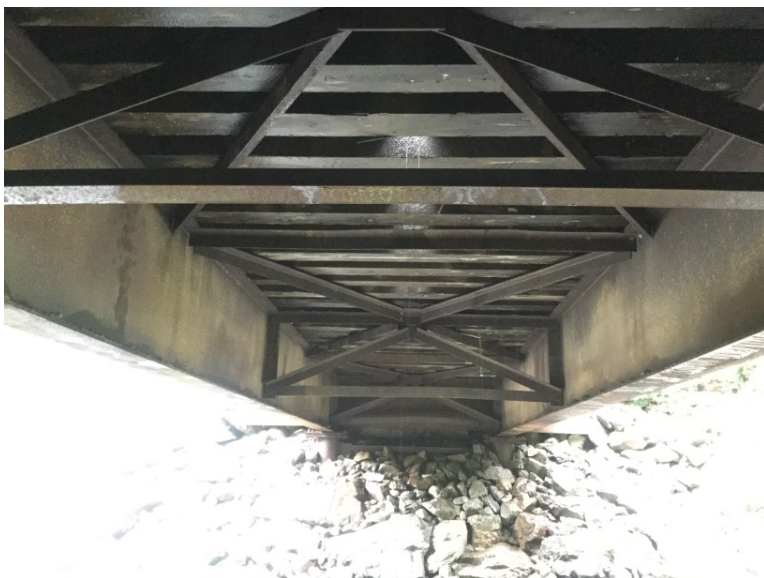
Superstructure

Does not appear as though it was coated

Girders Fair Minor surface corrosion

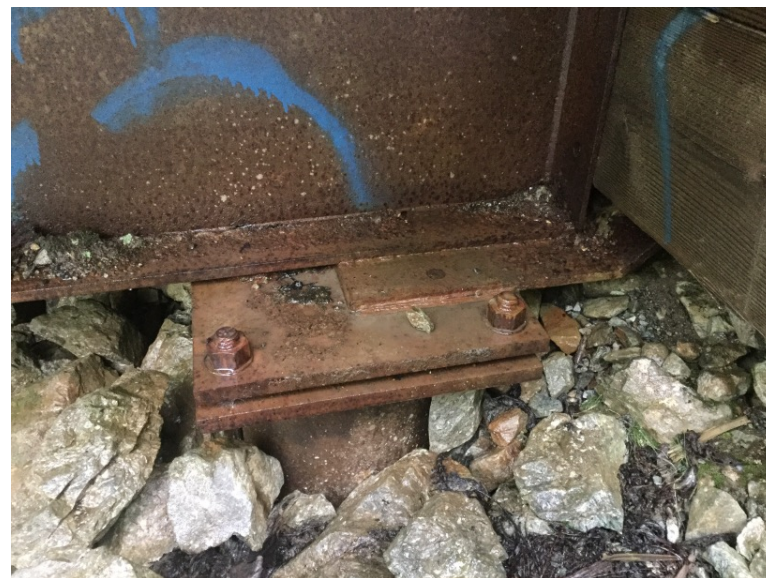
Downstream left bearing

Bearings Fair
