CK-2199  
CK-2199

NAHATLATCH 34.2km

2020 Inspection

Crossing Name Tachewana Creek

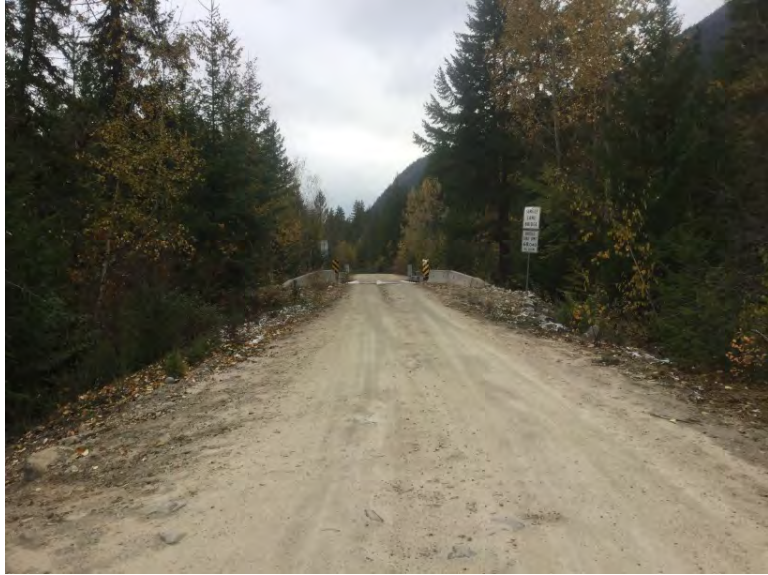
Approach from Left Bank when facing downstream

Road Surface Poor Potholes at approaches

Grade approaches. The current load rating of L75 or 68 tonnes to continue.

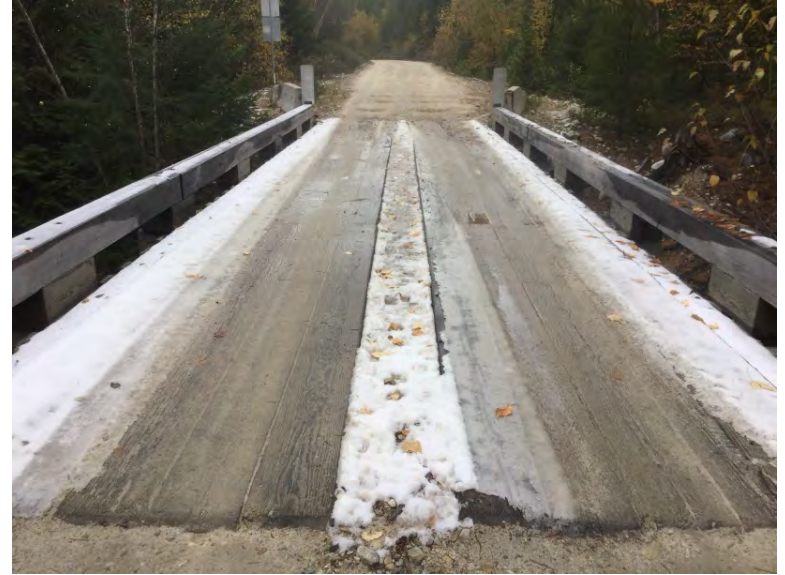
Overall Deck Condition Fair

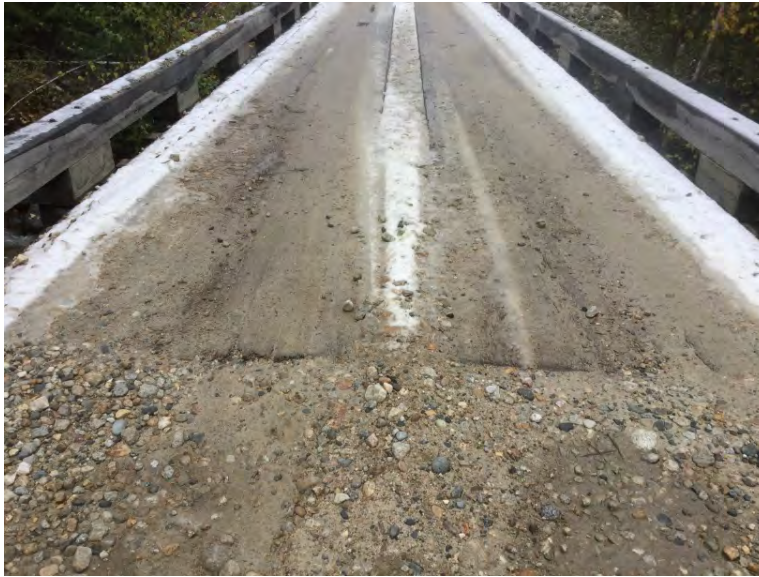
Running Planks Fair

Minor wear on planks

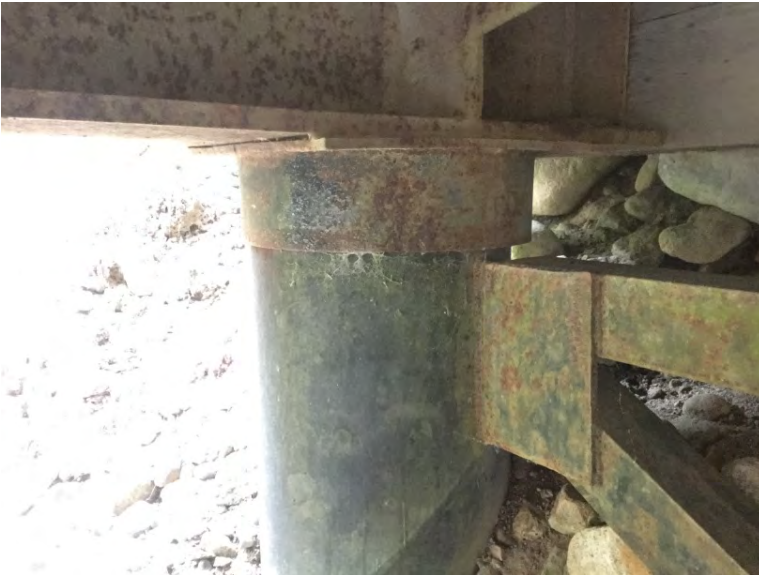
Bearing

Bearings Fair

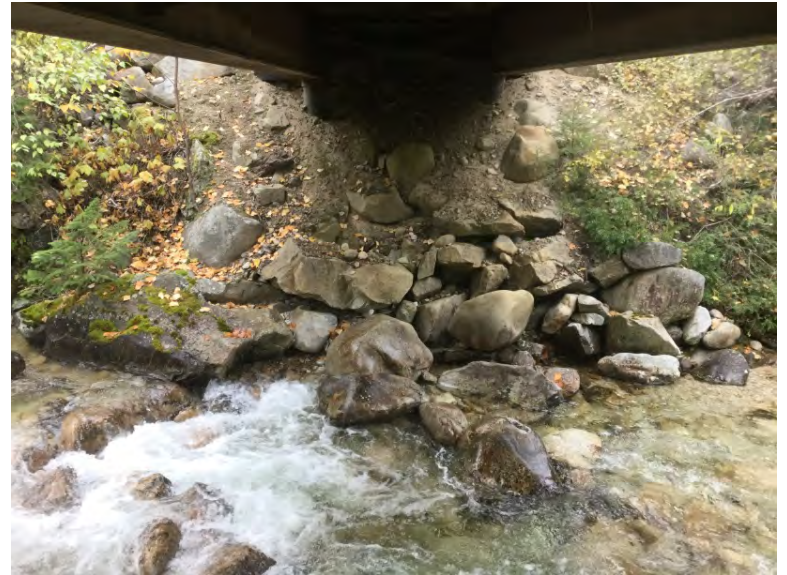
Left Bank Abutment when facing downstream

Fill Fair Ravelling from behind both ballast walls but stable

Riprap Fair Loose, round and not well keyed

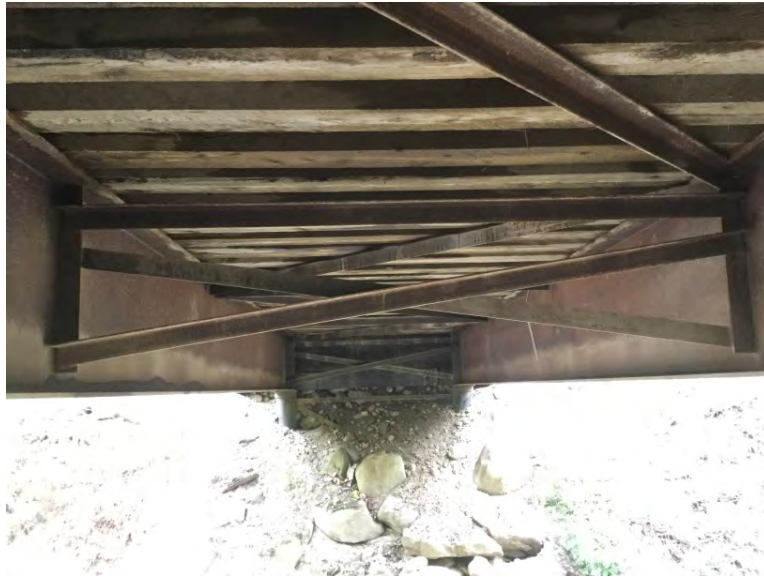
Superstructure

Girders Fair Minor corrosion

Diaphragms Fair 3 welded bays
