CK-2201  
CK-2201

KOOKIPI 3.2km

2020 Inspection

Crossing Name Kookipi Creek

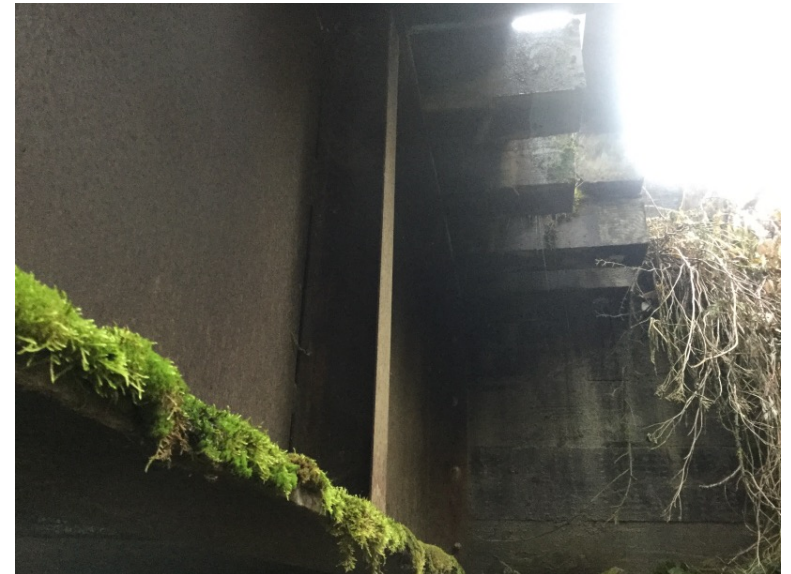
Stiffener located 1880mm from girder end on right bank and 1940mm on left bank

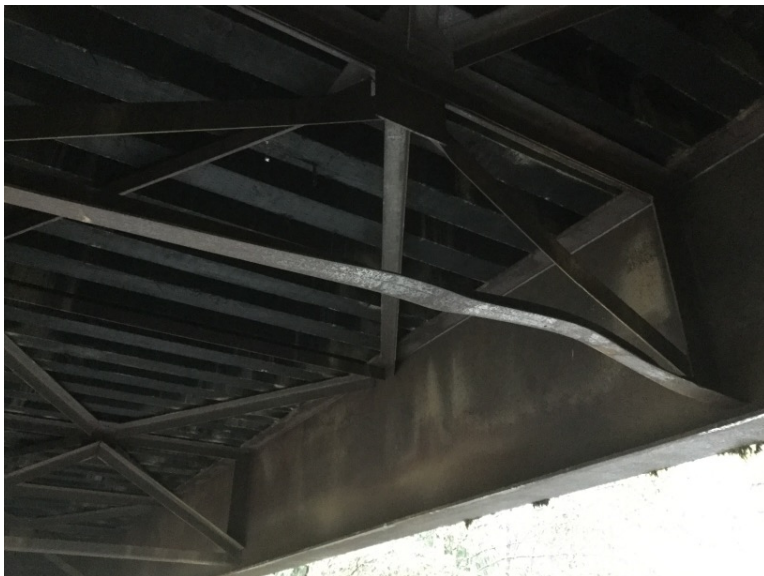
Bottom chord on 2nd diaphragm on right bank distorted
