CK-2202  
CK-2202

KOOKIPI 15.8km

2020 Inspection

Crossing Name Side Creek

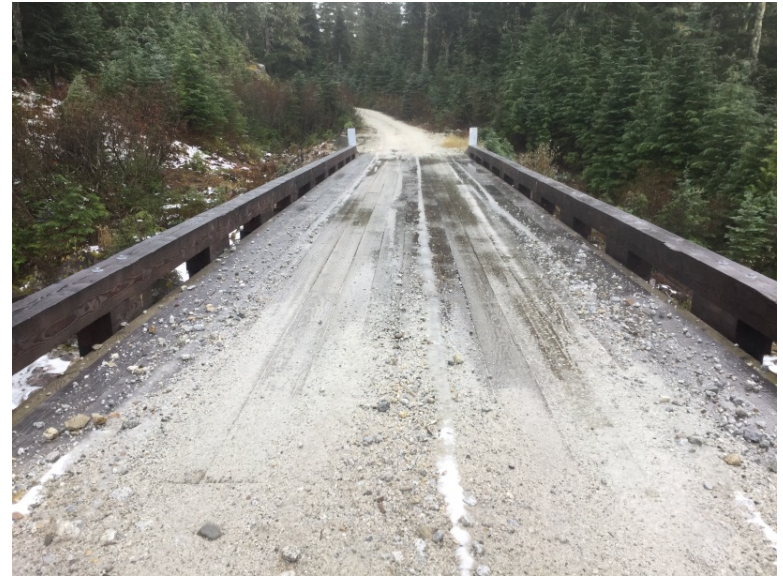
Overall Deck Condition      Good

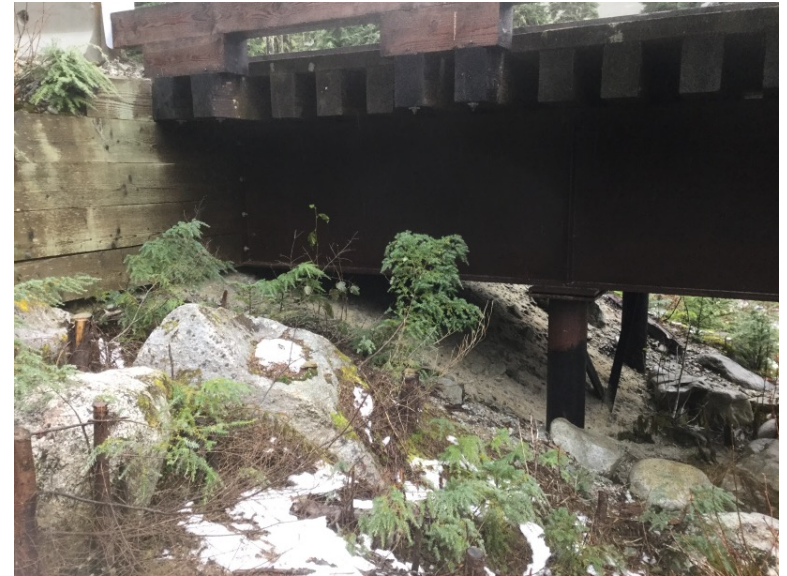
Bearing

Bearings Good

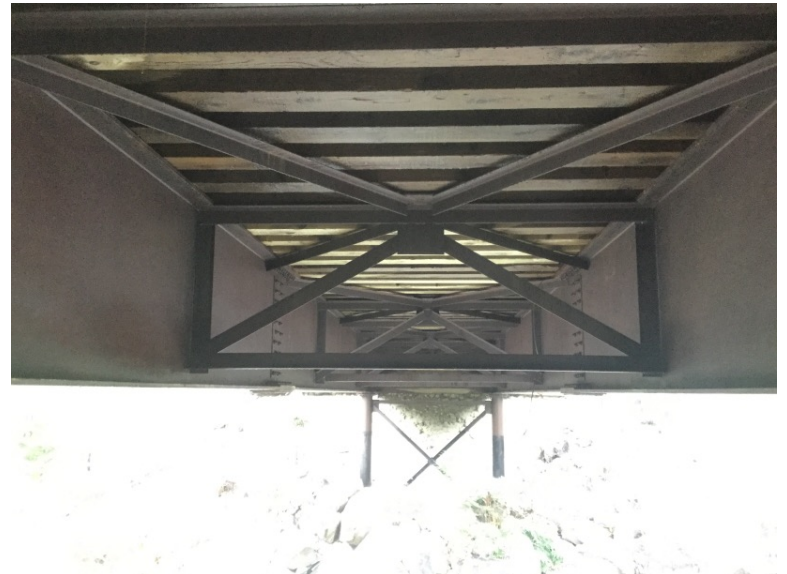
Superstructure

Diaphragms Fair 6 welded bays

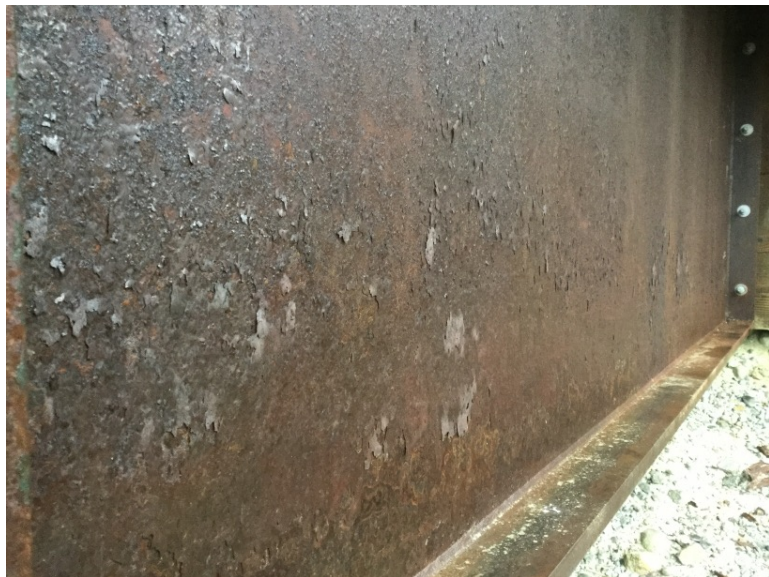
Girders Fair Minor corrosion

Corrosion on girders
