CK-2209  
CK-2209A

MOWHOKAM EAST 0.1km

2020 Inspection

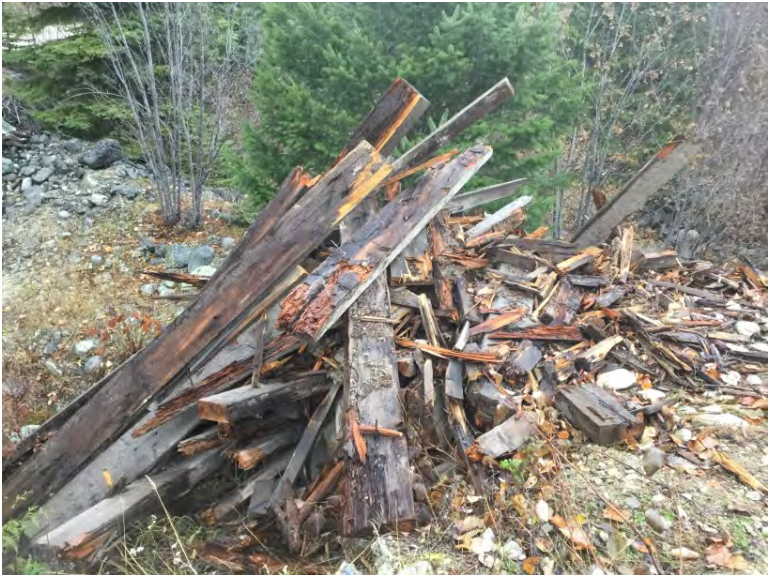
Old planks and subdeck

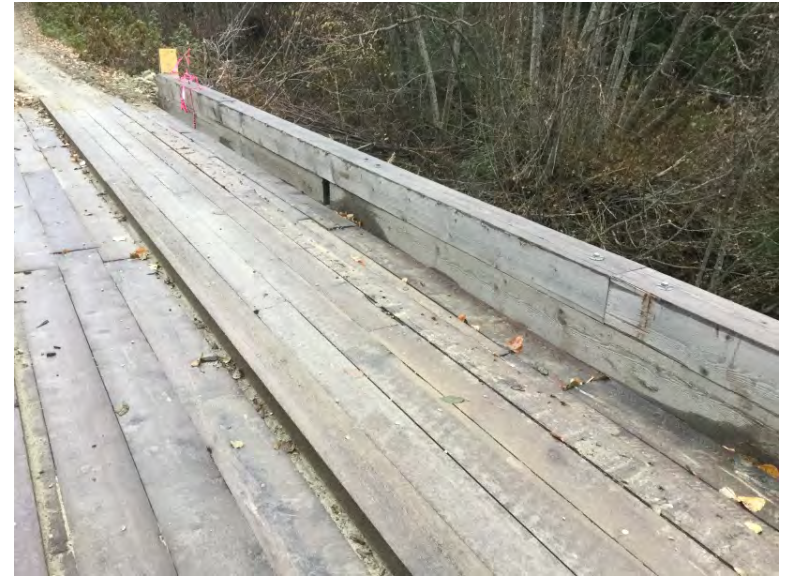
Downstream has full length risers

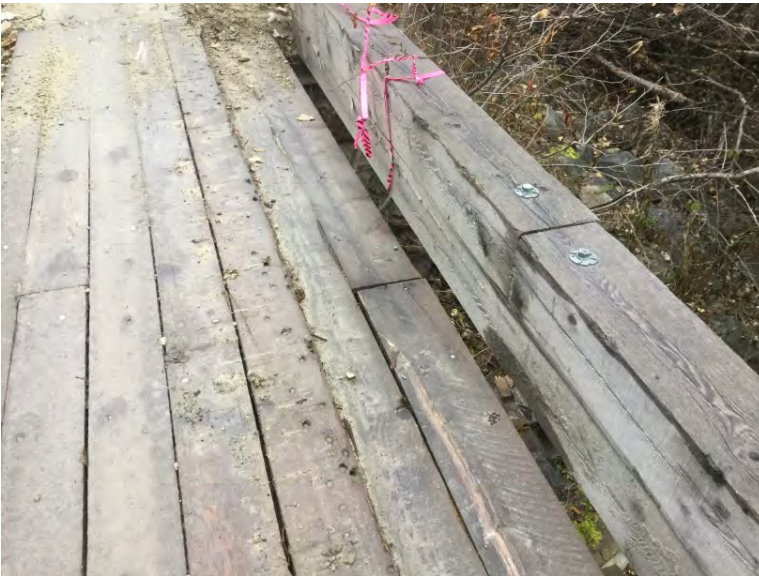
The subdeck and planks were recently replaced; however the cross ties were not. The cross ties were cored and sampled at various locations near their ends and rot was found, some ties had up to 50% rot at the sampled location. Also, the existing cross ties are not long enough in locations along the downstream ends to fully support the timber guardrail. The cross ties require replacement prior to industrial activity, when they are replaced ensure they're fastened to the girders. Add log fenders to each corner of the bridge. Limit loading to L30 or 27 tonnes. Post load rating signs. Continue to monitor the riprap condition and consider replacing it with angular material, that is well graded, sufficiently thick, keyed together and into the stream banks. Please submit the record drawings, structural drawings and Crossing Assurance Statements for this original installation.

Downstream left bank missing appropriate length ties

| Repair Item | Repair Description |
|---|---|
| 2 | Replace cross ties prior to industrial activity, and ensure they are fastened to the girders |

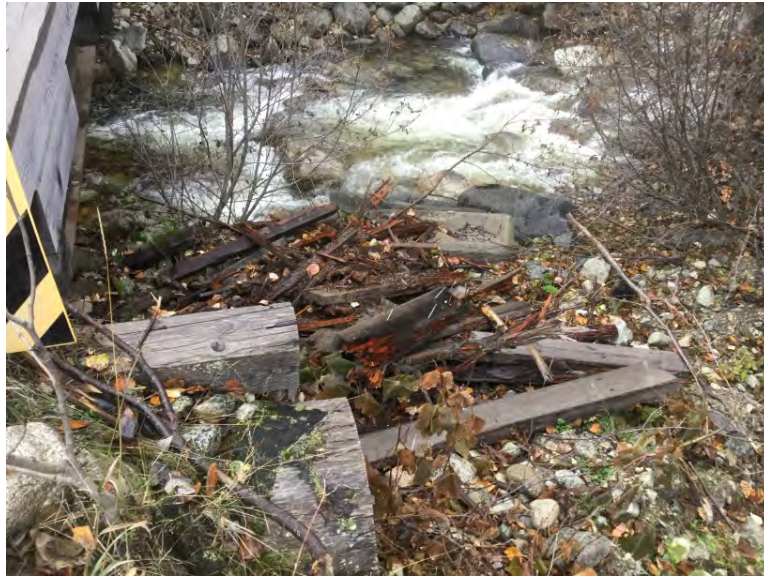
Old planks and subdeck spoiled at upstream left bank

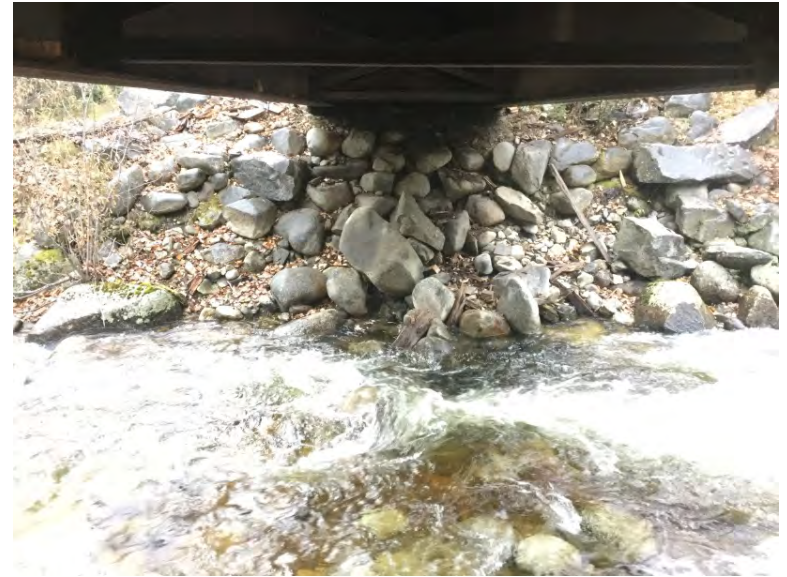
Right Bank Abutment when facing downstream

Oversteepened, round and not well keyed together or into the stream bed

| Repair Item | Repair Description |
|---|---|
| 4 | Add angular riprap to each abutment, ensuring its well graded, sufficiently thick, and keyed together and into the stream banks |

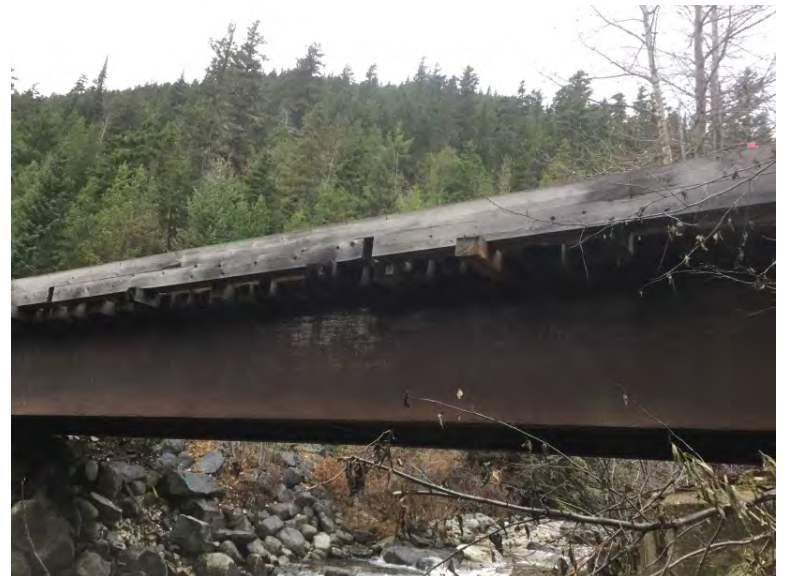
Guardrail and risers only fastened to a single in 6 locations along downstream end

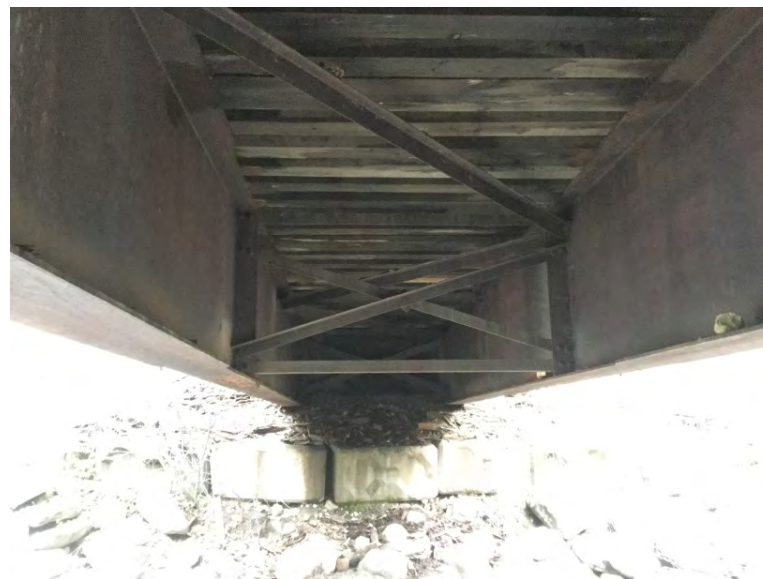
Superstructure

Only a section of a longer girder set used

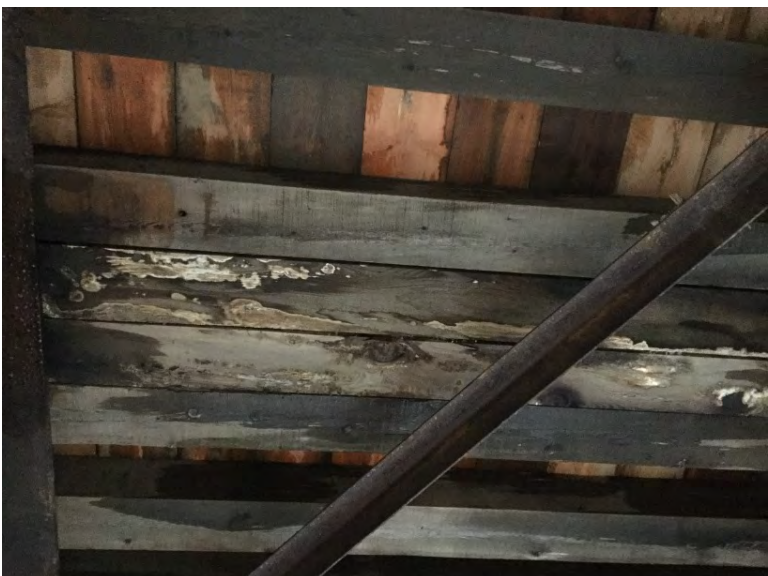
Only subdeck and planks were recently replaced

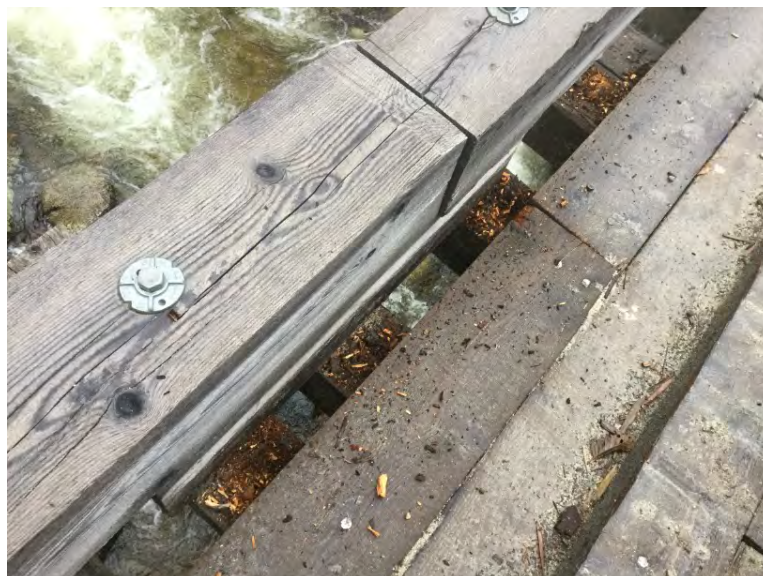
Ties      Poor      Significant rot on ends of ties at both upstream and downstream locations

Tie condition upstream

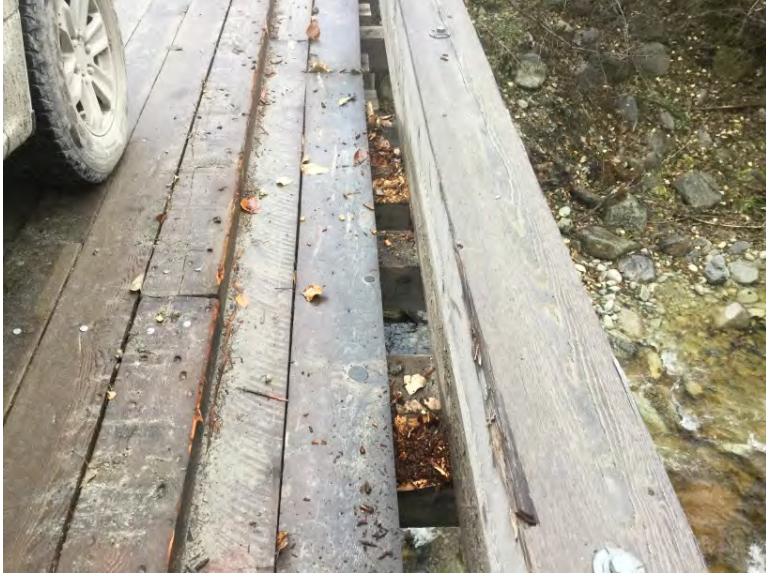
Tie condition downstream
