CK-2210  
CK-2210

## MOWHOKAM EAST 6.3km

2020 Inspection

Crossing Name Mowhokam Creek

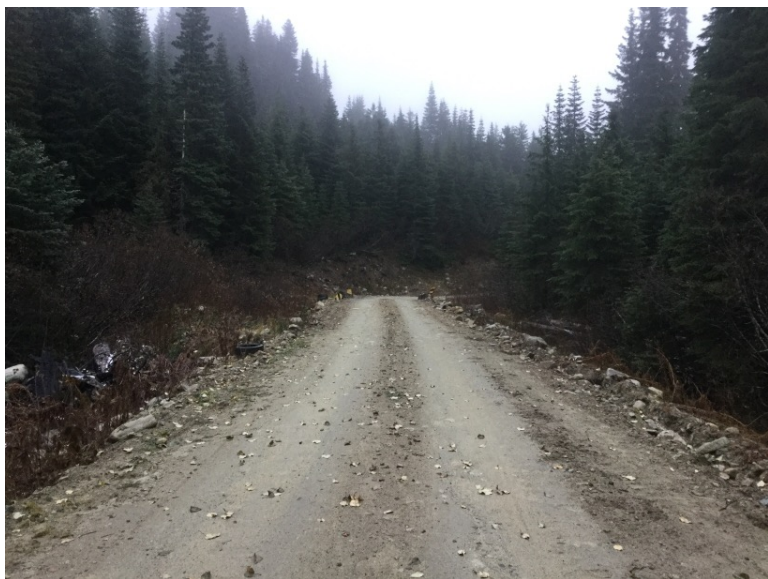
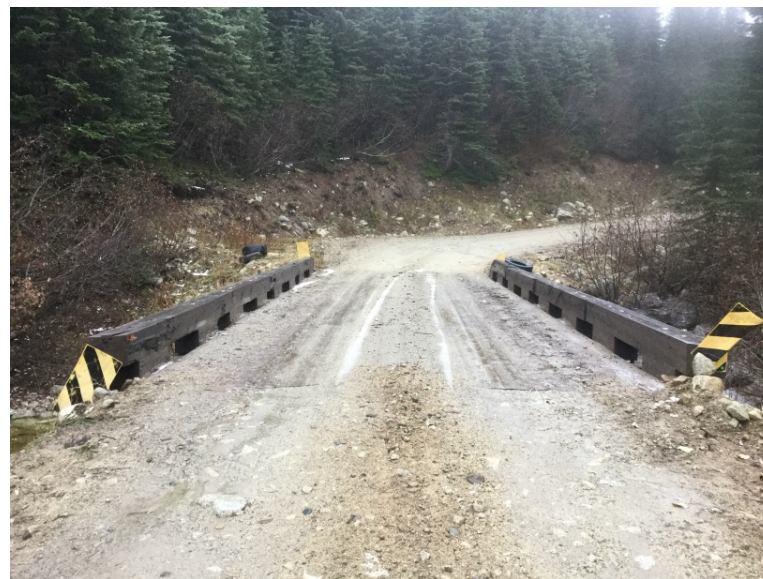
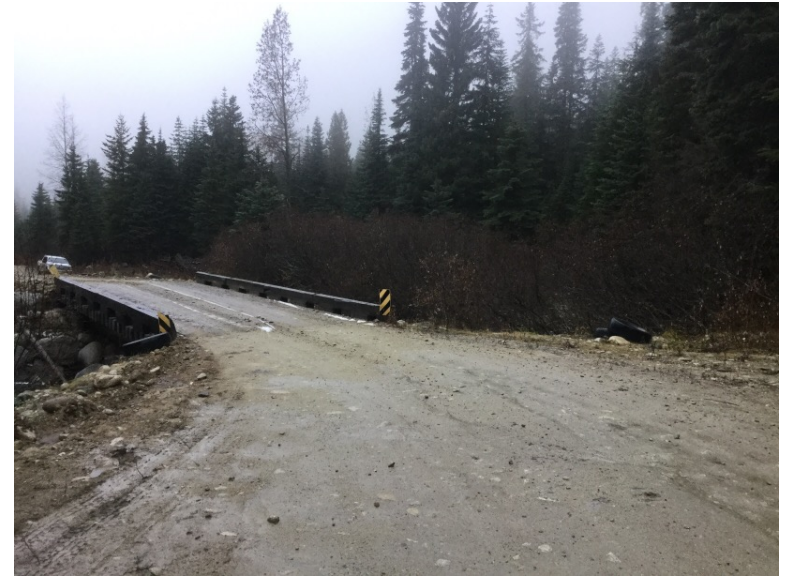
Delineator Missing  
Left ☒ 0 ☐ 1 ☐ 2 poor condition

Delineator Missing  
Right ☒ 0 ☐ 1 ☐ 2 poor condition

Fender Condition Poor None

Approach from Left Bank when facing downstream

Add log fenders at all 4 corners of the bridge, minimum 6m length x 600mm diameter. Replace all 4 delineators. L75 or 68 tonnes rating.

| Repair Item | Repair Description |
|---|---|
| 1 Approach. Approach fenders (install). # of units. Priority:Medium | Install log fenders |
| 2 Structure. Delineator maintenance. . Priority:Medium | Replace all 4 delineators |

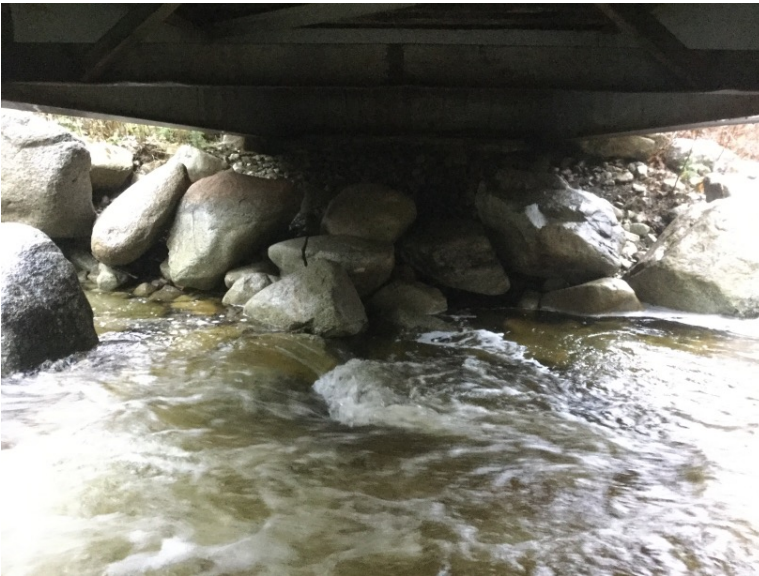
Left Bank Abutment when facing downstream

Caps or Sills Fair Single log sills

Riprap Fair round rock not well graded or keyed into streambed

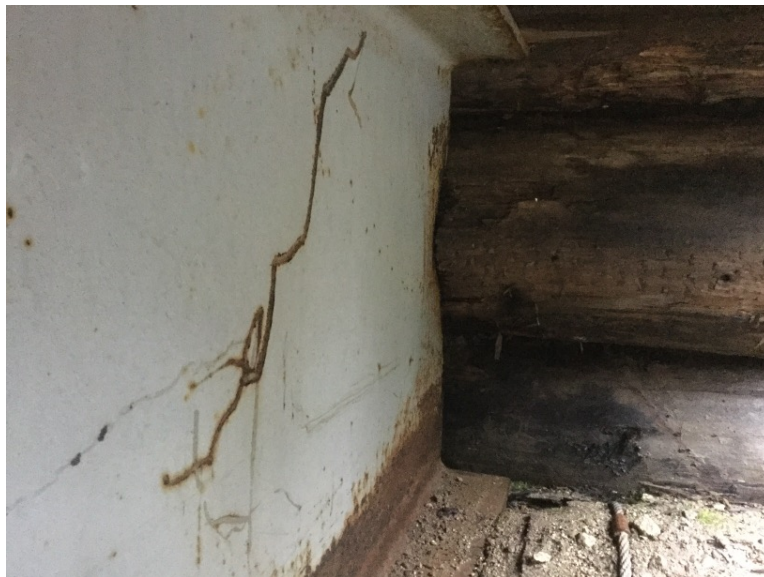
Painted. Web distortion noted upstream right bank

Minor web distortion

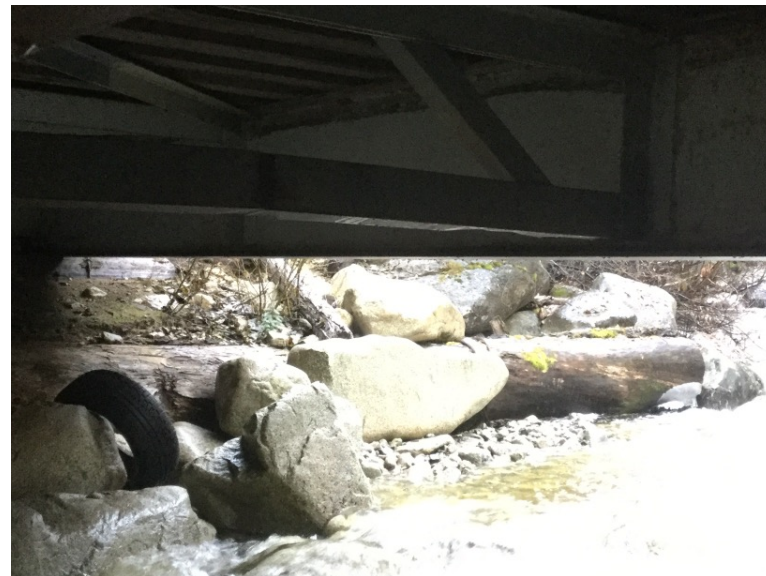
Distortion noted on bottom chord

Bottom chord damage
