## Permanent Bridge Inspection Report

| Structure #: | CK-2213 | Site #: | CK-2213 | Road Name: | PEERS | Inspection Date: | 2020/06/21 |
| KM: | 0.20 | User km: | 0.20 | Crossing Name: | Coquihalla River | Next Inspection Date: | 2021/06/21 |

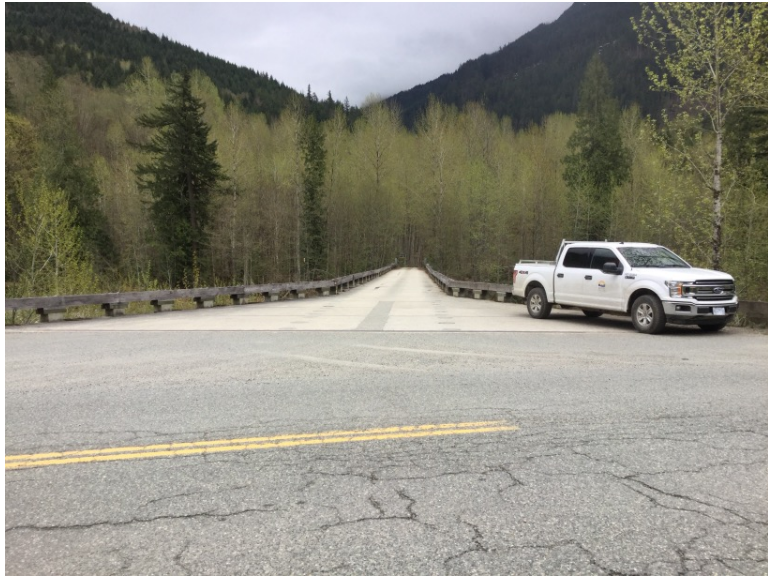
Approach from Right Bank when facing downstream

| Alignment | Fair | T jct at right bank |

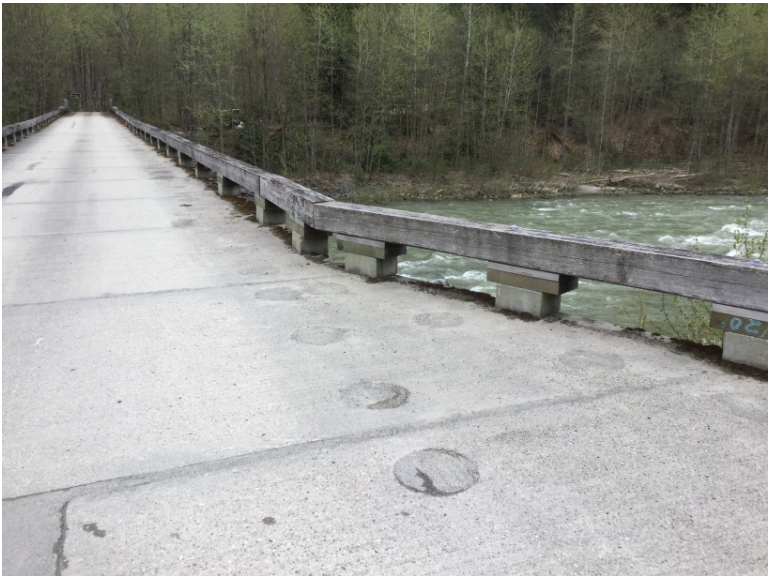
Guard Rail

| Hardware | Fair | Loose rail bolts | | | | | |
| Hardware | Fair | loose rail bolts | | | | | |

| | 1 | Suggested | Medium | \$ | tighten loose rail bolts | | | | | |

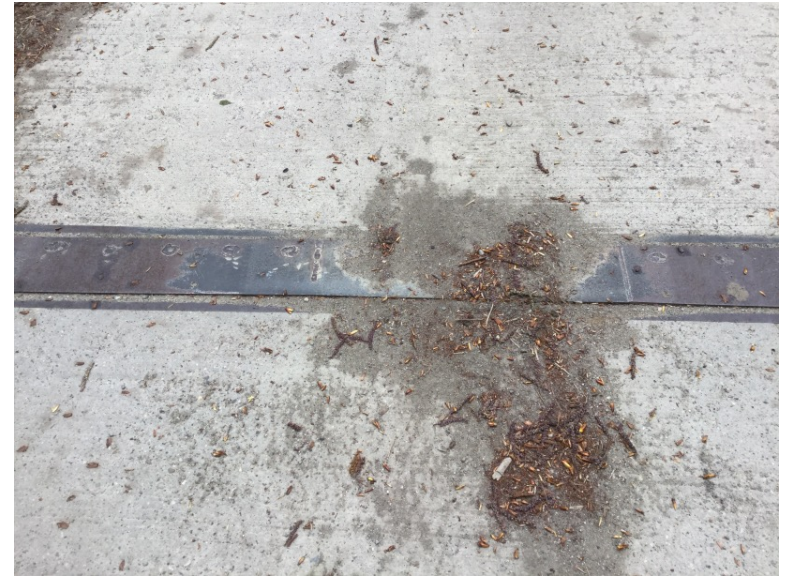
Left span to center span deck joint

| Deck Joints | Fair | unsealed and indications of moisture getting through | | | | | |

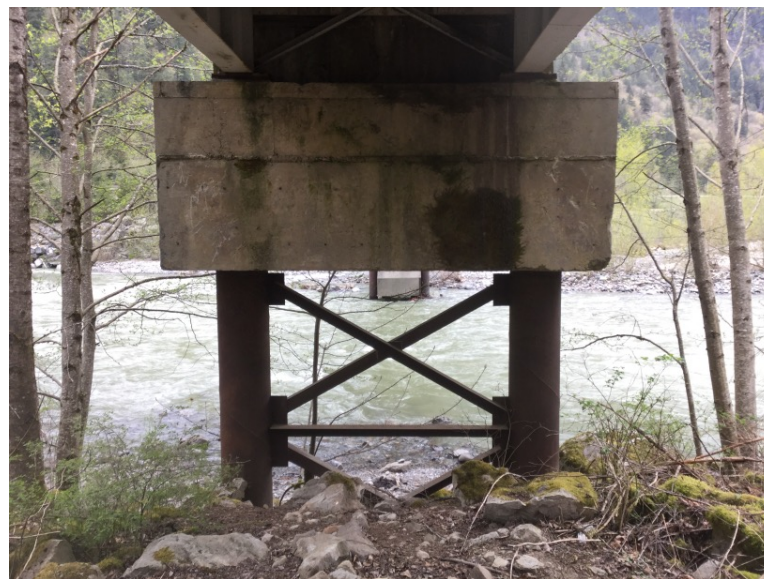
Left bank pier left face

| Bearings | Fair | bolts appear to be slightly bent towards the stream side | | | | | |
| Caps | Fair | minor spall with water staining and moss growth | | | | | |

| | 2 | Suggested | Low | \$ | clean sediment and debris off pier cap 1 at next close proximity inspection | | | | | |

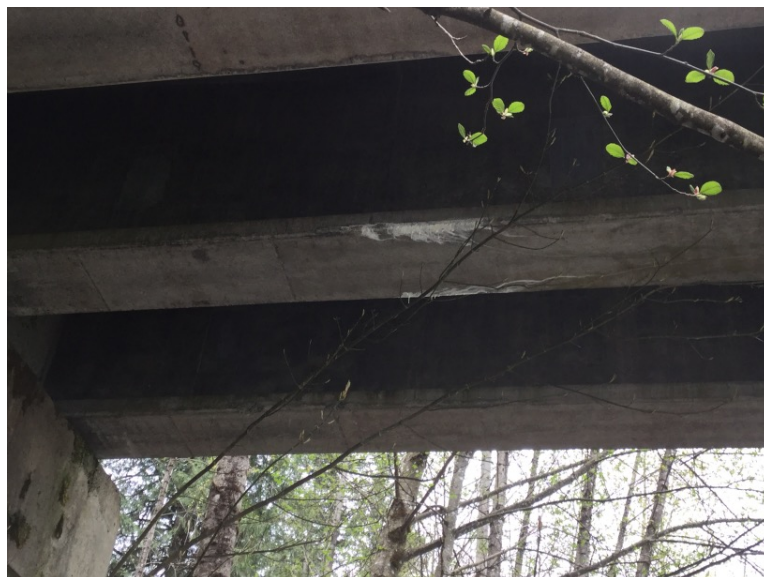
| Girders | Fair | girder 2 has hairline crack in bottom flange with efflorescence present, no change from what has been previously noted | | | | | |

Effluence on center girder near left pier

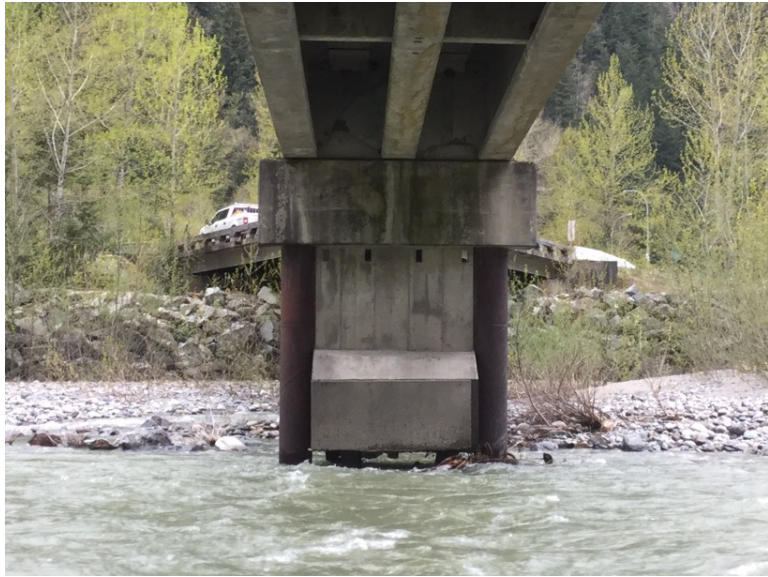
Right pier left face

| Bearings | Fair | plates appear to be slightly curved upwards on ends | | | | | |
| Caps | Good | previous inspections noted spall but has been recently repaired | | | | | |
| Riprap | Poor | none | | | | | |

| | <b>Comment:</b> | Scour noted under pier 2 | | | | | | | | |

| | 4 | concrete cap and bearing condition at both piers, and scour under pier 2 | | | | | | | | |
