CK-2214

PEERS 0.3km

2020 Inspection

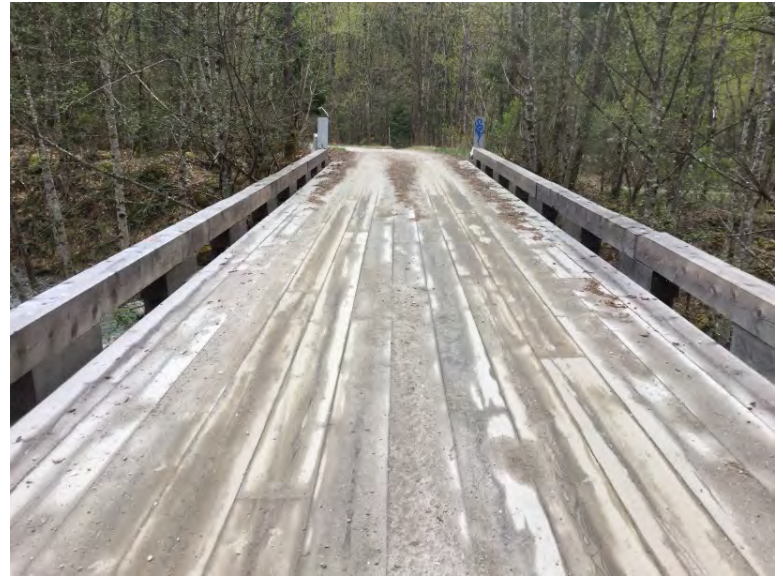
Overall Deck Condition      **Good**

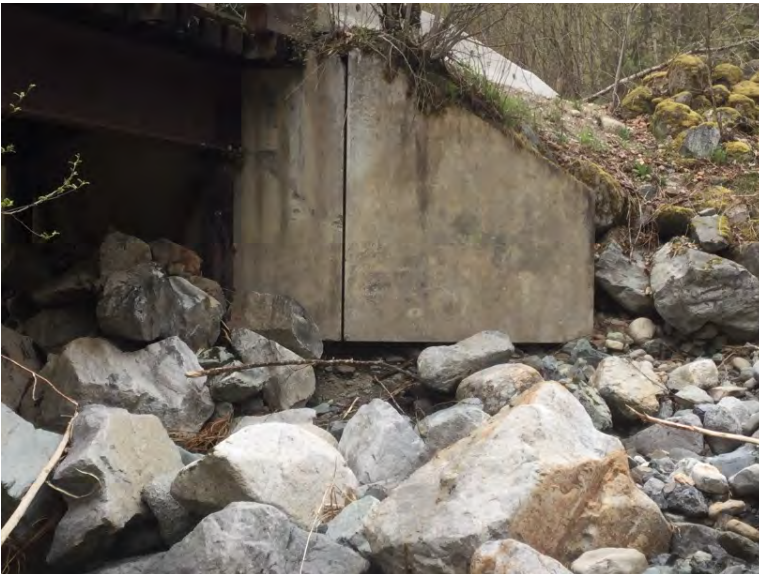
Ballast Wall Fair Minor damage and hairline cracks noted

Fill Fair Scour upstream right bank

Upstream right bank ballast and wingwall scour

1 High Repair upstream right bank riprap condition

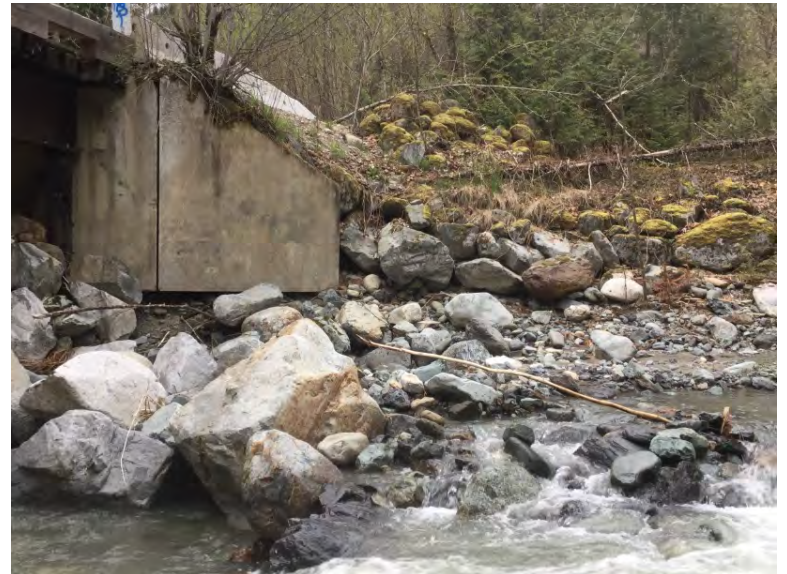
The riprap at the upstream right bank has been scoured and requires repair. Monitor its condition until repaired. The original structural design noted L60 or 54 tonnes capacity; however a structural analysis of the girders was completed by Associated Engineering noting they have capacity to support the CL-625 vehicle. The timber deck is consistent with Ministry requirements for CL-625 loading, and there aren't any signs of settlement or distress in the substructure. Increasing the vehicle loads slightly to accommodate highway legal traffic presents a low risk to the Ministry, and as such the load rating can be increased to CL-625 or 63 tonnes. Inspect again next year to ensure no signs of distress are occurring.

Riprap Fair Scour upstream right bank; large rock but not well graded or keyed together

Upstream right bank riprap scour

Item Monitor Description Frequency  
1 Monitor scour at upstream right bank Annual

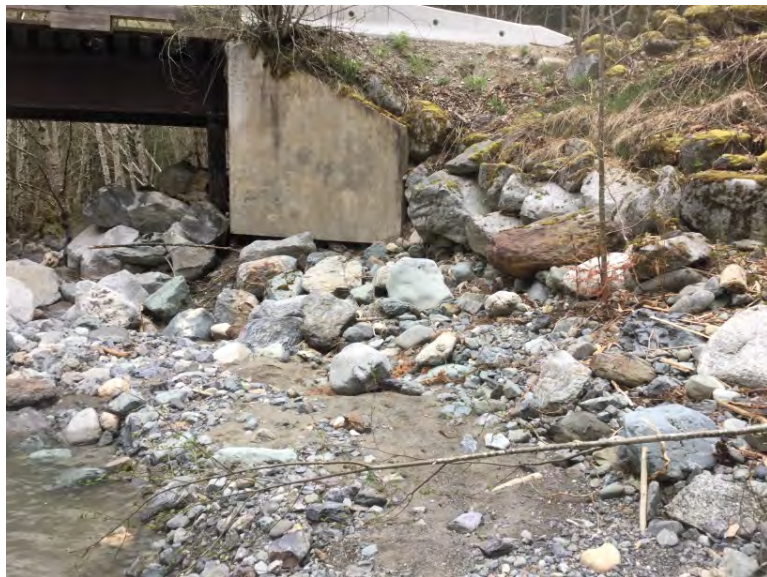
Upstream right bank scour

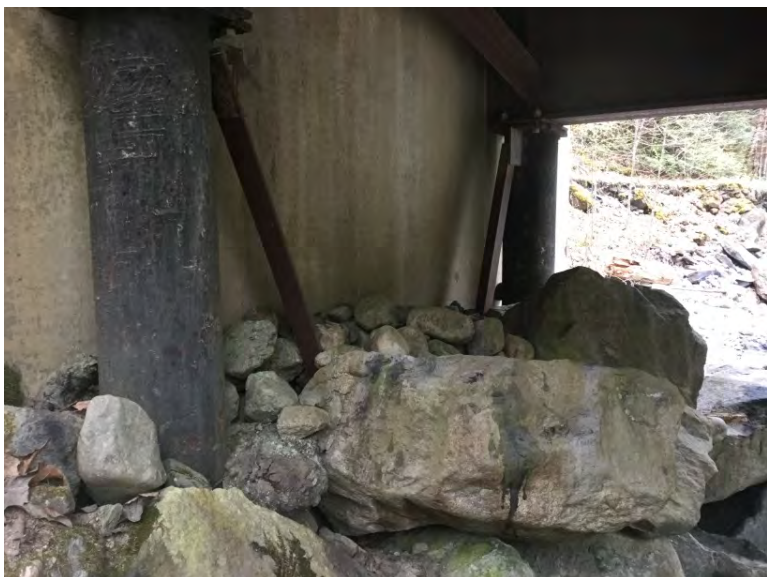
Diaphragms Good 4 welded bays

Single bay of bracing
