CK-2215

Peers 1.7km

2020 Inspection

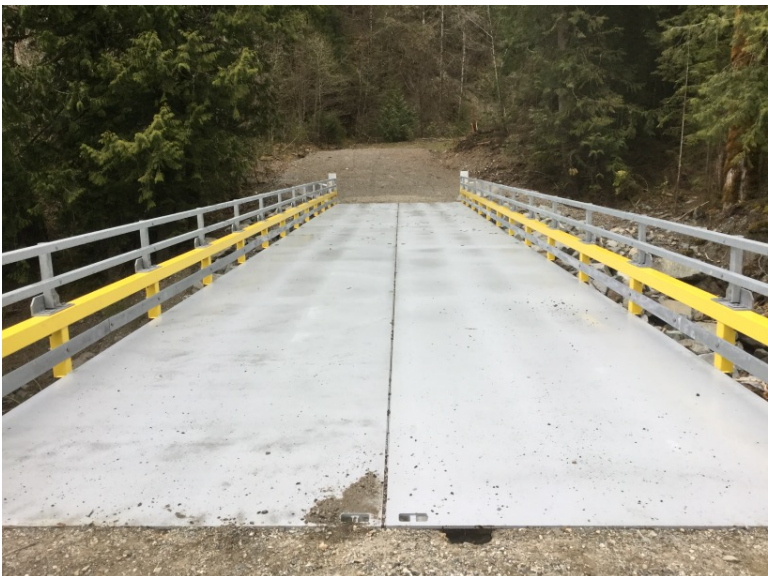
Overall Deck Condition      **Excellent**

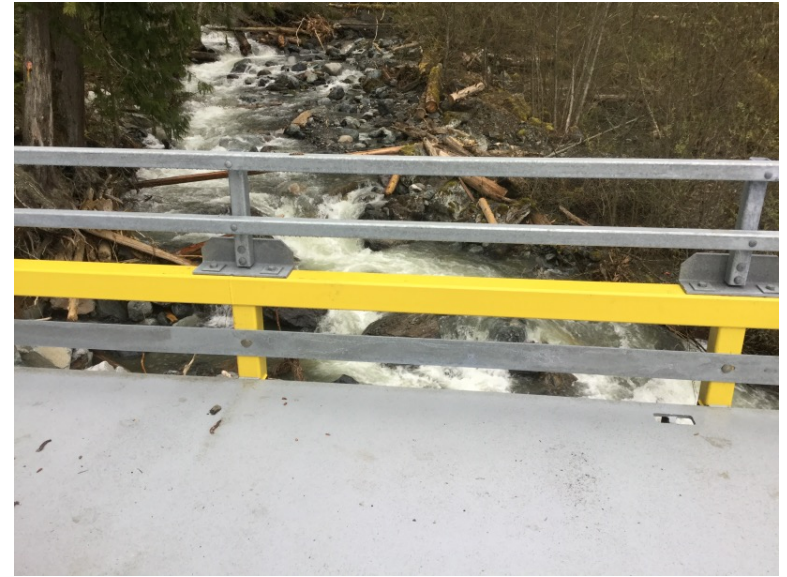
Handrail and footrail

Hand Rails/Walkouts      **Excellent**

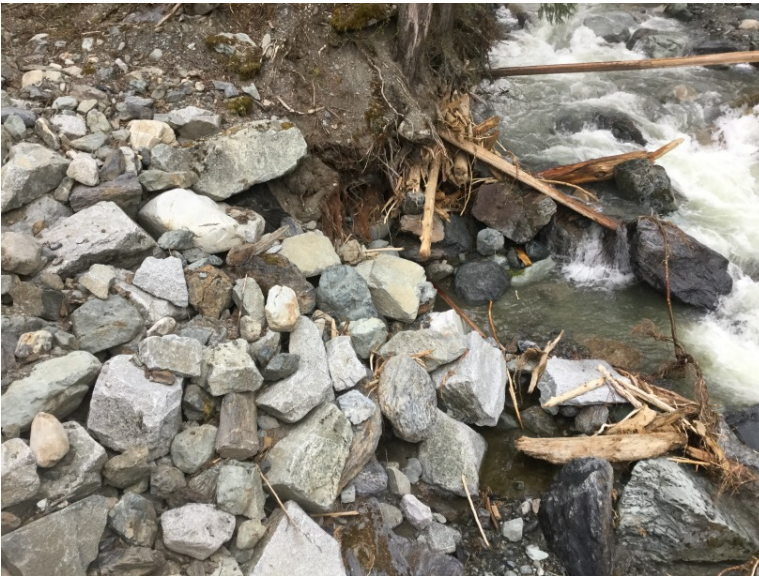
I recommend removing the 2 cedar and 1 cottonwood trees overhanging the bank located at the upstream right bank location. You will notice that these trees have been undermined and present a risk to the structure should further scour occur. In this same location the riprap condition has been slightly comprised (scoured) and needs to be monitored. The current load rating of L100 or 91 tonnes to continue.

Riprap Fair Upstream right bank starting to scour - monitor

Upstream right bank riprap scour

1 Riprap condition at upstream right bank Every Routine Inspection

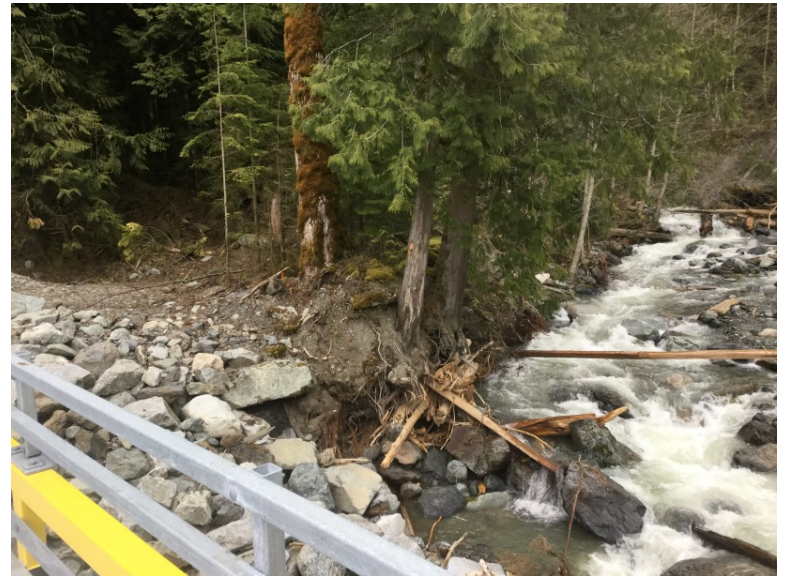
2 cedars and 1 cottonwood should be taken down

1 High Remove 2 cedars and 1 cottonwood from upstream right bank

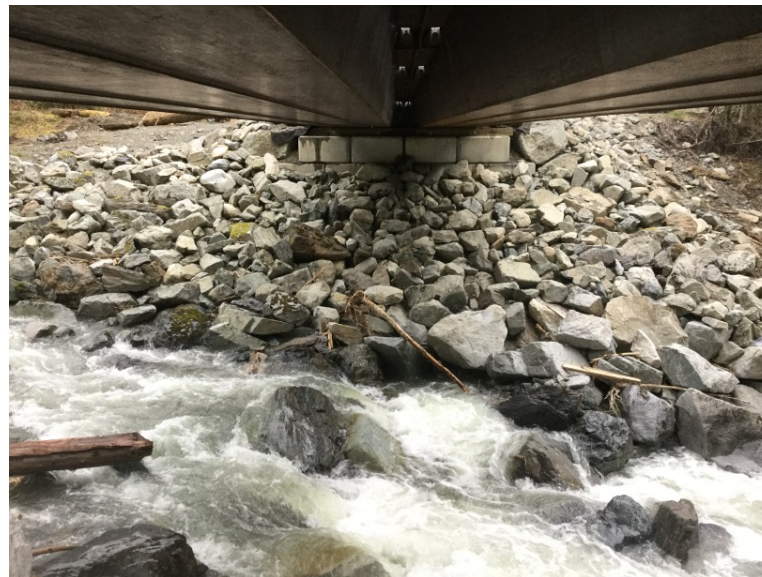
Left Bank Abutment when facing downstream

Concrete Good Lock blocks both banks

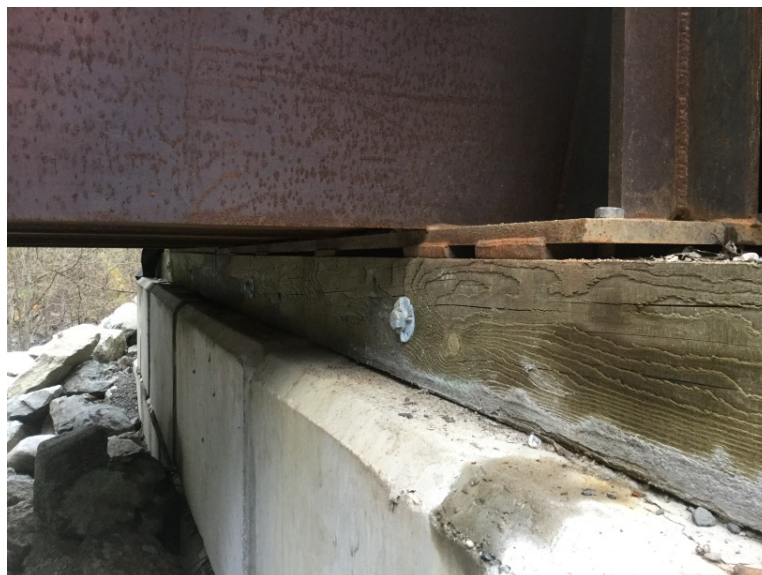
Bearings Good Shims have been welded to the down stream left bank bearing plate for consistent bearing

Steel shims downstream left bank
