CK-2235  
CK-2235

SCUZZY 6.6km

2020 Inspection

Crossing Name Scuzzy Creek

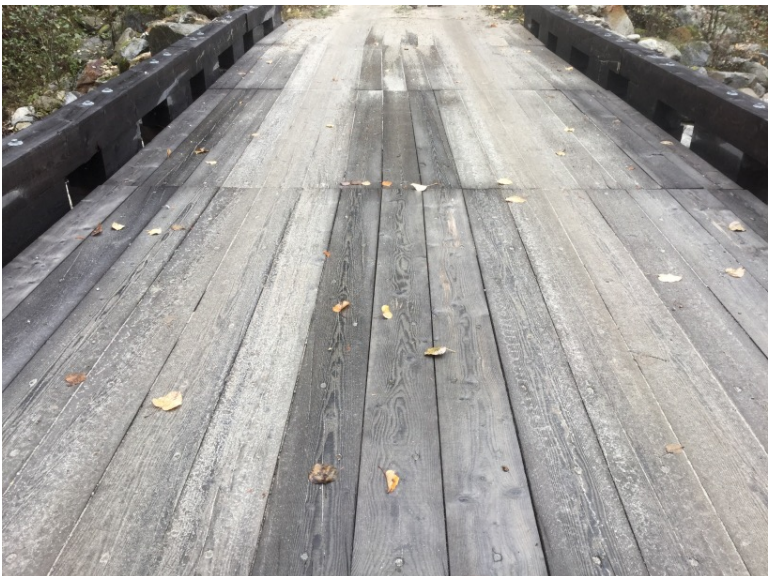
No apparent change in the riprap scour compared to the 2018 inspection. Both the upstream right bank and downstream left bank should continue to be monitored, especially following heavy precipitation events. The modular deck panels are slightly misaligned but appear to have been installed that way.

Deck panels slightly misaligned

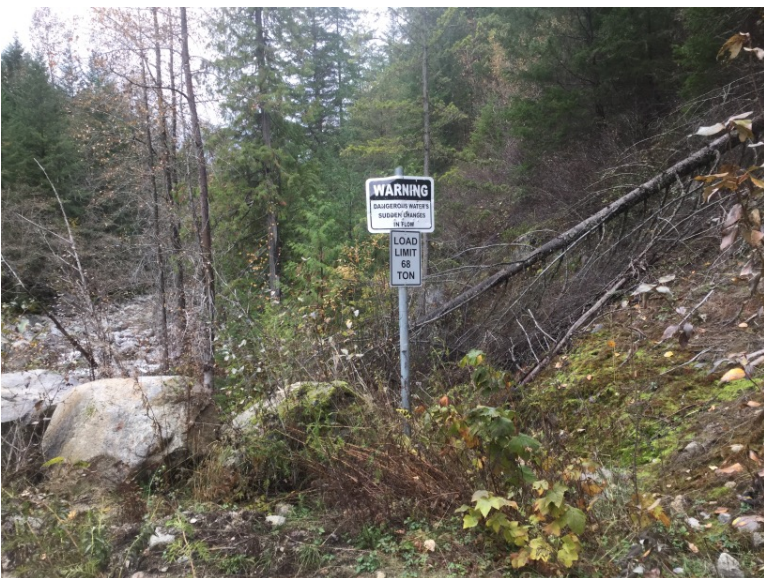
Load Rating Sign

Load rating sign **INCORRECT**

Remove or update load rating sign. The current load rating of L75 or 68 **TONNES** to continue.

| Repair Item | Repair Description |
|---|---|
| 1    High | Remove or update load rating sign |

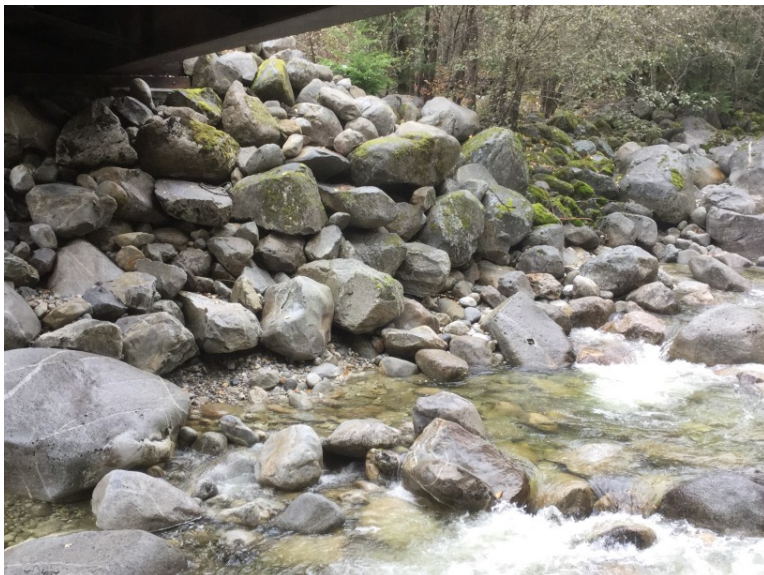
Scour noted upstream right bank and down stream left bank

Comments    Riprap appears scoured

Upstream right bank riprap appears oversteepened

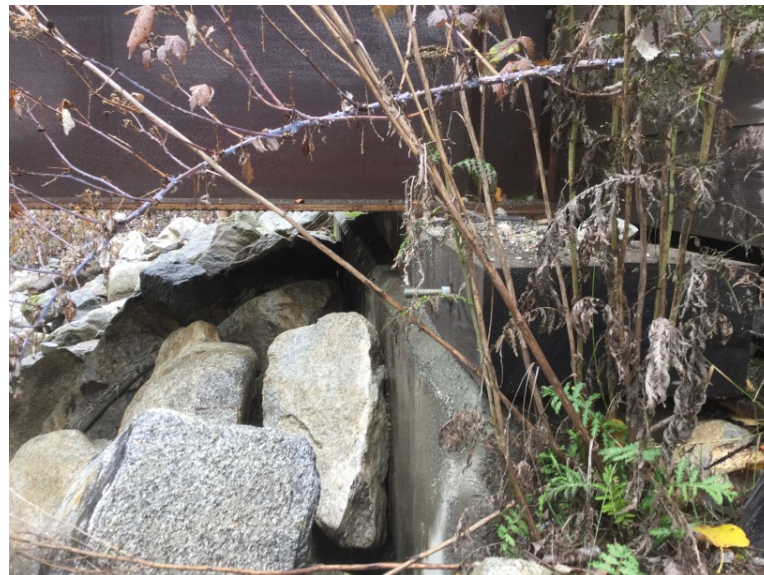
Placed slightly skewed on lock blocks

Timber sill at left bank is skewed to lockblocks
