CK-2248  
CK-2248

SPUZZUM 16000 0.2km

2020 Inspection

| Crossing Name | Spuzzum Creek |

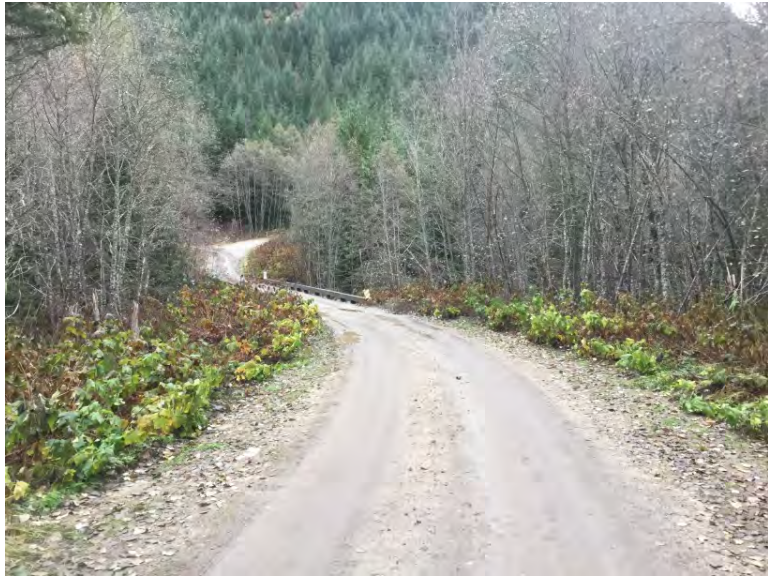
Approach from Left Bank when facing downstream

Potholes at left approach

| Repair Item | Repair Description |
|---|---|
| 1 Approach. Area/sight line brushing. m <sup>2</sup> . Priority:Low | Brush approaches |
| 2 Approach. Approach surfacing grading. m. Priority:Low | Grade appaches |

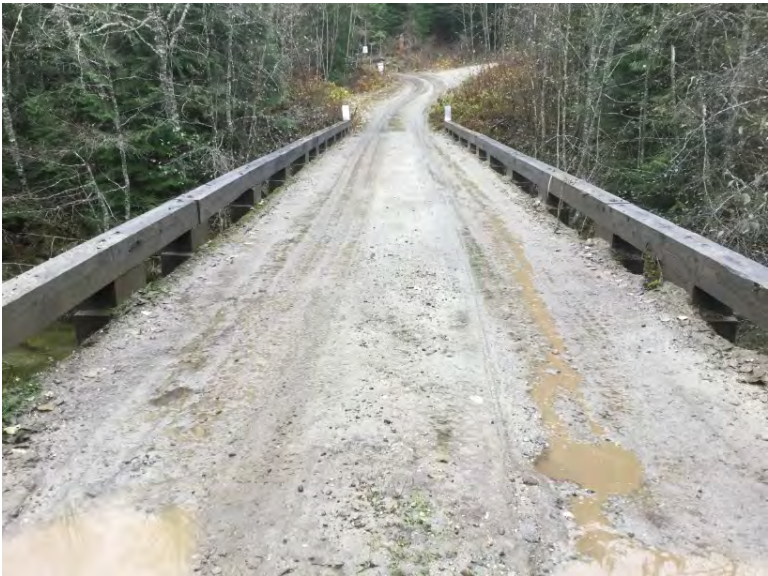
Deck

Proper assessment of grout pockets not completed due to frozen sediment on deck, however no issues apparent from underneath

Grout Pockets      Unrated      Not completely visible due to sediment on deck, no issues noted underneath

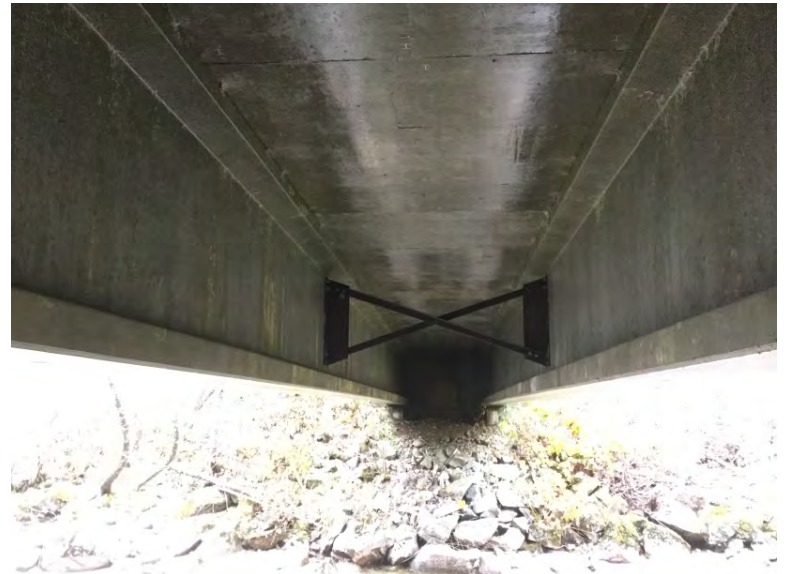
Superstructure

1 bolted bay at center
