CK-2278  
CK-2278

## SUMALLO 1.4km

2020 Inspection

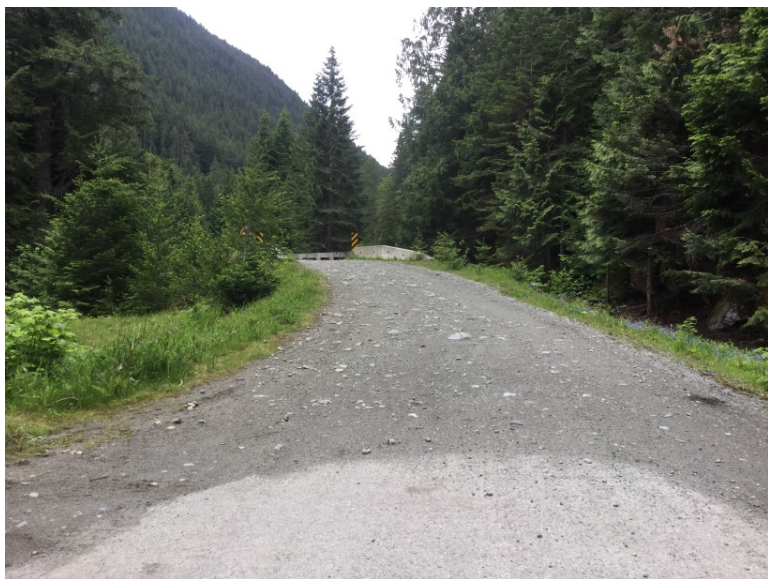
Approach from Left Bank when facing downstream

HC and VC left approach limits visibility

| Repair Item | Repair Description |
|---|---|
| 2 Approach. Area/sight line brushing. m². Priority:Low | Brush and grade approaches |
| 3 Approach. Bridge Ahead Signs. # of signs.<br>Priority:Low | Post bridge ahead signs |

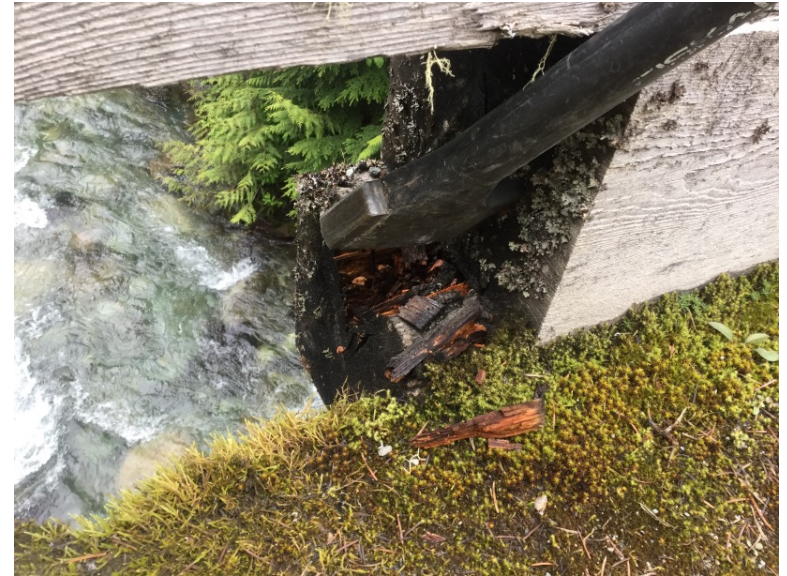
Curb Rail/Blocks/Posts      Poor      Rotten risers and blocks

Overall Deck Condition      Poor      Due to rail condition

Risers and blocks rotten

Replace guardrail, risers and blocks. Brush and grade approaches when active and post bridge ahead signs. The current load rating of L75 or 68 tonnes to continue.

| Repair Item | Repair Description |
|---|---|
| 1 Structure. Full Curb Replacement. .<br>Priority:Medium | Replace guardrail, risers and blocks |
