CK-2287  
CK-2287

SILVERHOPE 0.6km

2020 Inspection

Crossing Name Silverhope Creek (structure #  
FSR # 8148 Branch # 1

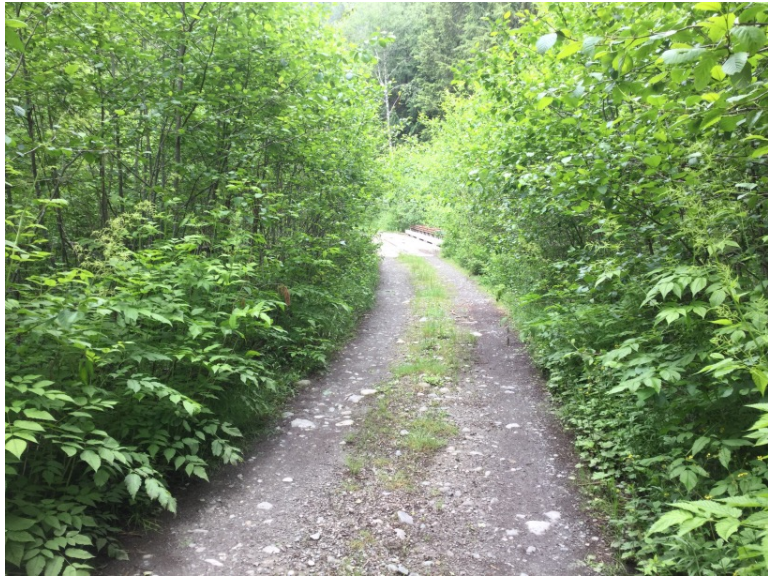
Approach from Right Bank when facing downstream

Bridge Ahead Signs  
Missing ☐ 0 ☐ 1 ☒ 2

Brushing Required Y

Delineator Missing  
Left ☐ 0 ☒ 1 ☐ 2

Delineator Missing  
Right ☐ 0 ☒ 1 ☐ 2

| Repair Item | Repair Description |
|---|---|
| 1 Approach. Area/sight line brushing. m².<br>Priority:Medium | Brush approaches |
| 2 Approach. Bridge Ahead Signs. # of signs.<br>Priority:Medium | Post bridge ahead signs |
| 3 Approach. Add Warning Signs. # of signs.<br>Priority:Medium | Post load rating signs |
| 5 Structure. Delineator maintenance. .<br>Priority:Medium | Replacing missing delineators |

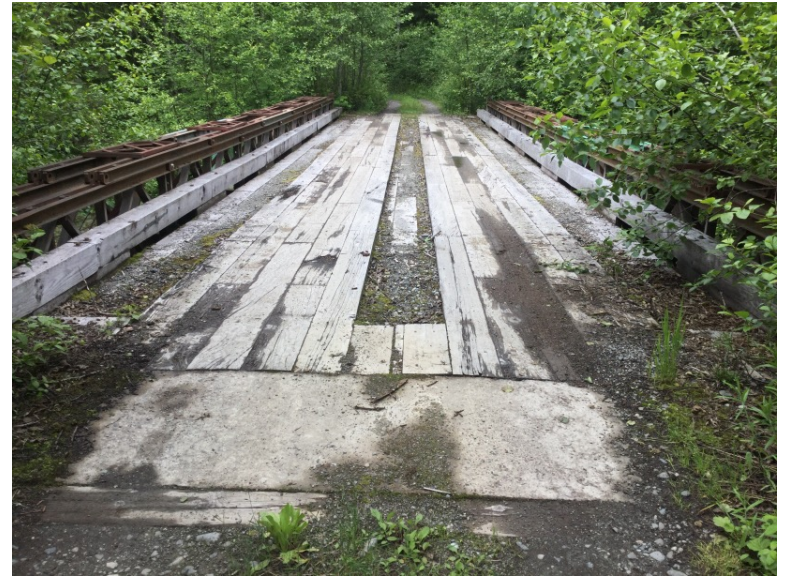
| Running Planks | Poor | Rotten |

| Sub Deck | Poor | Rotten |

| Ties | Poor | Rotten |

| Nails | Poor | Protruding |

| Curb Rail/Blocks/Posts | Poor | Rotten |

| Overall Deck Condition | Poor | Rotten |

| Repair Item | Repair Description |
|---|---|
| 4 Structure. Major redecking (crossties or laminated deck). m. Priority:High | Replace entire deck system |

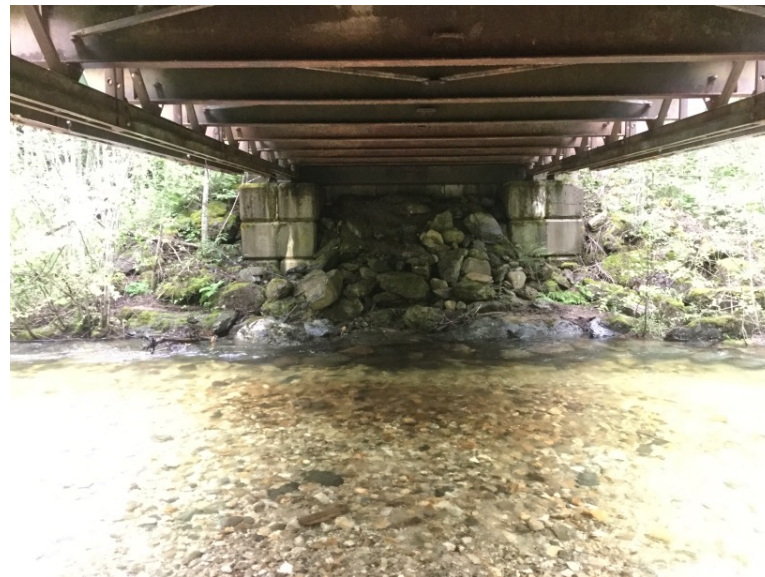
Right Bank Abutment when facing downstream

3 high x 2 wide lock block columns at each corner - right bank blocks have noted cracking and efflorescence

| Item | Monitor Description | Frequency |
|---|---|---|
| 1 | Lock block condition | Routine Inspection |

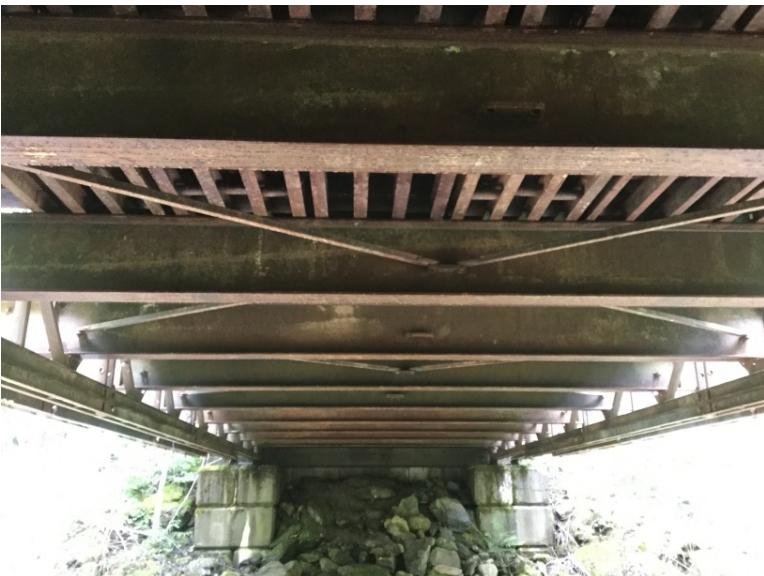
Superstructure

Girders Fair 6 panel Double single acrow

Bracing Fair Minor deformation with random braces
