CK-2288  
CK-2288A

UZTLIUS 6.1km

2020 Inspection

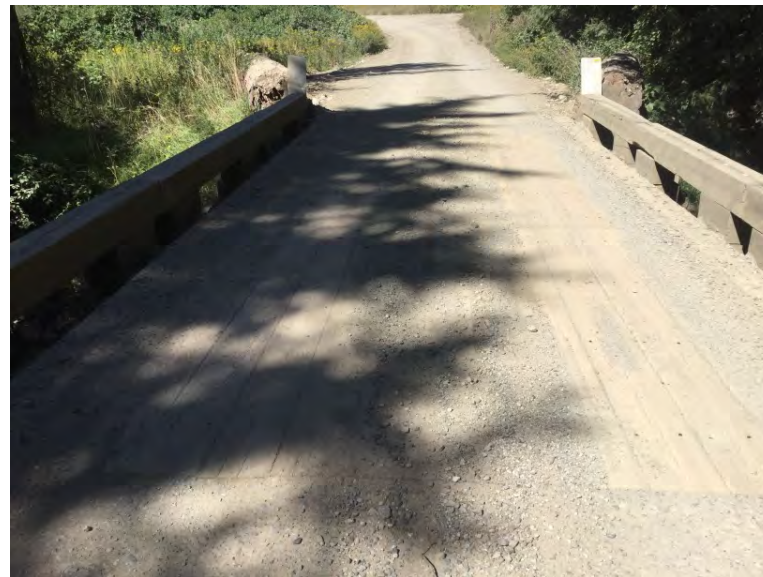
Overall Deck Condition Good

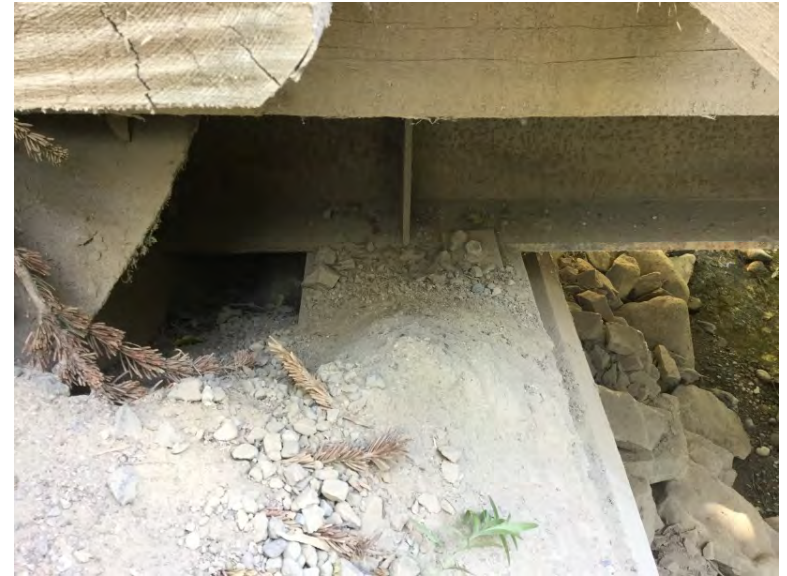
Bearing

Bearings Good

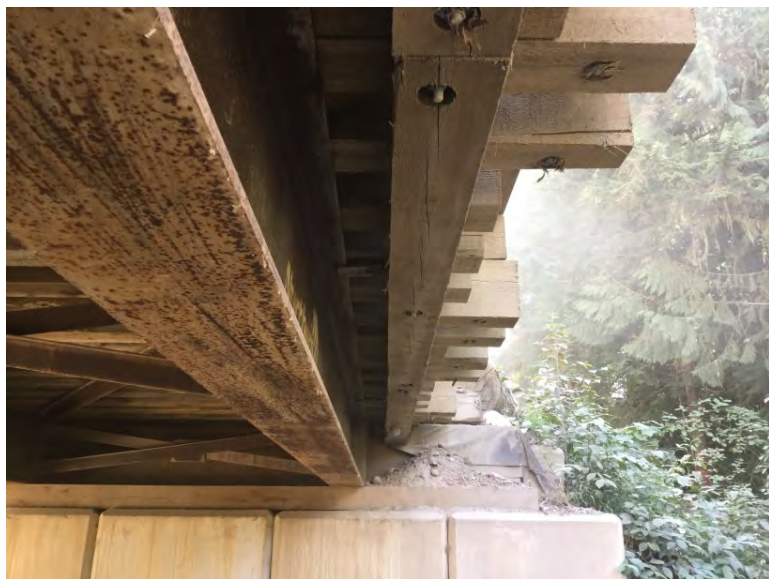
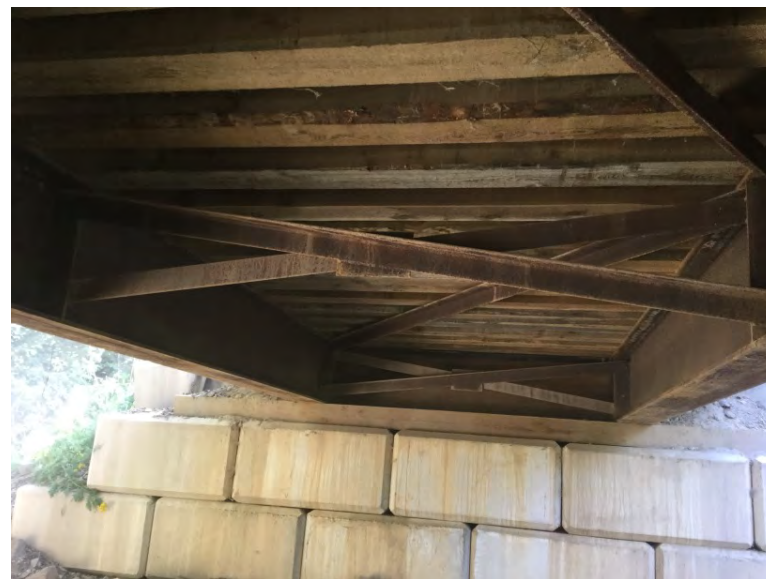
Superstructure

Girders Fair

Diaphragms Fair 3 welded bays

Bracing Fair
