CK-2291  
CK-2291

UZTLIUS 17.7km

2020 Inspection

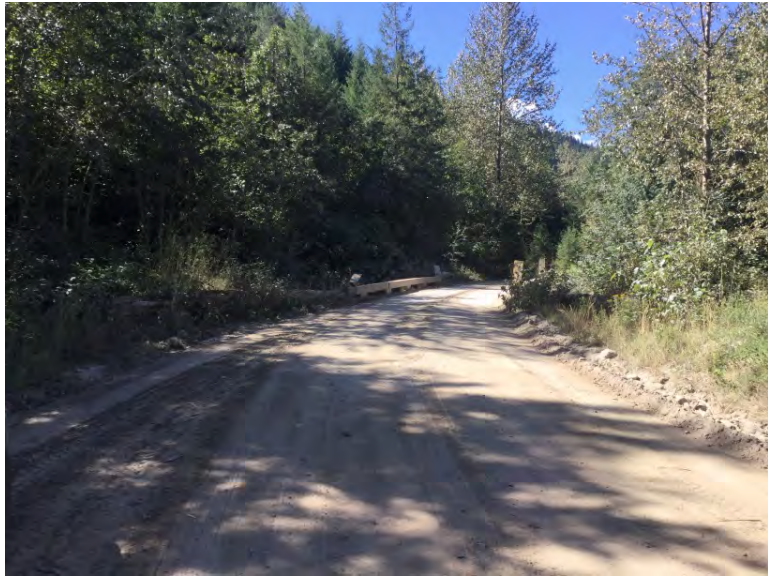
Approach from Right Bank when facing downstream

Alignment Fair

HC both approaches

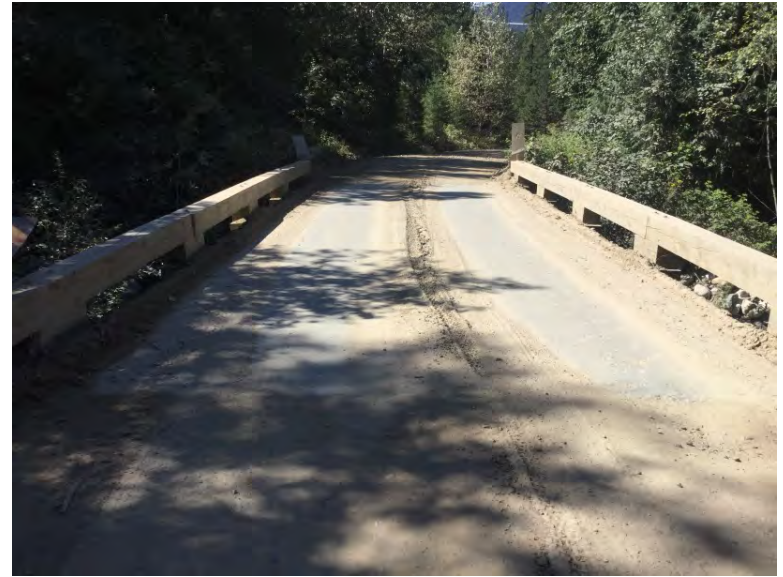
Overall Deck Condition      **Good**

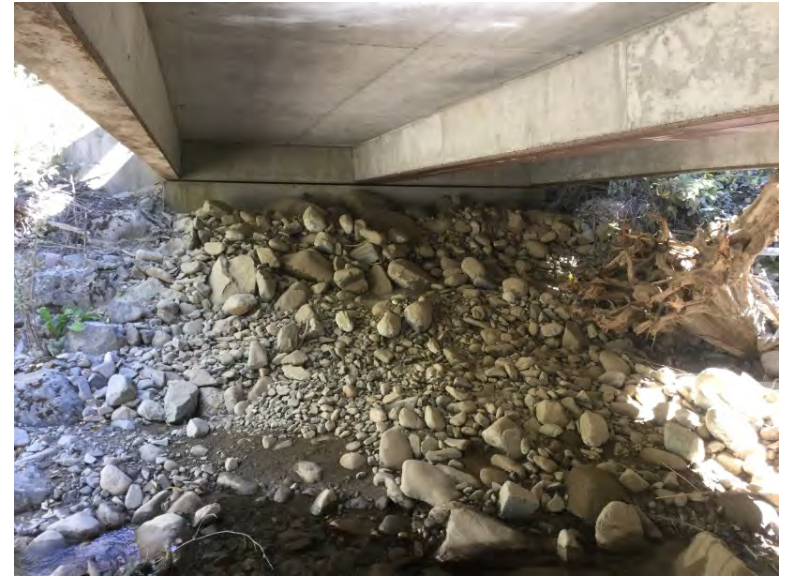
Right Bank Abutment when facing downstream

Riprap Fair Small and round but functioning well

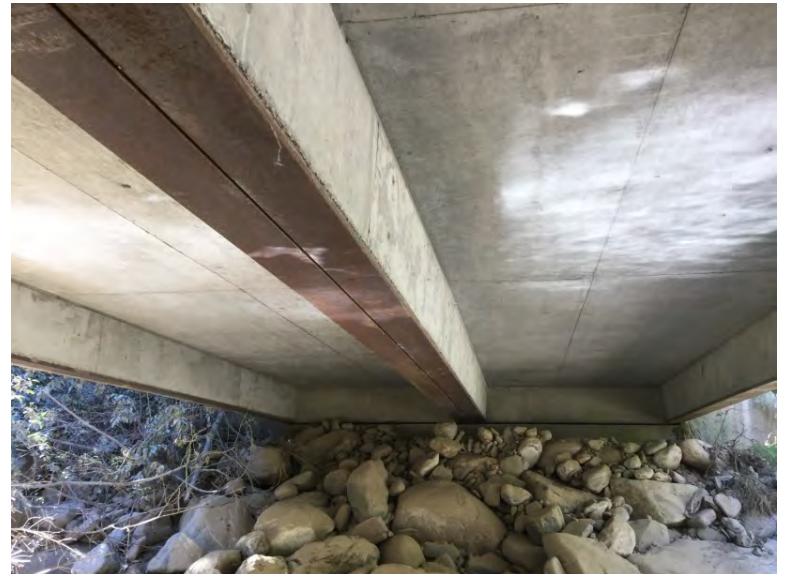
Superstructure

Girders **Good** Inverted C channel
