CK-2296  
CK-2296

UZTLIUS 24.5km

2020 Inspection

Crossing Name Uztlius Creek

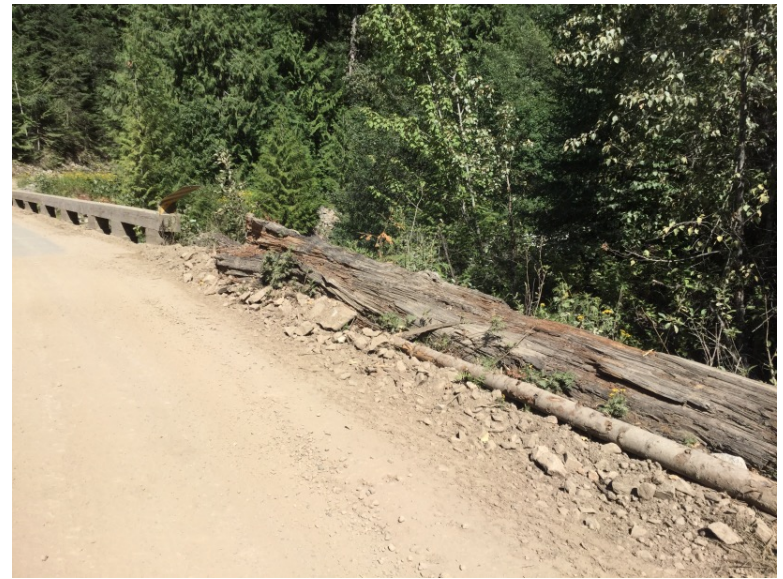
Fender at upstream left bank

Upstream left approach off road surface and in poor condition

Replace upstream left approach log fender. The current load rating of L75 or 68 tonnes to continue.

| Repair Item | Repair Description |
|---|---|
| 1 Approach. Approach fenders (install). # of units. Priority:Medium | Replace upstream left approach log fender |
