CK-2297  
CK-2297A

UZTLIUS 25.9km

2020 Inspection

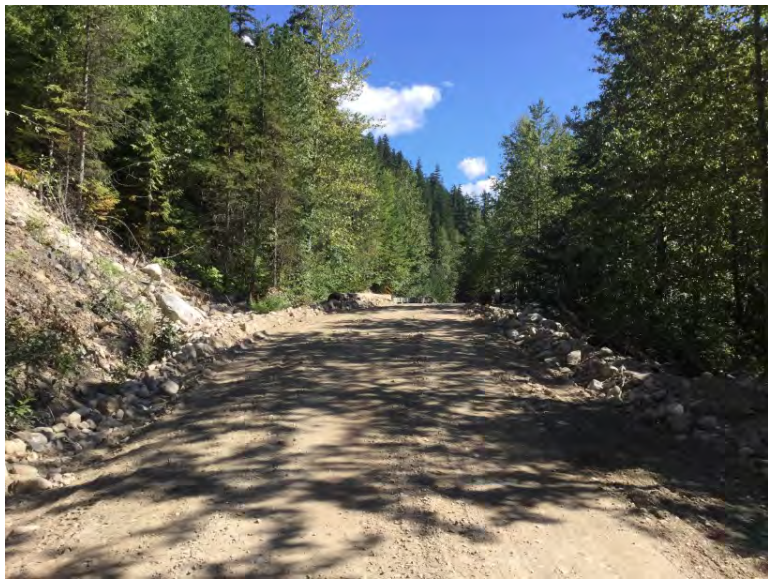
Approach from Right Bank when facing downstream

Slight VC and HC both approaches

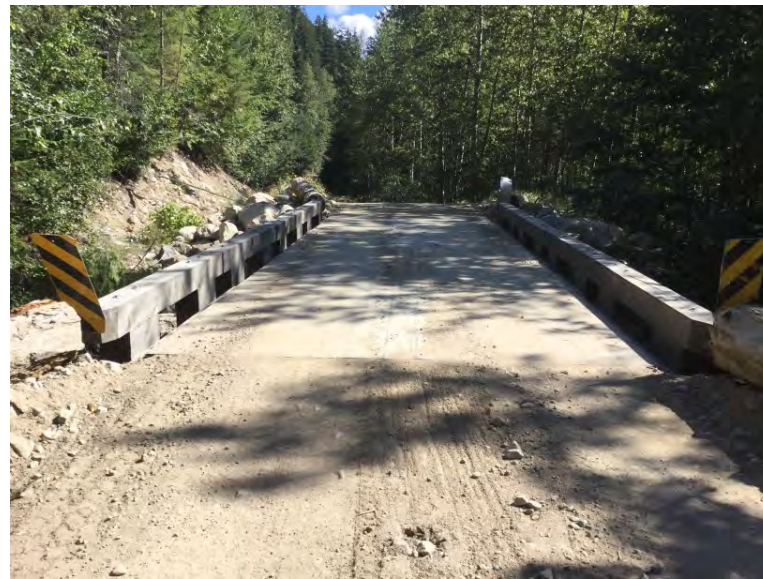
Overall Deck Condition      **Good**

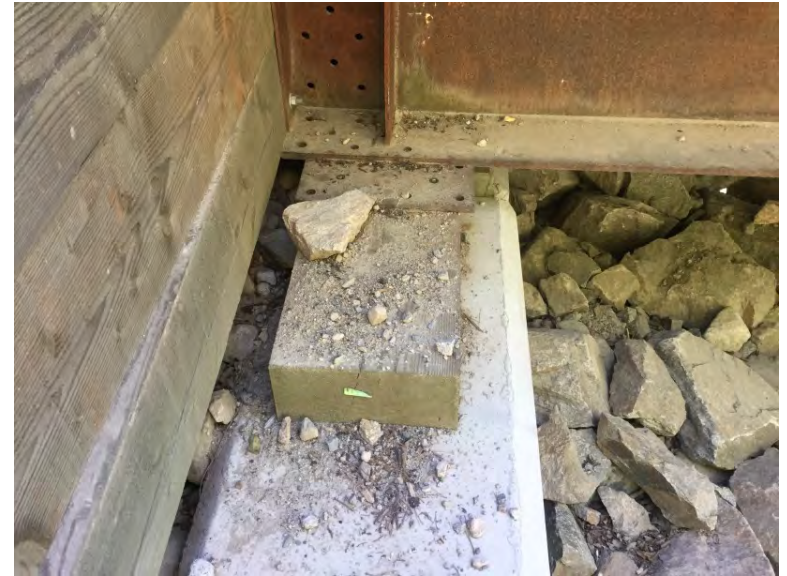
Bearing

Bearings Good

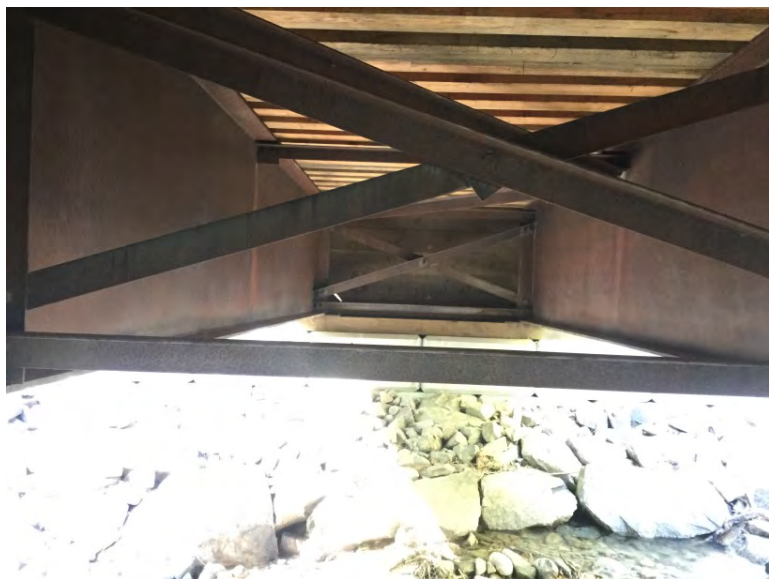
Superstructure

Girders Fair Section from a 30.480m L75
