CK-2300  
CK-2300A

UZTLIUS 13.4km

2020 Inspection

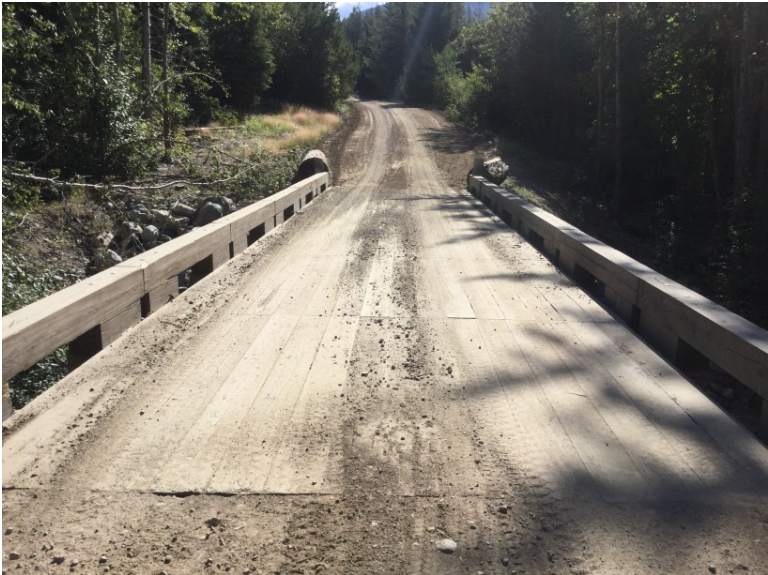
Overall Deck Condition      **Good**

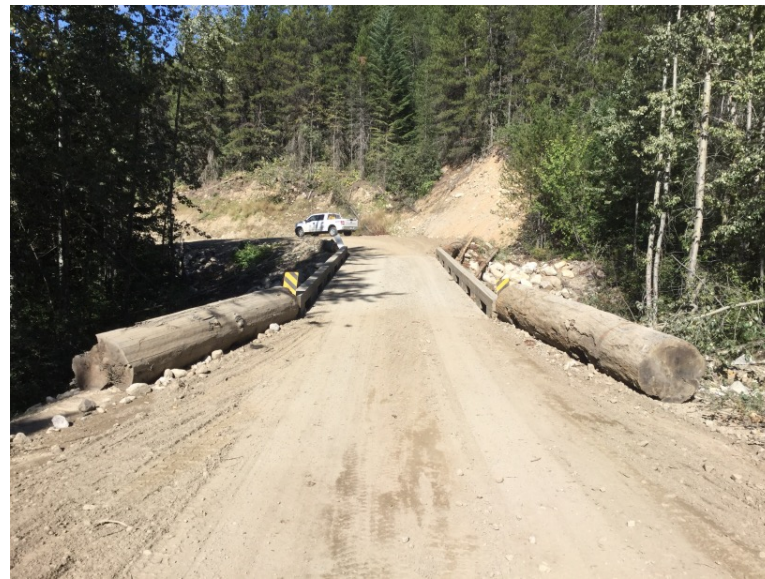
Approach from Left Bank when facing downstream

Delineator Missing  
Left ☐ 0 ☒ 1 ☐ 2

| Repair Item | Repair Description |
|---|---|
| 1 Structure. Delineator maintenance. .<br>Priority:Medium | Replace missing delineator |

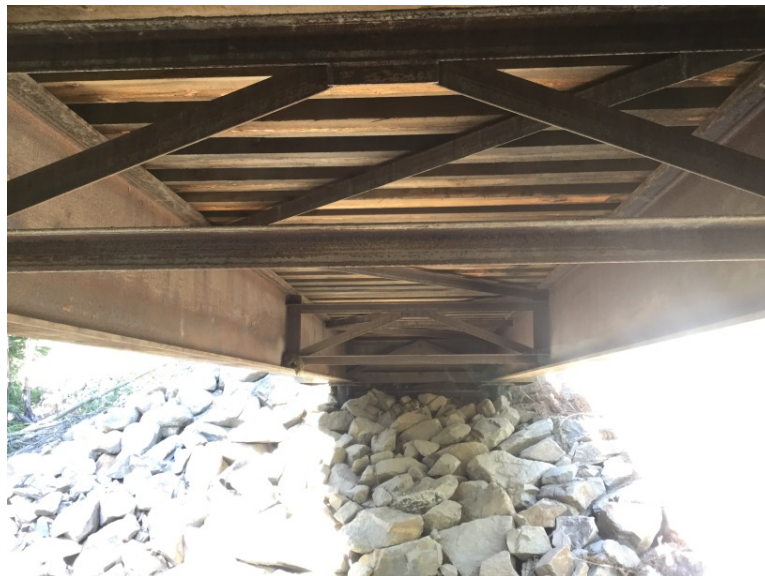
Superstructure

Girders Fair Minor corrosion

Diaphragms Fair 4 welded bays
