CK-2302  
CK-2302A

UZTLIUS 35.4km

2020 Inspection

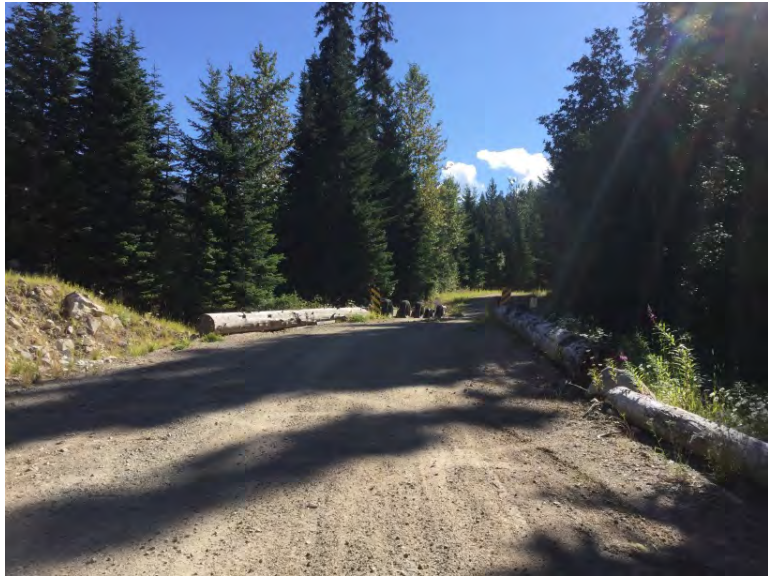
Approach from Right Bank when facing downstream

HC and VC right approach, VC left approach

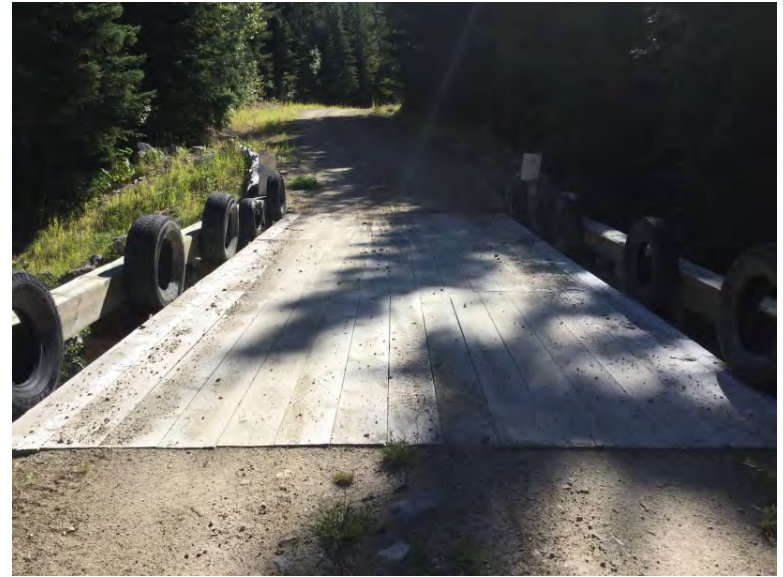
Deck to Girder Bolts      **Fair**

Overall Deck Condition      **Fair**
