CK-2305  
CK-2305

EAST ANDERSON 11.7km

2020 Inspection

| Crossing Name | East Anderson Creek |

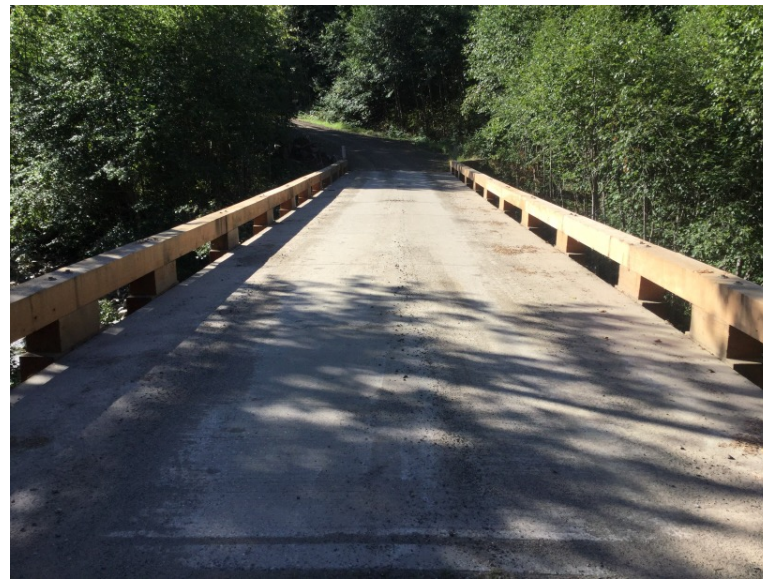
Deck

Running Surface      Fair      pitted and worn on wheel path

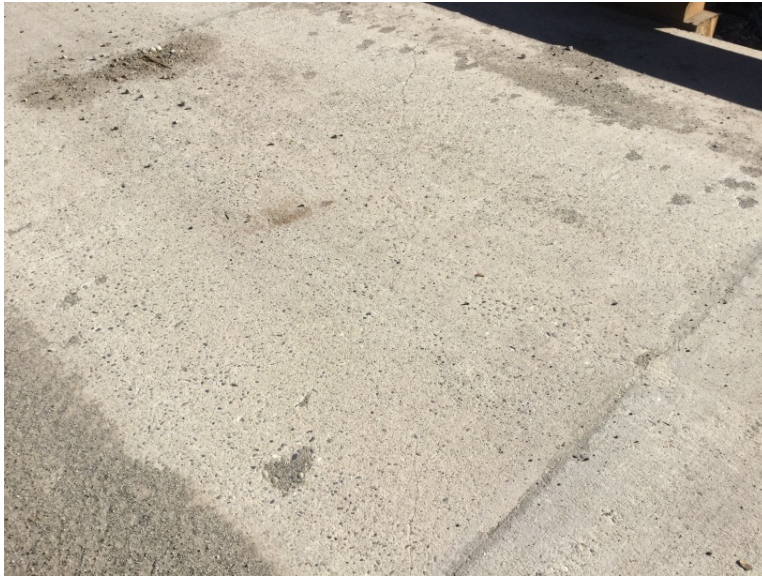
The 4th and 5th panels from the left end have diagonal cracks along the surface; however those cracks are not visible on the underside of the panels. The deck surface is worn and pitted. Left bank panel 1 is chipped underneath, exposing rebar which is rusting. Monitor panel condition.

Concrete Deck      Fair      Damage noted under panel 1 at left bank and panels 4 and 5 (left bank) have hairline cracks on the surface

Crack in deck panel

Repair the damaged deck panel (visible from underneath) consistent with the MoFLNRO Concrete Repair Guide for Concrete Bridge Components (2017). Deck panels 4 and 5 (from left bank) and the right bank ballast wall have hairline cracks on the surface that require monitoring. The current load rating of L75 or 68 tonnes can continue.

| Item | Monitor Description | Frequency |
|---|---|---|
| 1 | Cracking in deck panels and ballast wall | Annually |

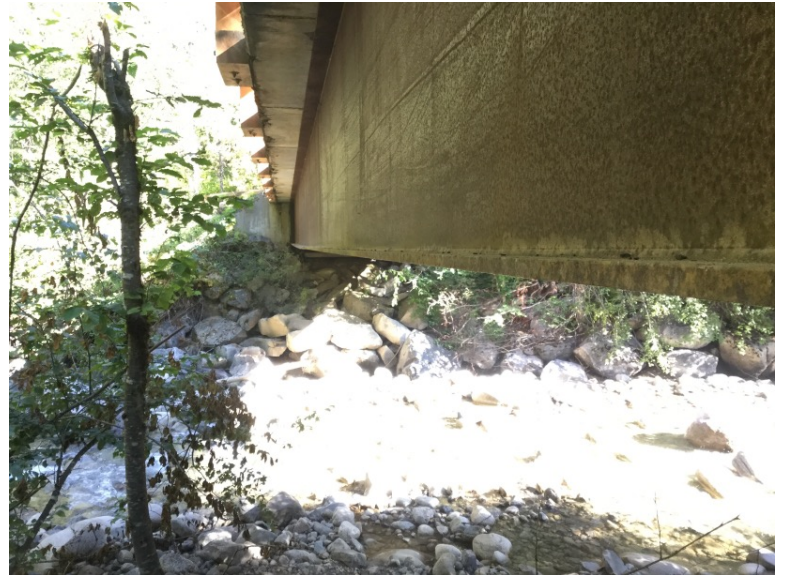
Girders Fair Sag noted and minor corrosion

Visible sag in girders

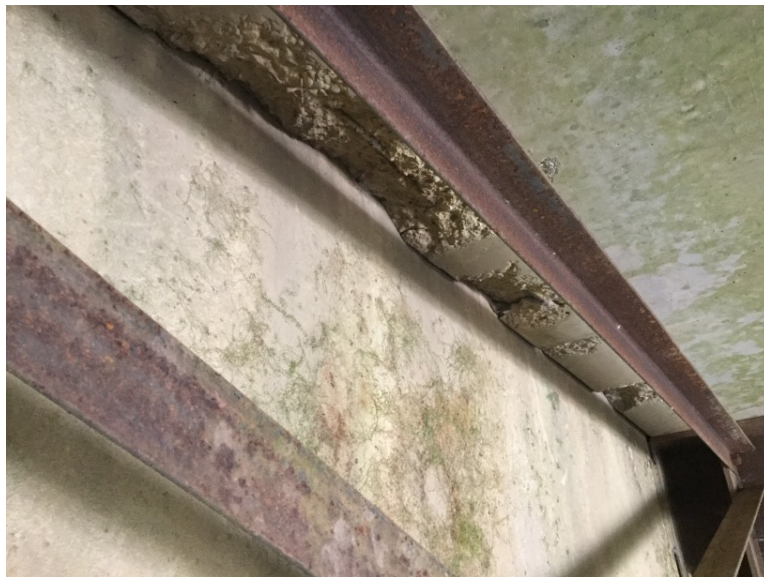
Damage under panel 1 at left bank

| Repair Item | Repair Description |
|---|---|
| 1 Structure. Concrete structural maintenance. m². Priority:Medium | Repair damaged deck panel |

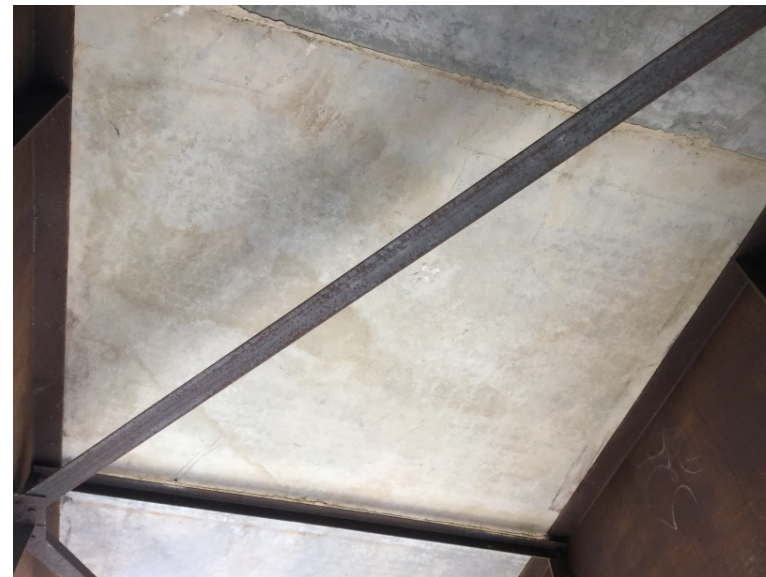
No cracking visible under panel

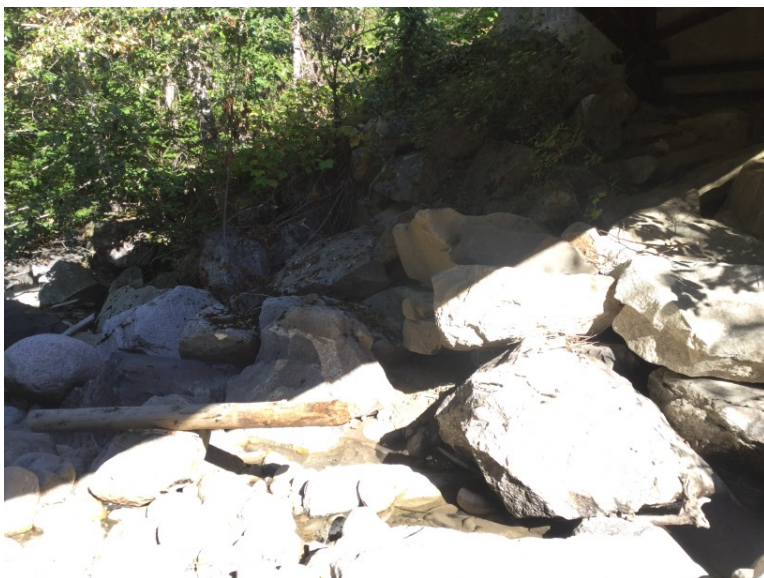
Riprap Fair Scour noted downstream right bank

Riprap scour downstream right bank

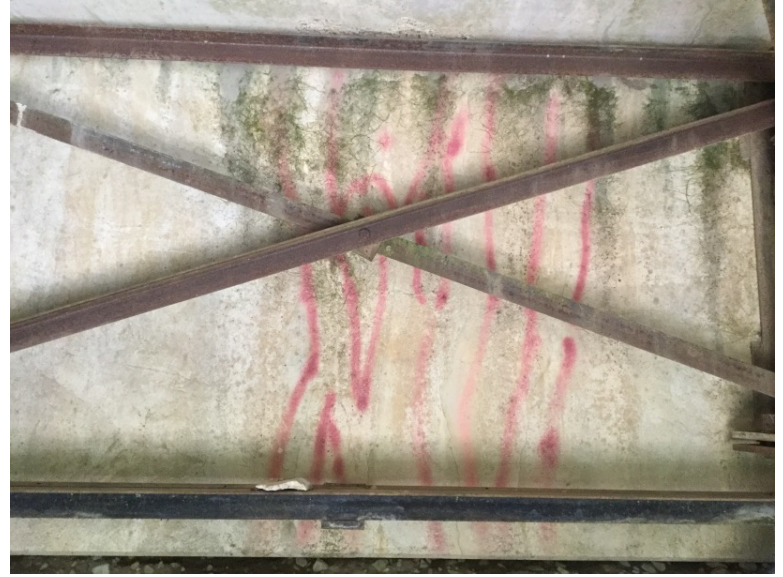
Ballast wall at right bank

Ballast Wall Fair Right bank has hairline cracks
