CK-2320  
CK-2320

## NAHATLATCH 22.5km

2020 Inspection

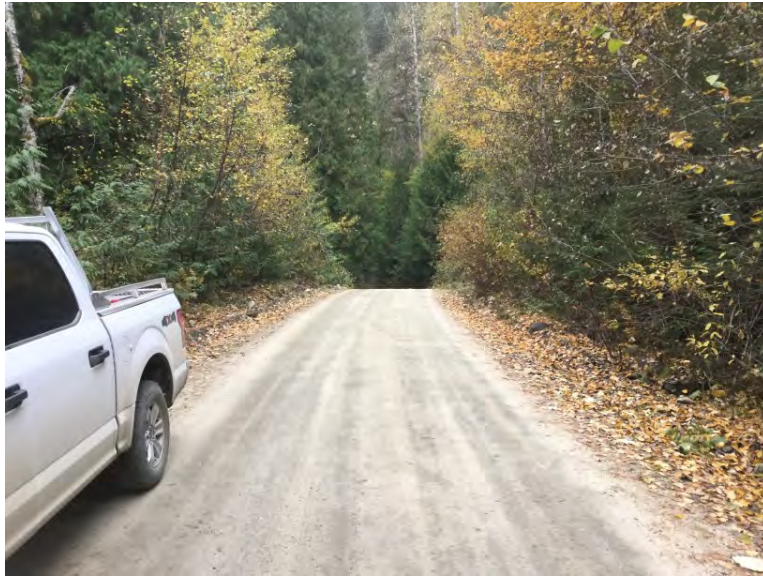
Approach from Left Bank when facing downstream

Alignment Fair

slight VC both approaches

Brushing Required Y

| 1 | Approach. Area/sight line brushing. m².<br>Priority:Medium | brush approaches |

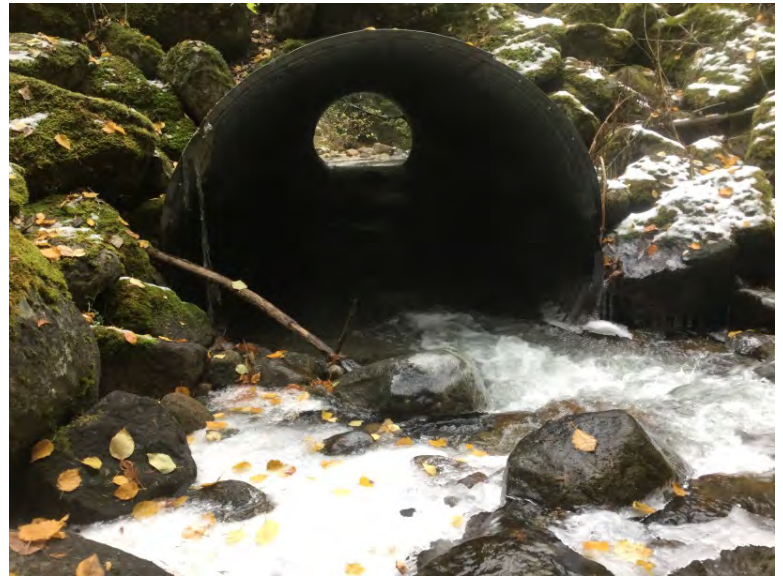
Inlet

Good

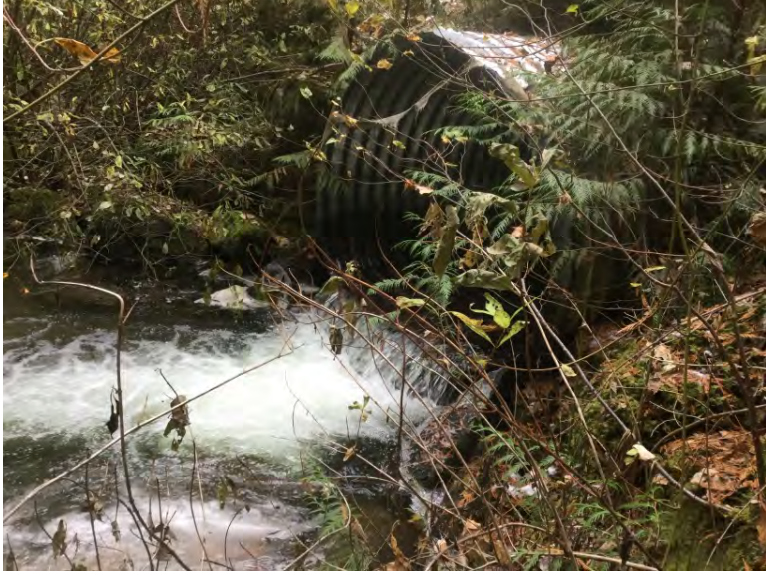
Outlet

Fair

0.5m drop

Brush approaches and monitor the scour noted at the outlet of the culvert. The current load rating or L75 or 68 tonnes to continue.

| Item | Monitor Description | Frequency |
|---|---|---|
| 1 | scour at outlet | Routine Inspection |
