CK-2321  
CK-2321A

BLUE MOUNTAIN 300 2.2km

2020 Inspection

| Crossing Name | Martyn Creek 2 |

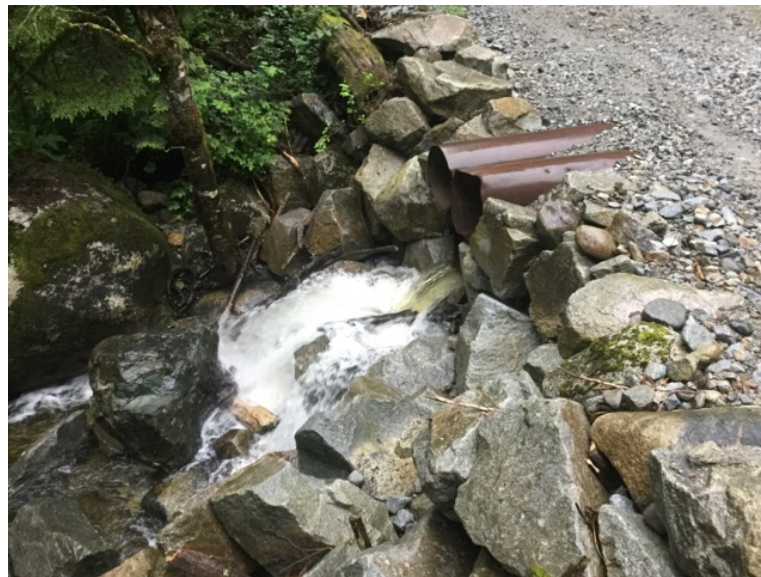
Outlet      Fair

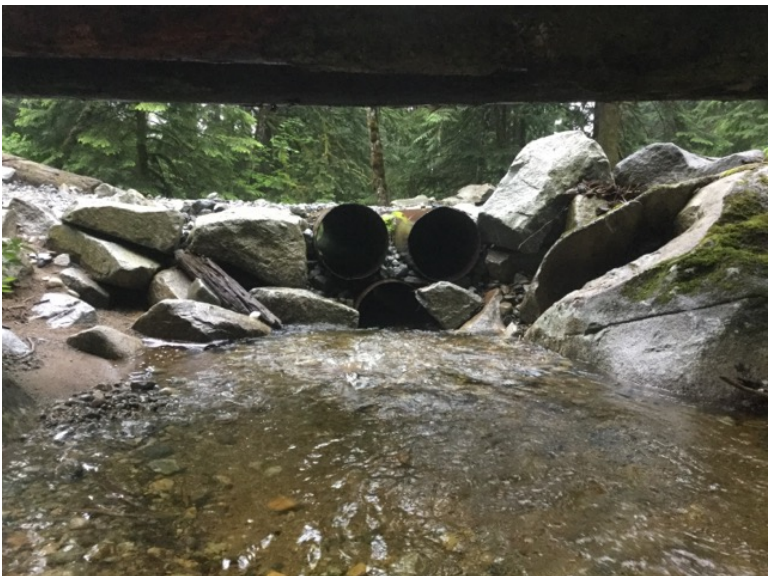
Inlet      Fair      Monitor aggrading material and remove debris accumulations

| Item | Monitor Description | Frequency |
|---|---|---|
| 1 Inlet aggradation | | Routine Inspection |

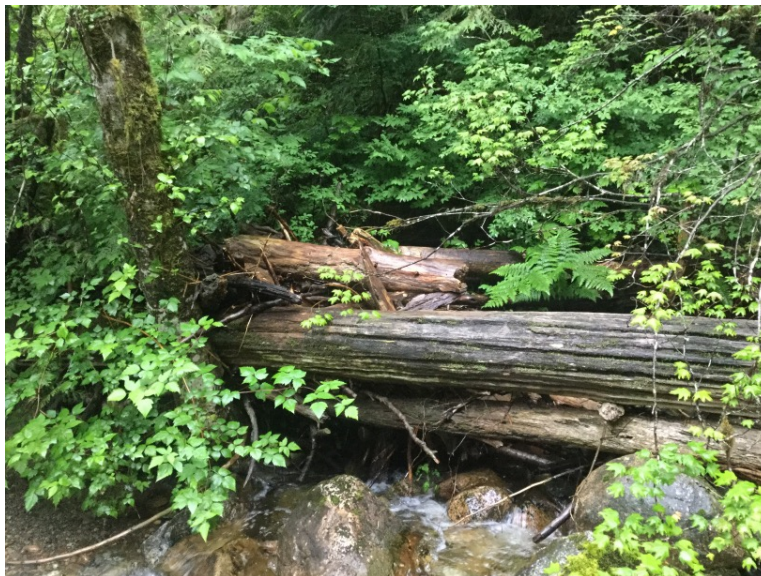
Debris accumulations at inlet

| Repair Item | Repair Description |
|---|---|
| 2 Medium | remove debris accumulations |
