CK-2356  
CK-2356

## KOOKIPI WEST 0.5km

2020 Inspection

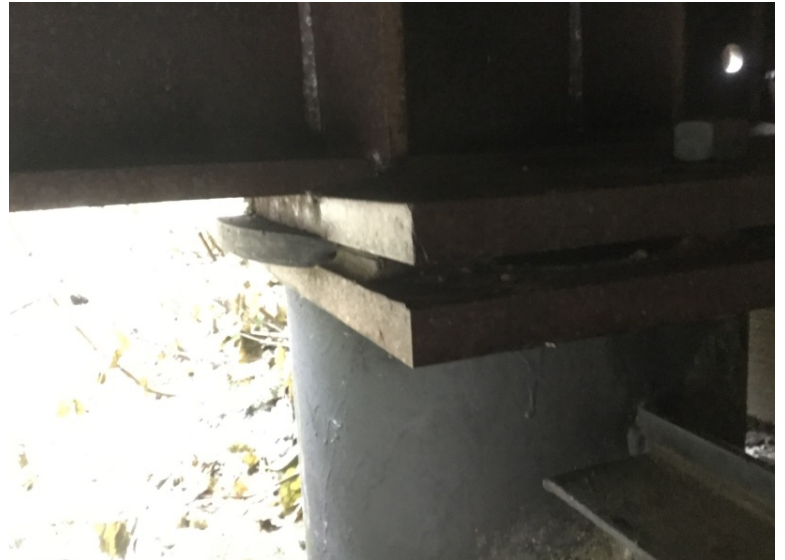
Upstream right bank bearing pads

Bearings Fair
