CK-2357  
CK-2357

Cantelon km

2020 Inspection

Crossing Name Cantelon Creek

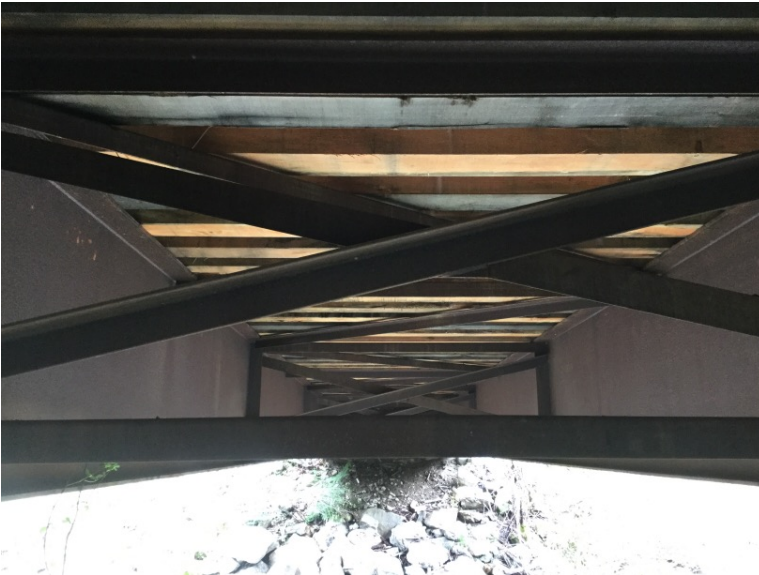
Superstructure

Girders Fair

Diaphragms Fair

Bracing Fair

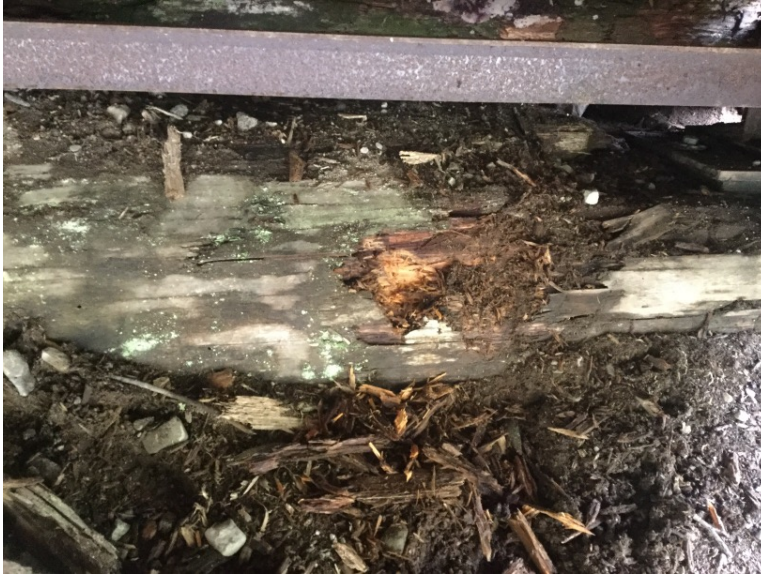
Caps or Sills Fair Up to 40mm of sap rot and timber shim at left bank

Log sill condition

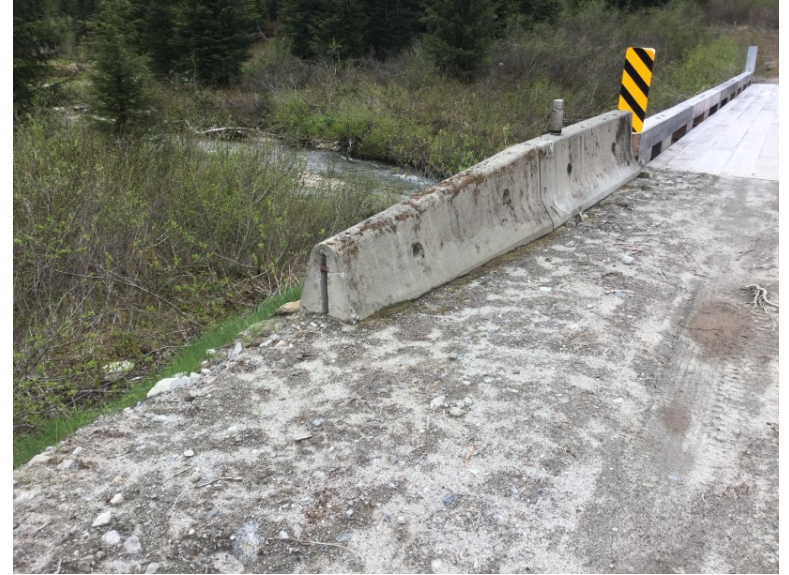
Missing bull nose at upstream right bank
