CK-2358  
CK-2358

## LOST CREEK 3.1km

2020 Inspection

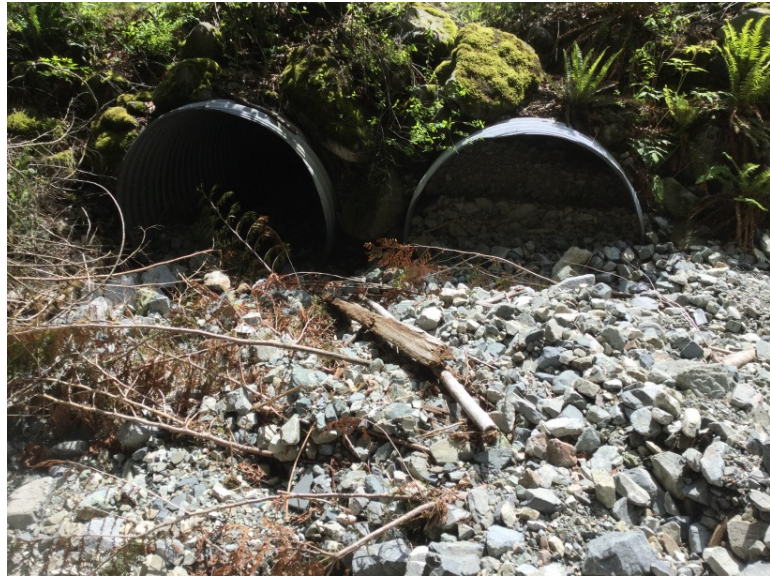
Inlet      Fair      Aggrading

| Estimated Present Water Level Width (m) | 0 | Aggradation | <input checked="" type="checkbox"/> | Scour | <input checked="" type="checkbox"/> |

Remove aggraded material from the inlet and dig a sump. Monitor the aggradation and outlet scour. The current load rating of BCL-625 or 63 tonnes to continue.

| Repair Item | Repair Description |
|---|---|
| 1 Medium | Remove aggraded material from inlet and dig sump |

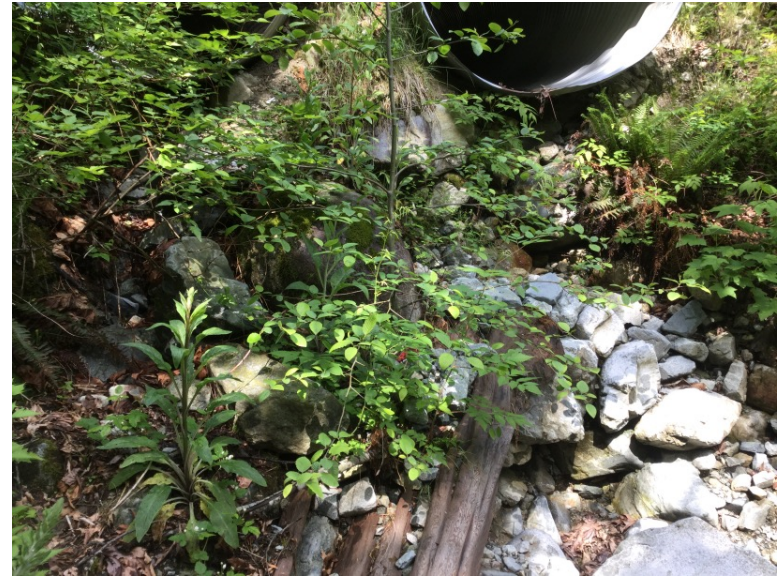
Outlet      Fair      Minor scour with over steepened fill slopes

| Item | Monitor Description | Frequency |
|---|---|---|
| 1 | Aggradation at the inlet and scour at the outlet | Routine Inspection |
