CK-2390  
CK-2390

CEDARFLAT 4.6km

2020 Inspection

| Crossing Name | Cedar Flat Creek |

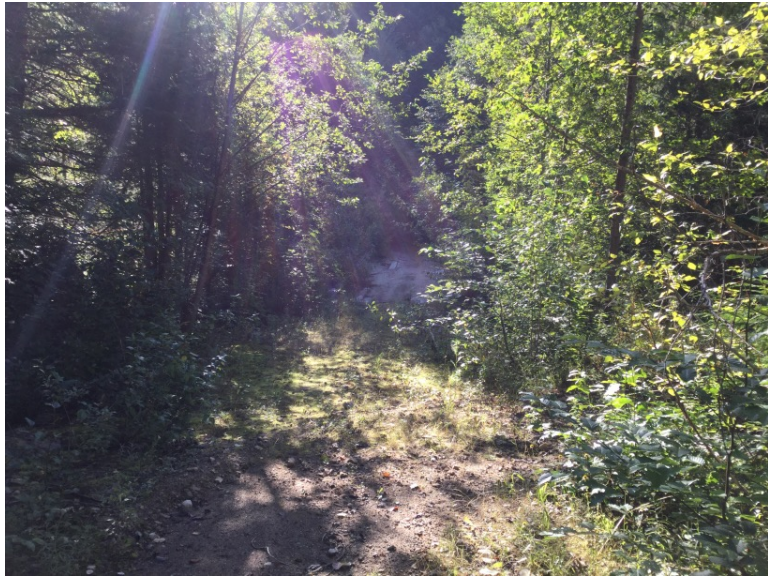
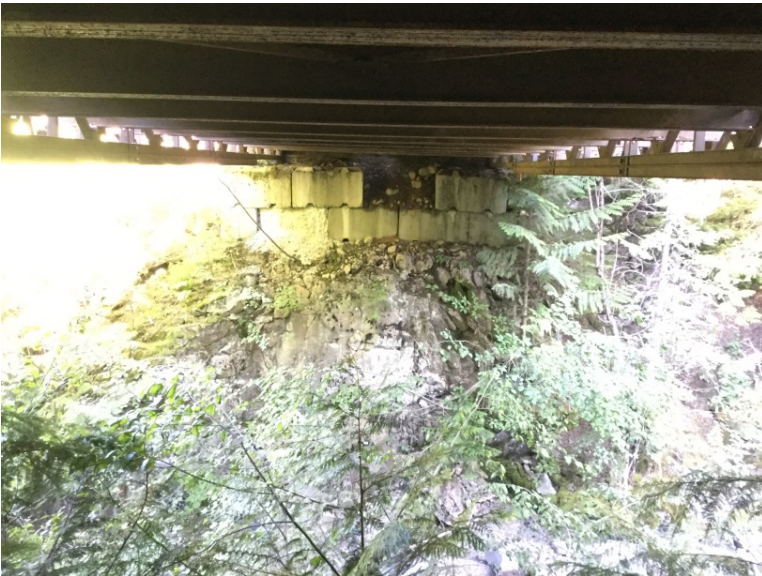
Right Bank Abutment when facing downstream

Concrete Poor 2 rows of lock blocks which are pitting, spalling and settling/rotating

Fill Poor Missing a lock block at the right abutment and fill failing into stream

| Repair Item | Repair Description |
|---|---|
| 1 | Replace prior to activity |

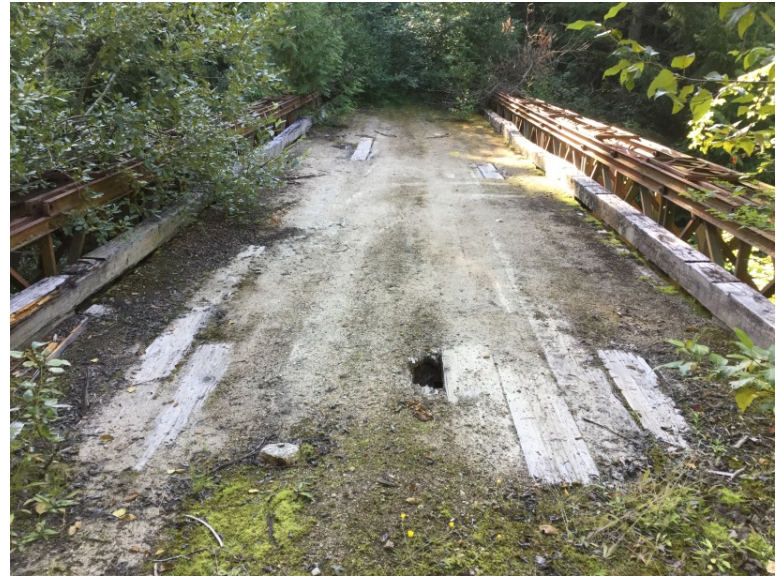
Deck

Poor

Rotten

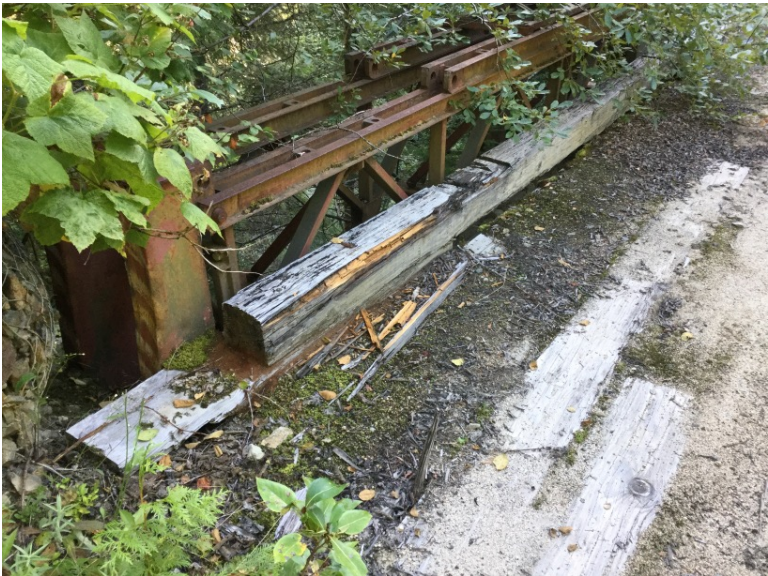
Guard Rail

Poor

Rotten

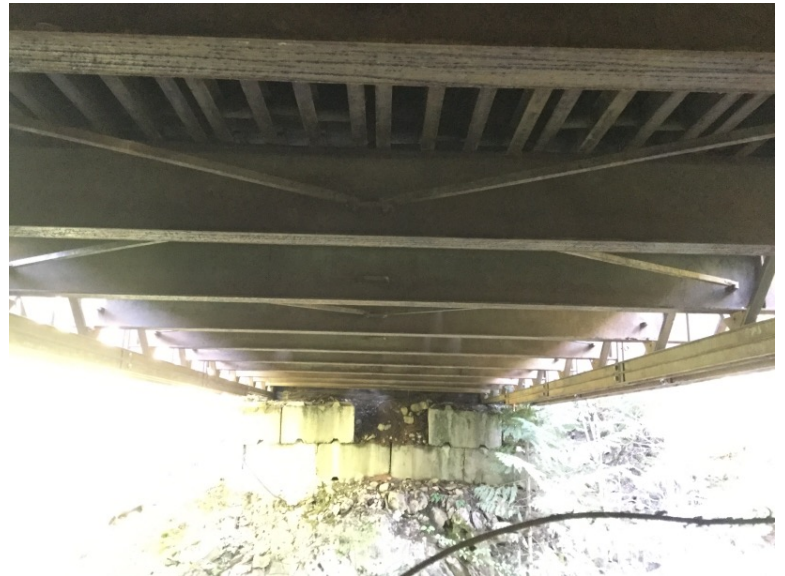
Superstructure

corrosion throughout entire structure

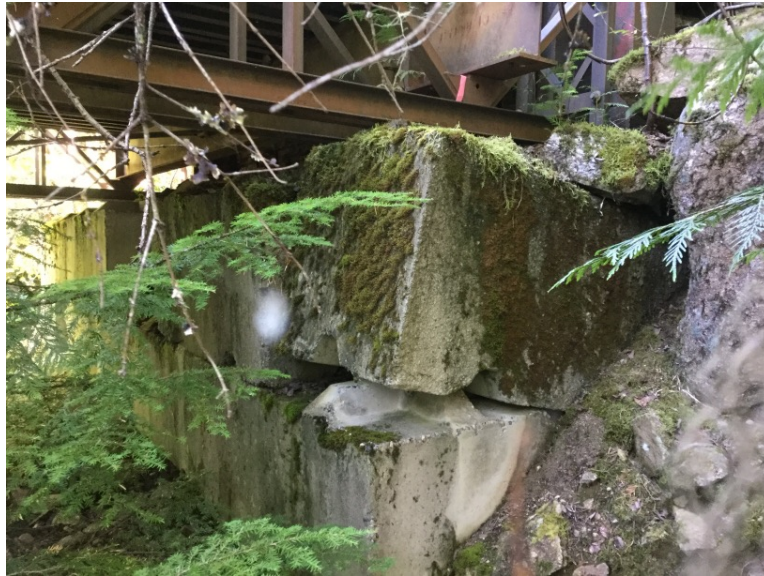
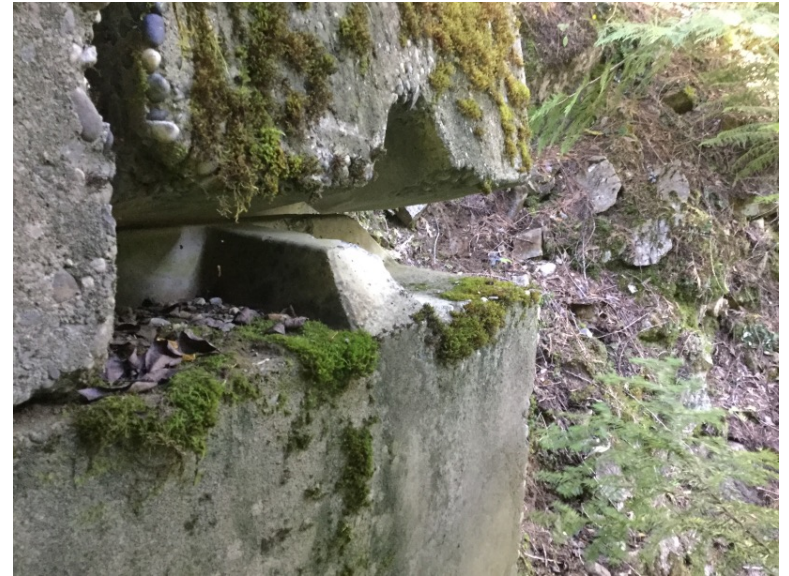
The upstream right bank bearing is in poor condition. The superstructure appears to be bearing right at the end of this block and causing the block to settle and the lock block rotate

Caps or Sills Poor Bearing plate rotating at right upstream bank

Bearings Poor Upstream right bank lock block is shifting under dead load of superstructure

Upstream right bank bearing block condition

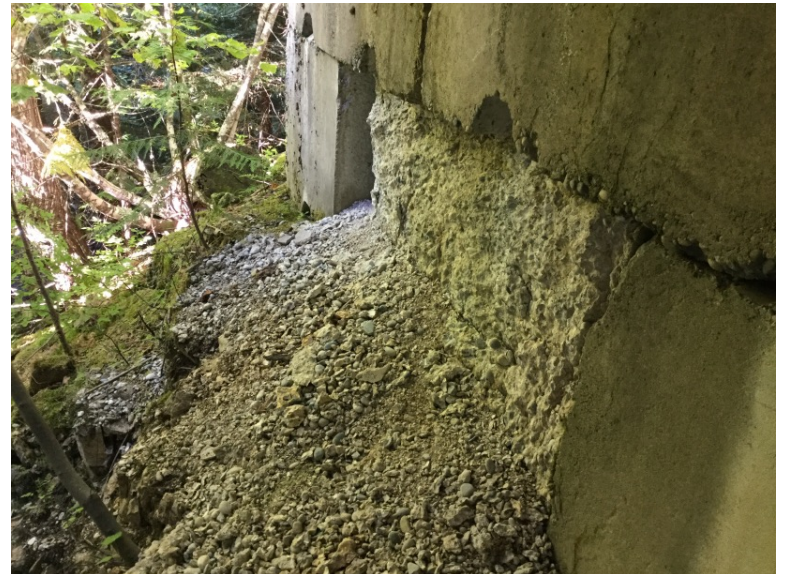
Lock block condition at downstream right bank
