# BC Ministry of Forests, Lands, and Natural Resource Operations

## Permanent Bridge Inspection Report

| Site #: | CK-2395 | Structure Name: | CK-2395 | Road Name: | ENGLISH 1600 | Inspection Date: | 2020/05/15 | |
| KM: | 0.30 | User km: | 0.30 | Crossing Name: | Big Silver River | Next Inspection Date: | 2020/08/01 | |

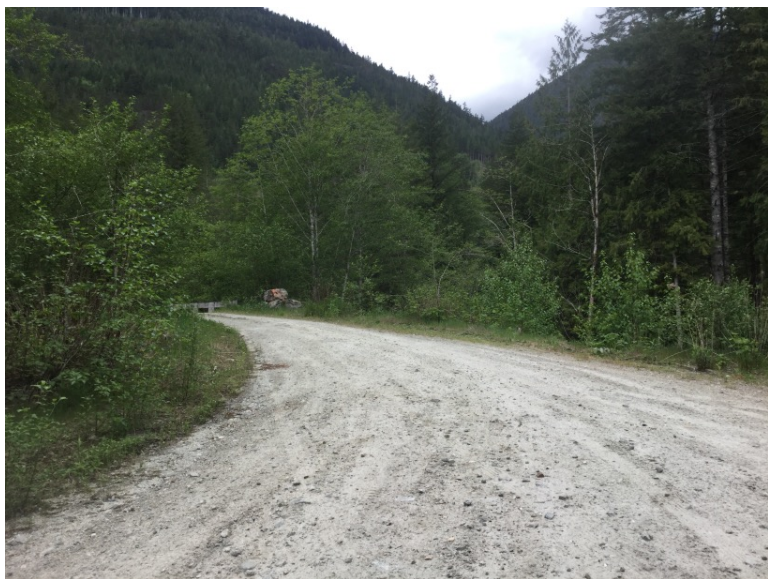
| Alignment | Fair | HC both approaches |

Approach from Left Bank when facing downstream

| | 1 | Suggested | Medium | \$1000.00 | Brush approaches | | | | | |

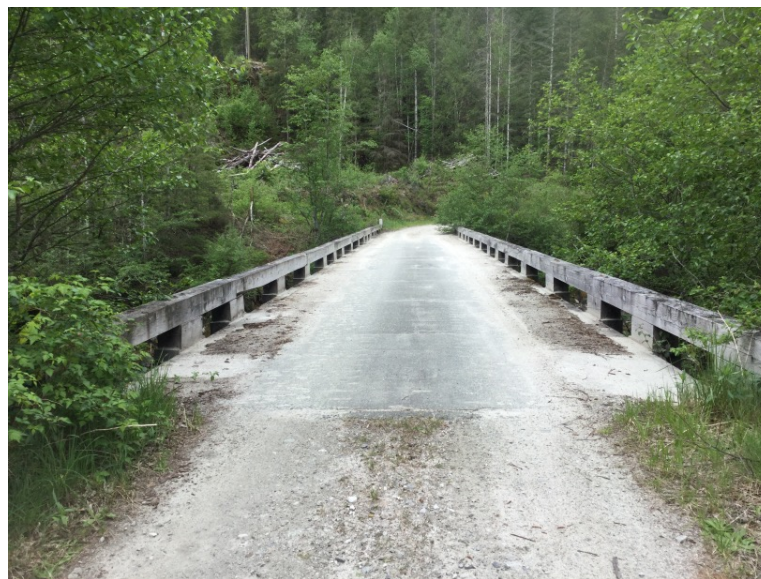
| Concrete Deck | Fair | Minor damage on wheel path |

Deck

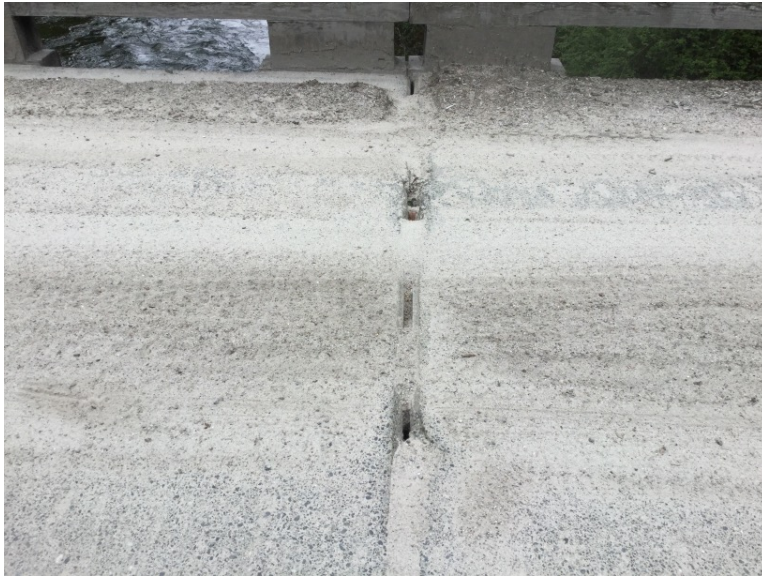
| Deck Joints | Fair | | | | | | |

Span deck joint

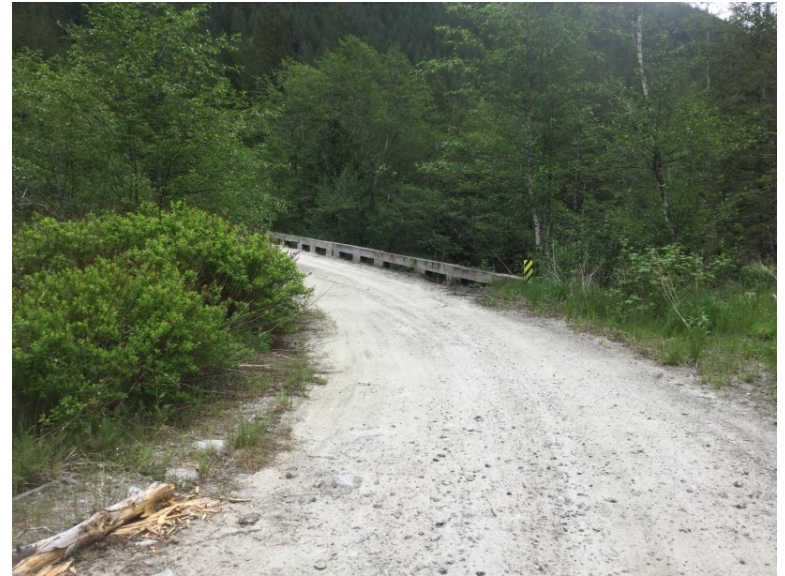
Approach from Right Bank when facing downstream

| | 2 | Suggested | Low | \$ 100.00 | Post bridge ahead signs | | | | | |

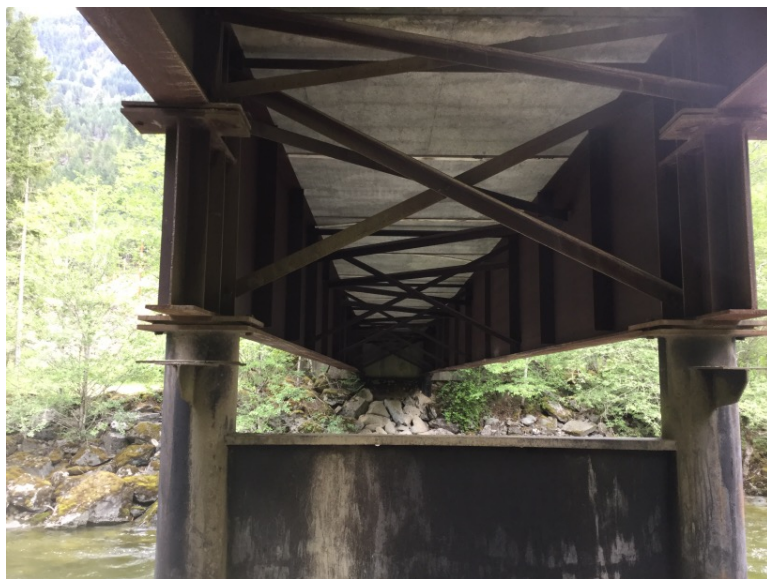
Main span superstructure

| Girders | Good | | | | | | |

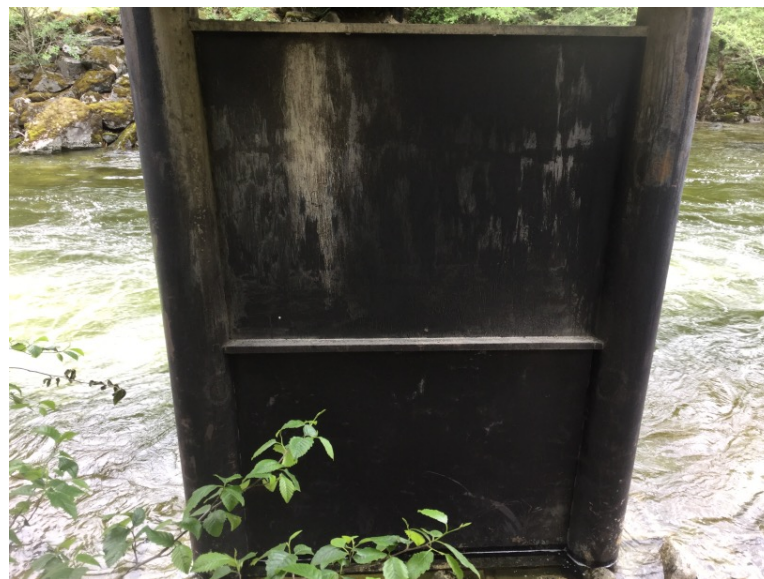
Pier

| Overall | Good | | | | | | |
