CK-2400

NESAKWATCH LAKE 1.07km

2020 Inspection

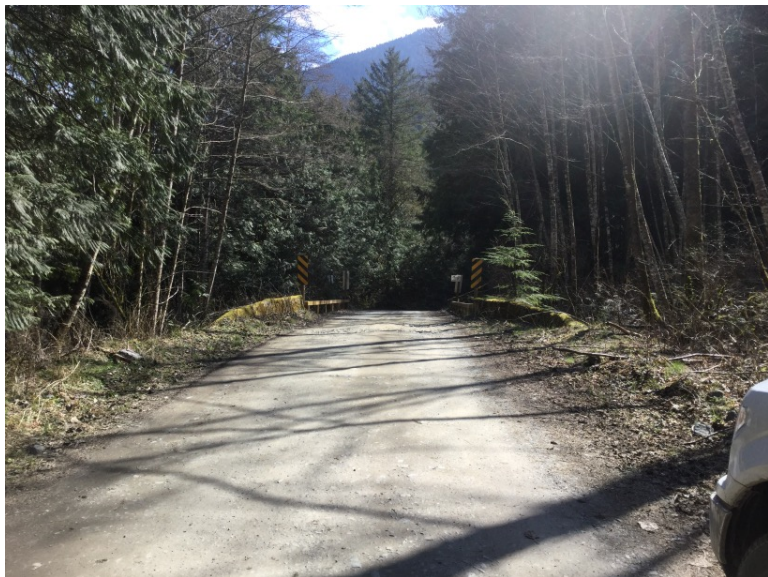
Approach from Left Bank when facing downstream

Bridge Ahead Signs  
Missing ☐ 0 ☐ 1 ☒ 2

| 1 | Low | Post bridge ahead signs |

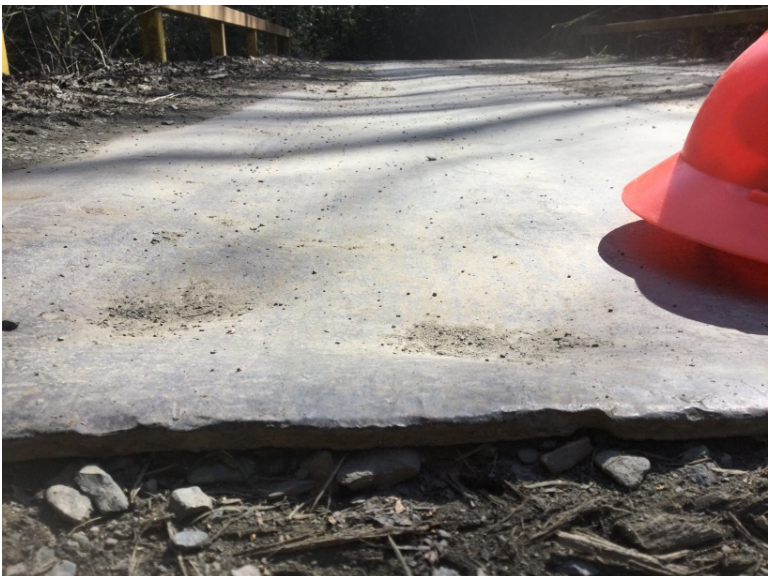
Steel Deck Plate      Fair      Minor deformation on wheel track

Deck deformation

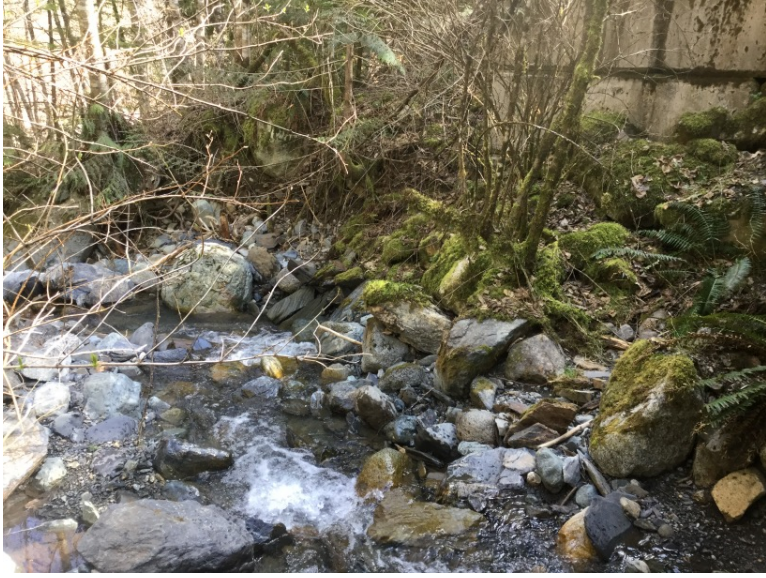
Bank erosion noted downstream right bank

Downstream right abutment scour

Post bridge ahead signs and monitor the downstream right bank fill slope erosion. The current load rating of L75 or 68 tonnes to continue.

| Item | Monitor Description | Frequency |
|---|---|---|
| 1 | Downstream right bank fill slope erosion | Routine Inspection |
