CK-2401

NESAKWATCH LAKE 1.64km

2020 Inspection

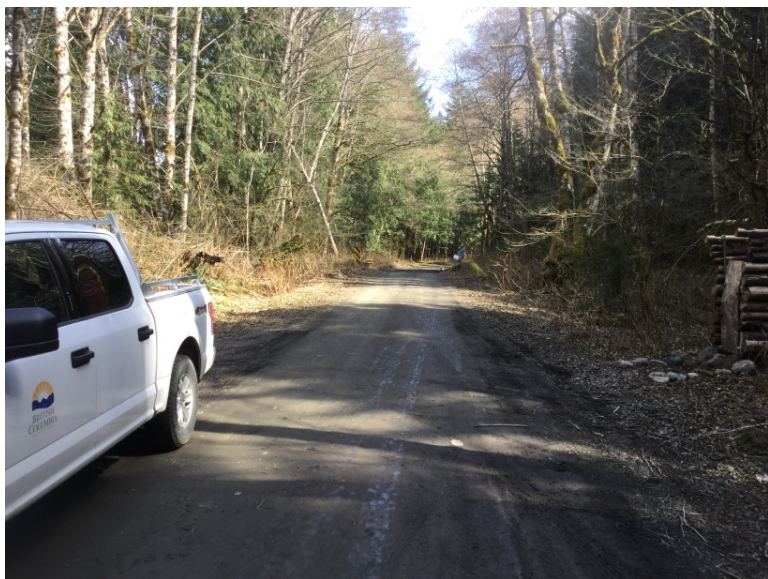
Approach from Left Bank when facing downstream

Brushing Required Y

Road Surface Fair

| Repair Item | Priority | Repair Description |
|---|---|---|
| 2 | Medium | Brush and grade approaches |

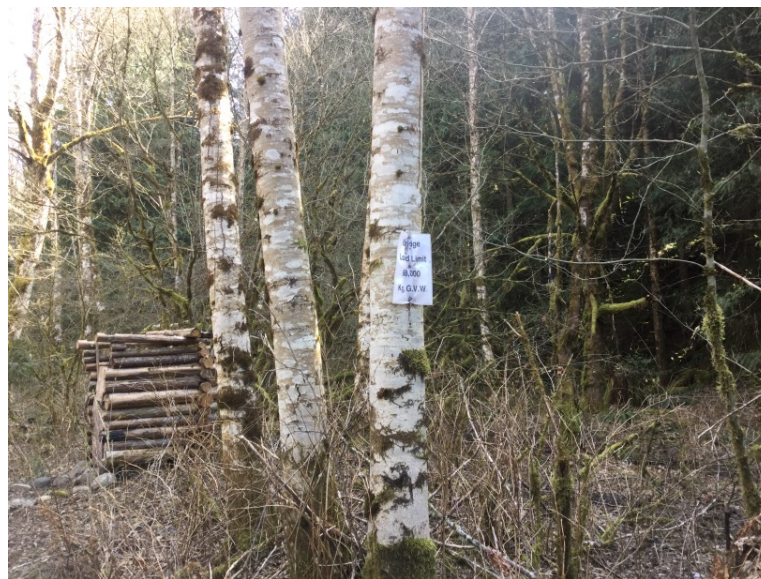
Load Rating Sign

| L75 or 68 tonnes | |

Posted Load Rating 68000

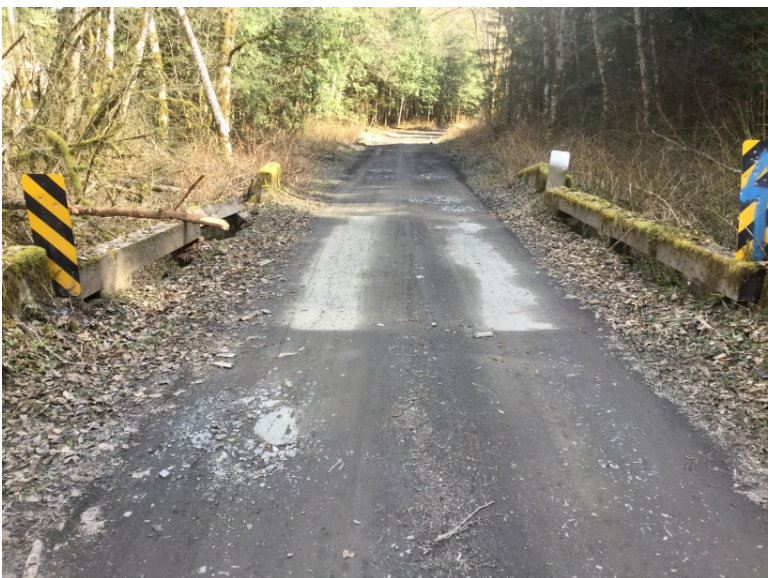
Running Surface      Fair

Concrete Deck      Good

Deck Joints      Good

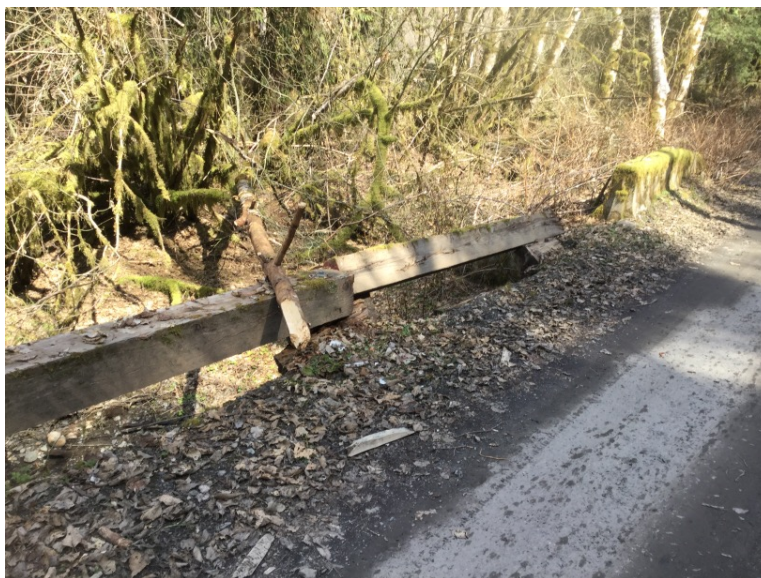
Guard Rail

Curb Rail/Blocks/Posts      Poor      Rotten and failed

Hardware      Poor      Loose rail bolts

Overall Deck Condition      Poor      Due to rail condition

| Repair Item | Priority | Repair Description |
|---|---|---|
| 1 | High | Replace guardrail, risers and blocks |

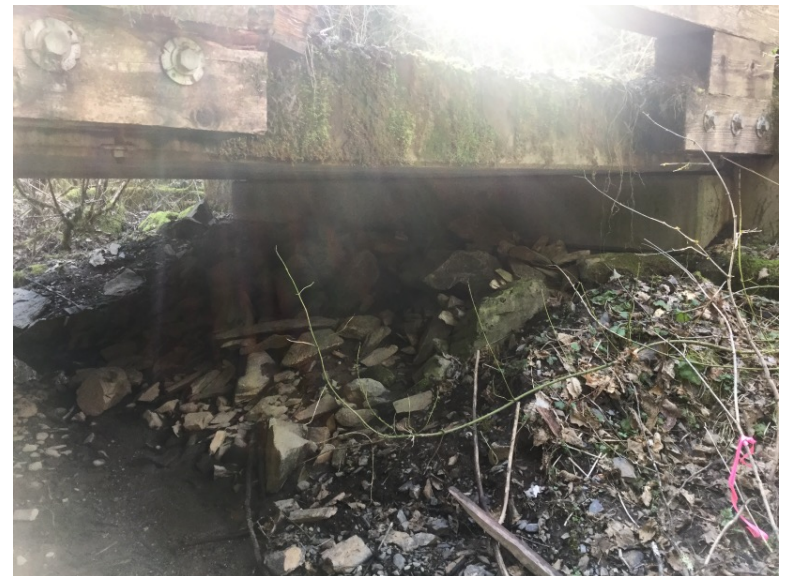
Left Bank Abutment when facing downstream

Concrete Good

Ballast Wall Good

Wing Wall Good
