CK-2442  
2442

AMERICAN 4700 0.15km

2020 Inspection

Crossing Name American Creek

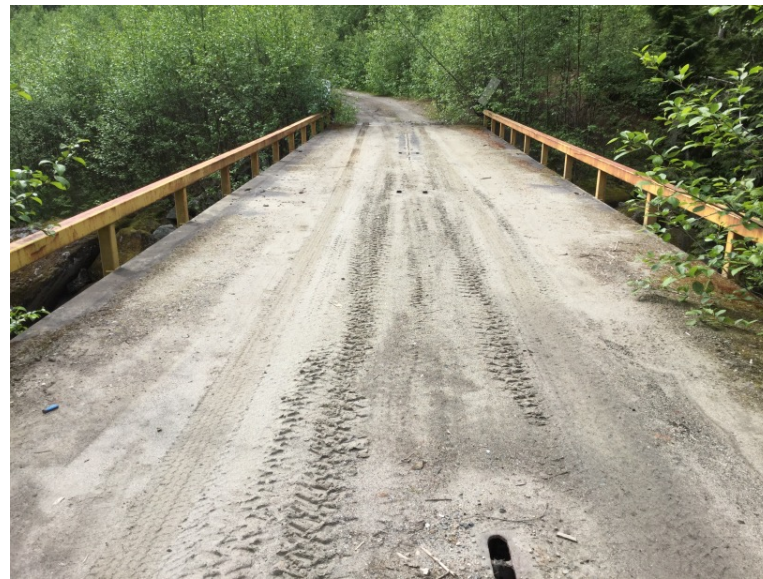
Steel Deck Plate      **Fair**      Minor deformation along sections on wheel path

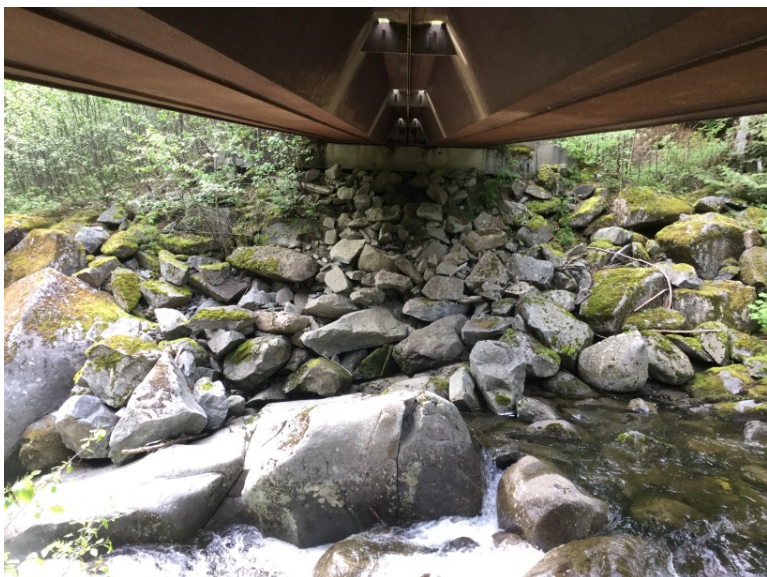
Right Bank Abutment when facing downstream

Only visible at right bank

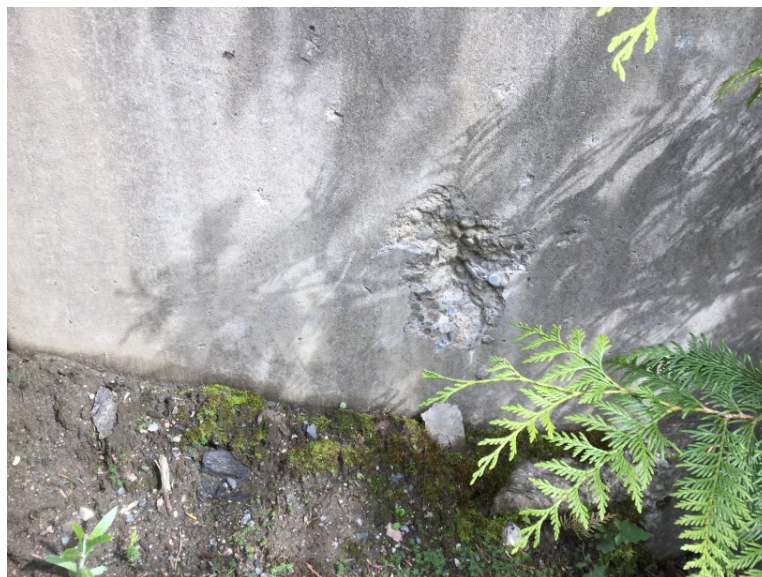
Ballast Wall Fair

Minor damage noted to both ballast walls
