CK-2446  
CK-2446

NORRISH 16.3km

2020 Inspection

Crossing Name Tom Creek

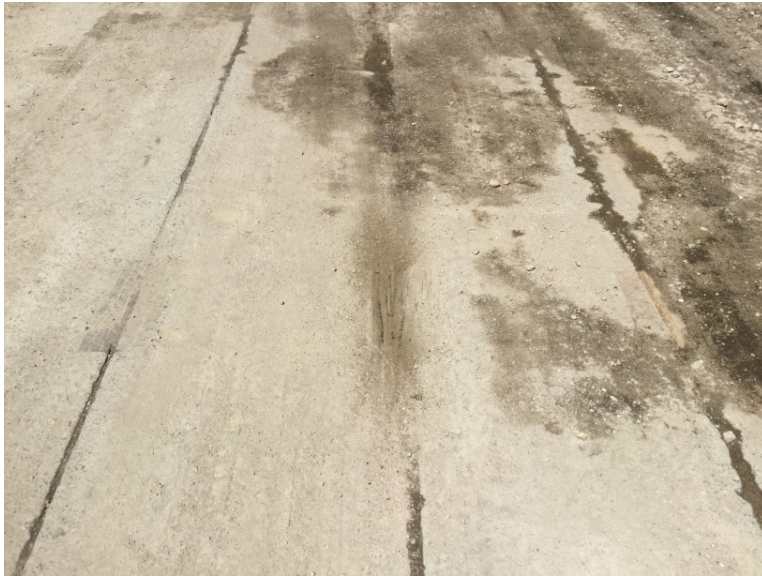
Shear connectors

Welded/grouted shear connectors Good Welded

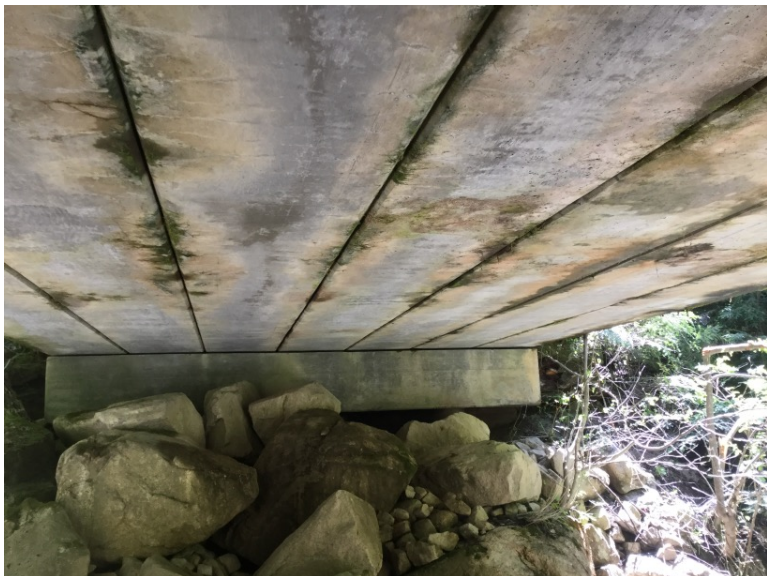
Superstructure

Girders Good 7 concrete slabs
