CK-2450  
CK-2450

NORRISH 5.1km

2020 Inspection

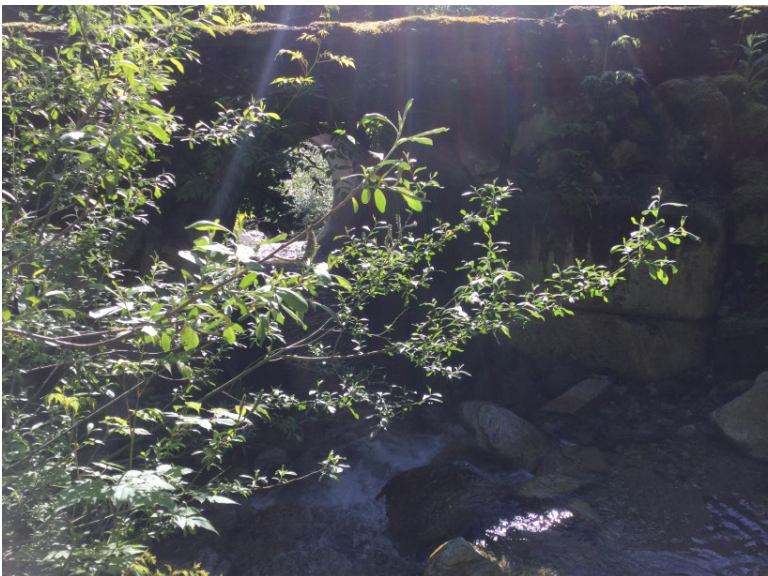
Inlet      Fair

Rip Rap      Fair      lock blocks used as riprap at inlet

| Repair Item | Repair Description |
|---|---|
| 1 Medium | Brush vegetation from the inlet and inside of curve through crossing location |

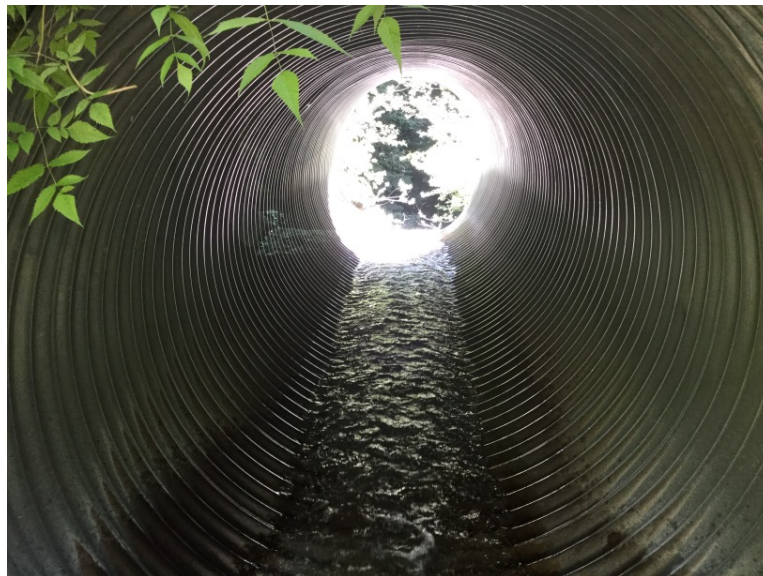
Looking through culvert from inlet

Coating      Fair      Minor corrosion on the floor

Floor      Fair      small deformation at the outlet 2m length

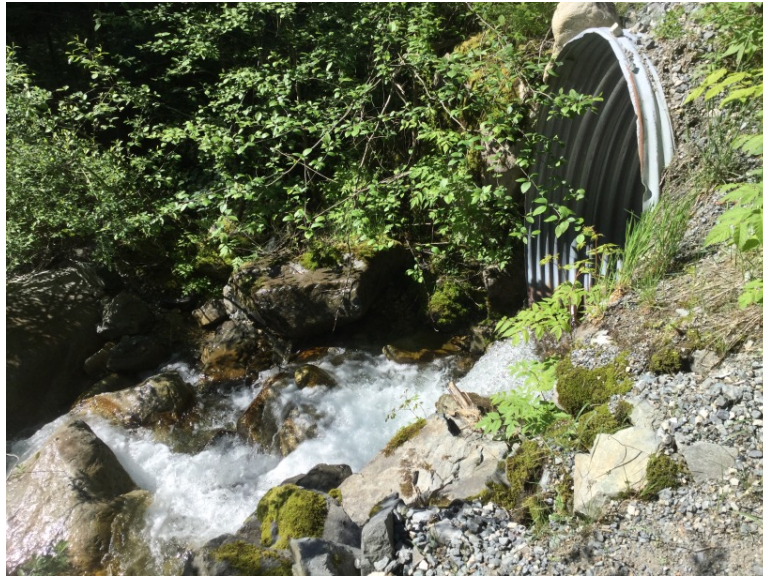
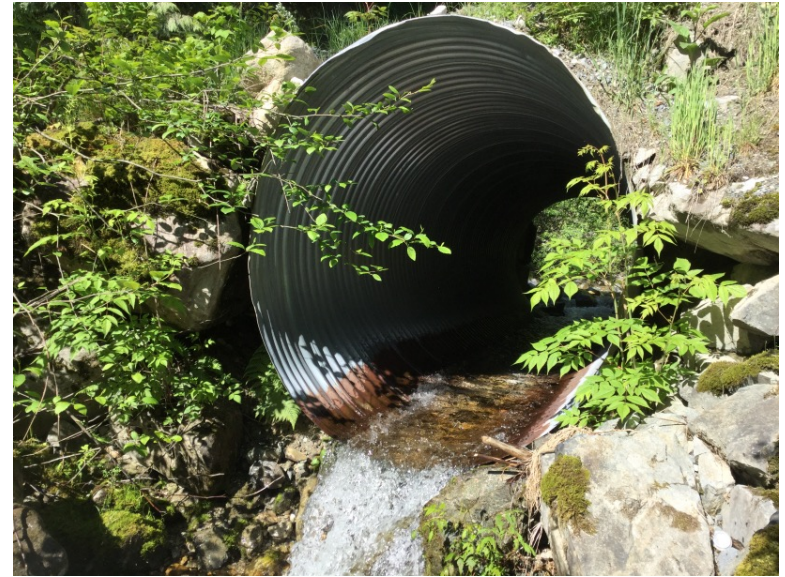
Outlet      Fair      1m drop at outlet

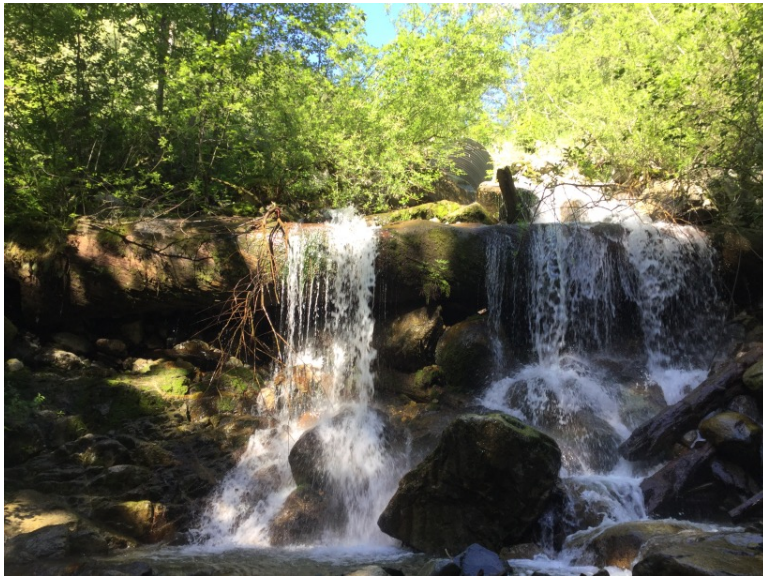
Log retaining fill

No apparent changes in log retaining fill at fill slope

Continue to monitor the log retaining fill at the outlet. Brush approaches and remove the vegetation from the inlet. The current load rating of BCL-625 or 63 tonnes to continue.

| Item | Monitor Description | Frequency |
|---|---|---|
| 1 | log retaining fill at the outlet | Annually |
