CK-2451  
CK-2451

NORRISH 5.6km

2020 Inspection

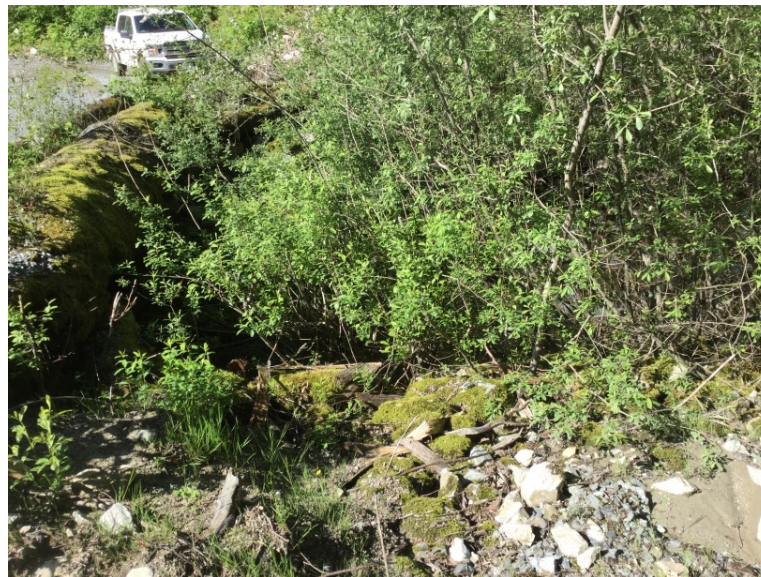
Inlet      Fair      CSP has deformed at the roof, and site requires brushing

Remove the vegetation from the inlet and monitor the condition of the culvert. The current load rating of BCL-625 or 63 tonnes to continue.

Brushing Required Y Brush inlet

| Repair Item | Repair Description |
|---|---|
| 1 Channel. Debris removal.<br># of sites/items.<br>Priority:Medium | Brush inlet |

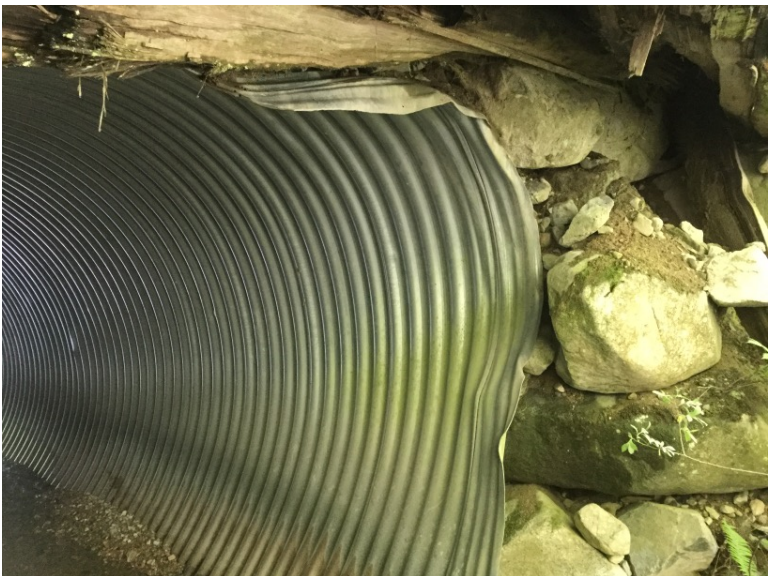
Fill      Fair      Log over the inlet has sloughed and has caused deformation to the CSP

Damage at inlet

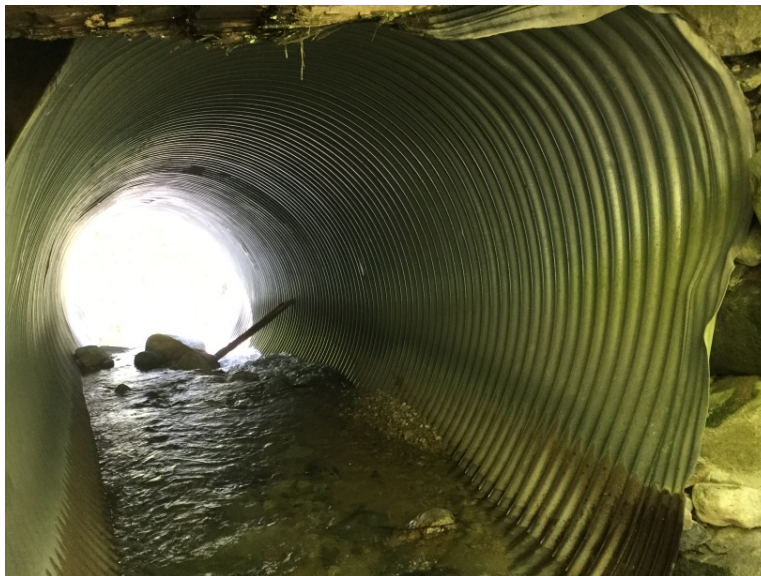
Overall      Fair      The culvert is deformed along the entire length of the culvert but is functioning well

Culvert shape is not round

| Item | Monitor Description | Frequency |
|---|---|---|
| 1 | culvert shape and condition | Every Routine Inspection |

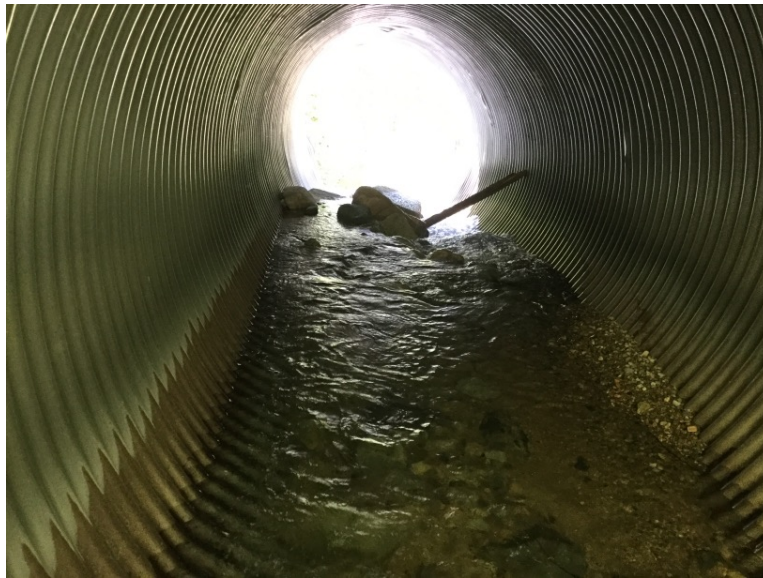
Material being transported into culvert

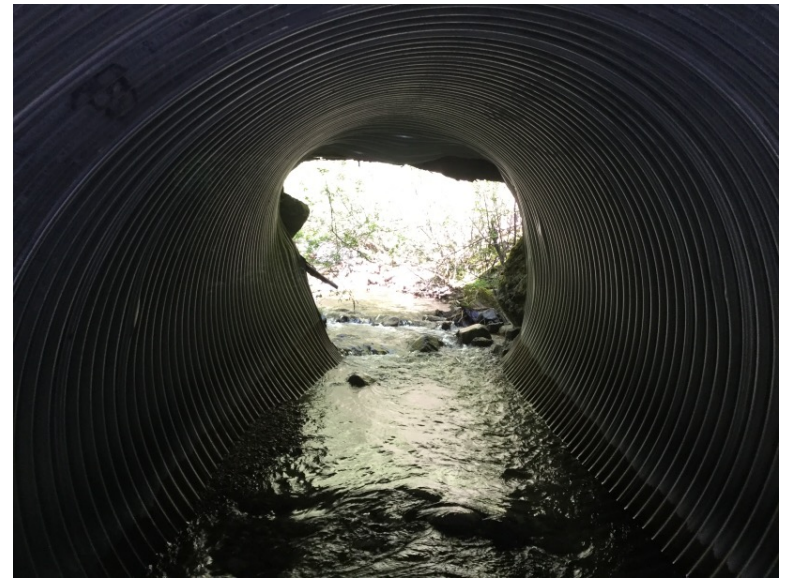
Coating      Fair      Minor corrosion noted on the floor

Culvert condition

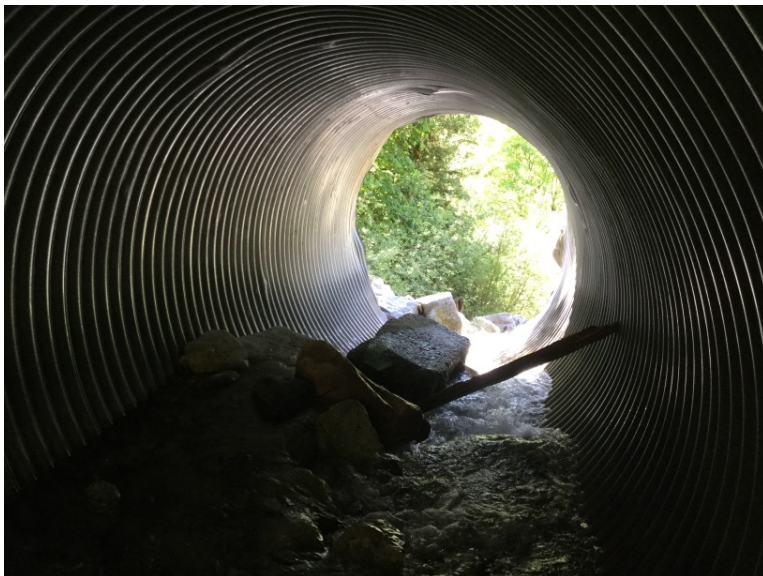
Floor      Fair      deformation noted along along outlet third of culvert but still functioning

Culvert appears to have settled at outlet

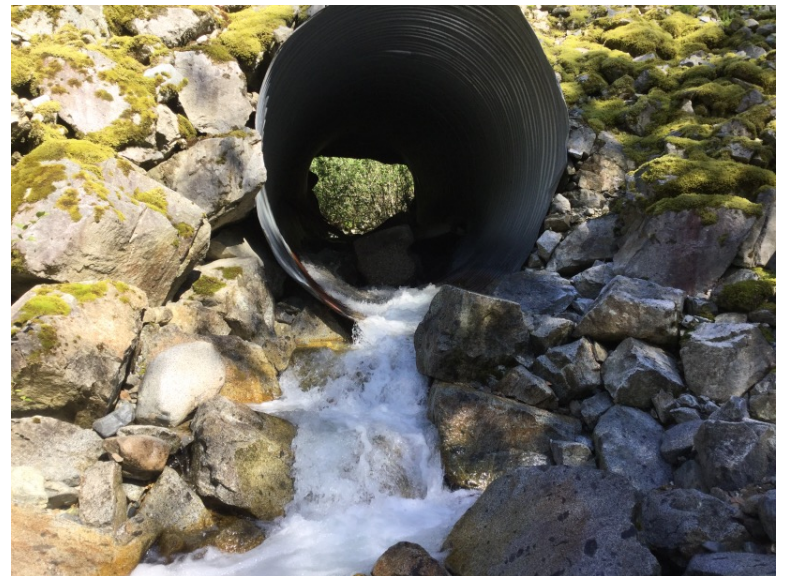
Outlet      Fair

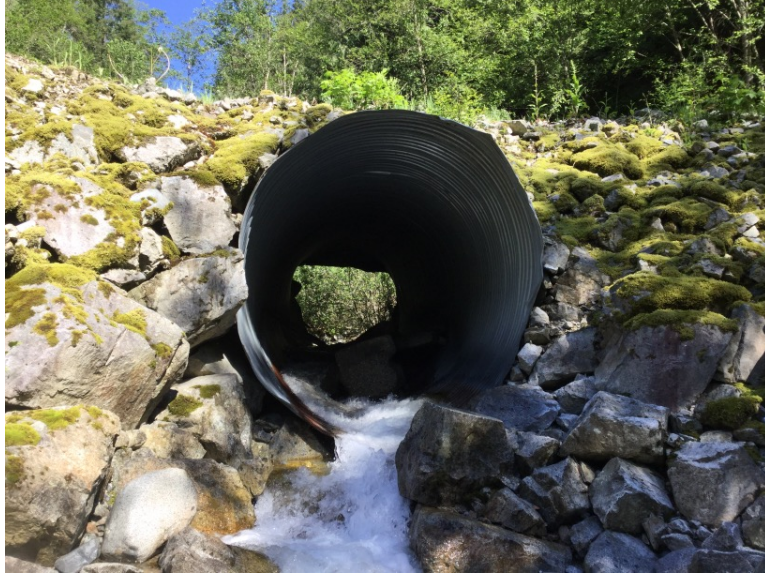
Culvert shape at outlet
