CK-2452  
CK-2452

NORRISH 7.1km

2020 Inspection

Crossing Name Rose Creek

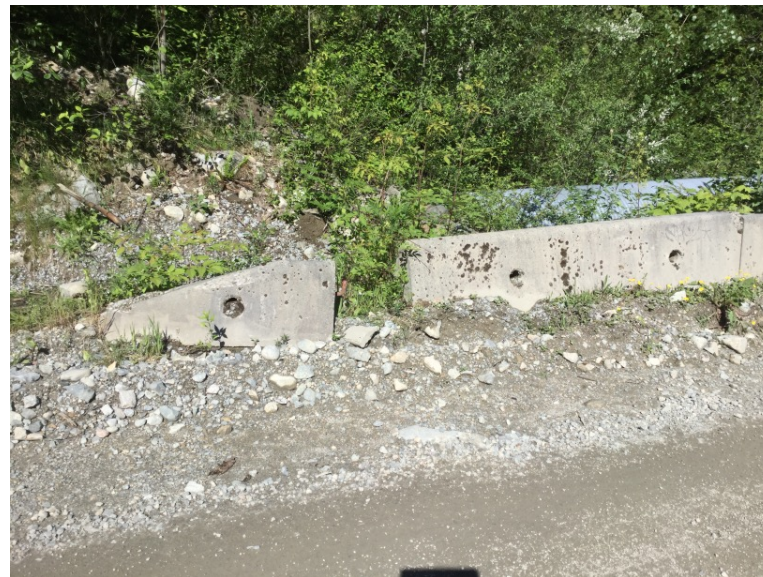
Fender Condition Good Upstream right approach bull nose not connected

Upstream right approach bull nose

Reattach the upstream right bank bull nose to the concrete barriers. Brush and grade approaches. Monitor the condition of both abutments. The current load rating of L165 or 150 tonnes to continue.

| Repair Item | Repair Description |
|---|---|
| 2 Approach. Approach fenders (re-Install). # of units. Priority:Low | Reattach upstream right approach bull nose |

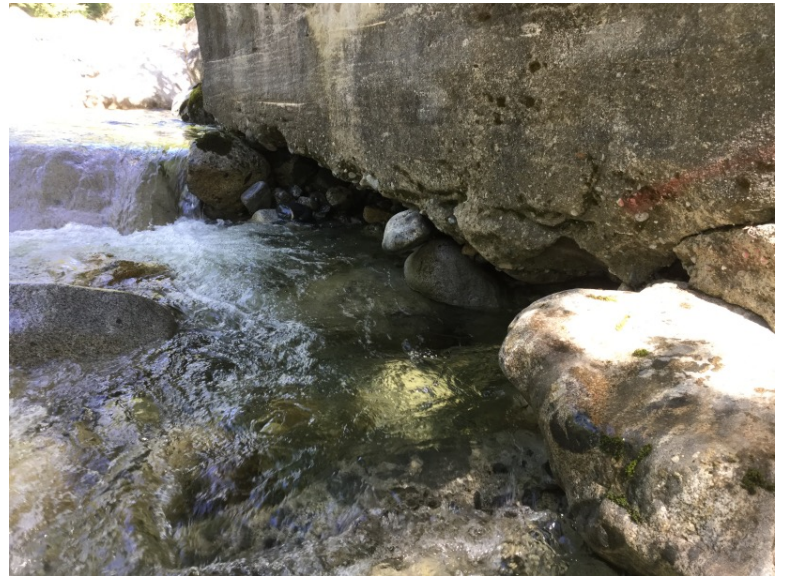
Comments Upstream left bank CIP is scoured and vertical crack directly under upstream girder

Scour under upstream left bank CIP

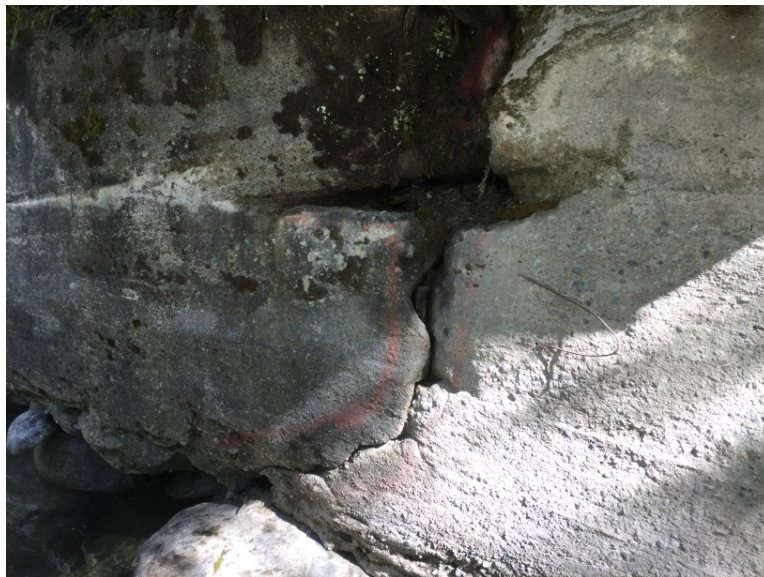
Concrete Fair CIP left bank with vertical crack under the upstream girder - no apparent change from old inspections. Lock blocks on right bank - some have spalls and others have visible cold joints

Vertical crack in CIP directly under upstream girder

| Item | Monitor Description | Frequency |
|---|---|---|
| 1 | Abutment condition | Every Routine Inspection |

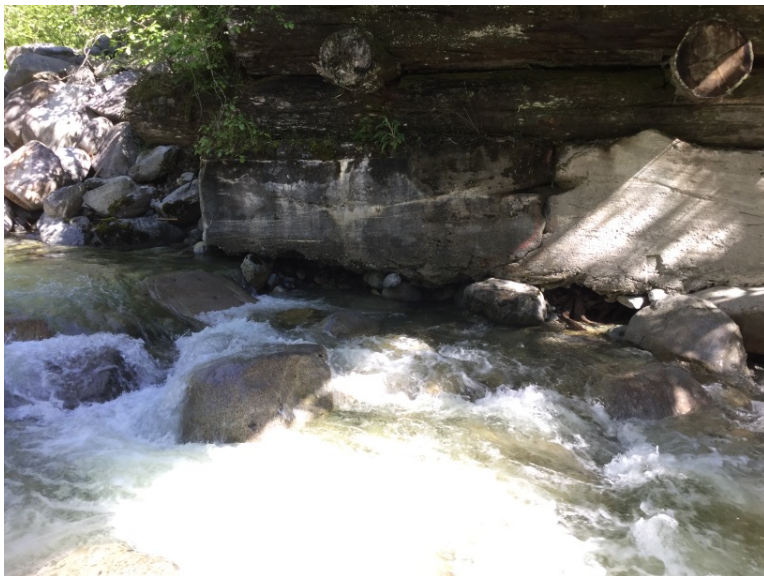
Scour under upstream left CIP
