CK-2453  
CK-2453

NORRISH 7.4km

2020 Inspection

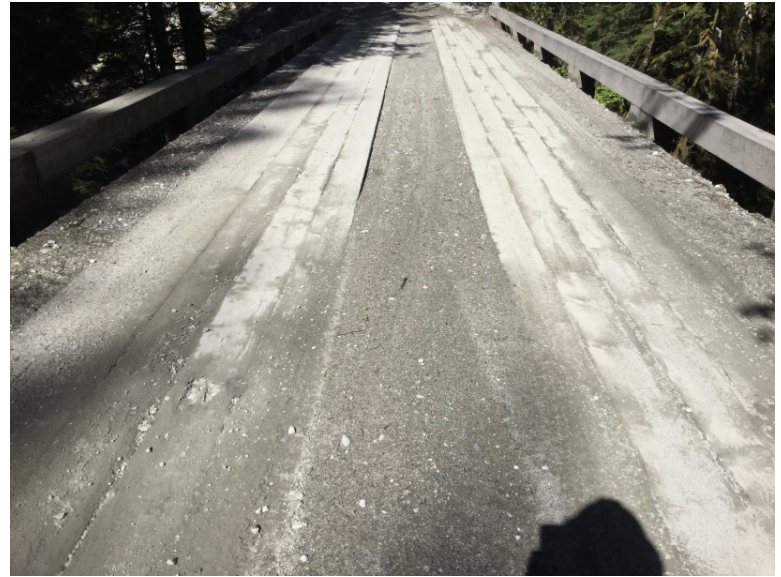
Overall Deck Condition      Fair

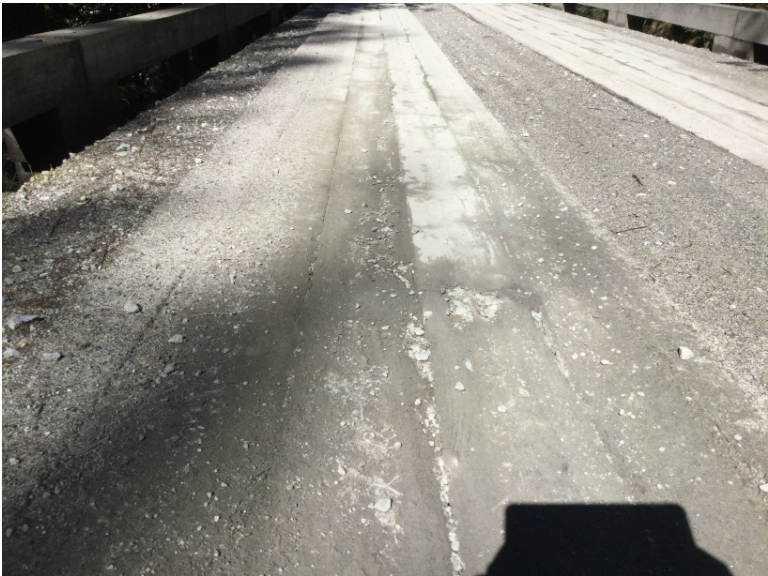
Running Planks      Fair      some showing signs of excessive wear

Nails      Fair      Starting to protrude on worn planks

Wear plank condition

The timber deck components were replaced in 2014 and the wear planks are now starting to show excessive wear. In order to get the maximum life span from those timber structural members I recommend replacing the wear planks. Monitor the condition of the left bank erosion under the fill retention log in front of the sill log. The current load rating of L100 or 91 tonnes to continue.

| Repair Item | Repair Description |
|---|---|
| 1 Structure. Minor redecking (wearing surface). m.<br>Priority:Medium | Replace wear planks |

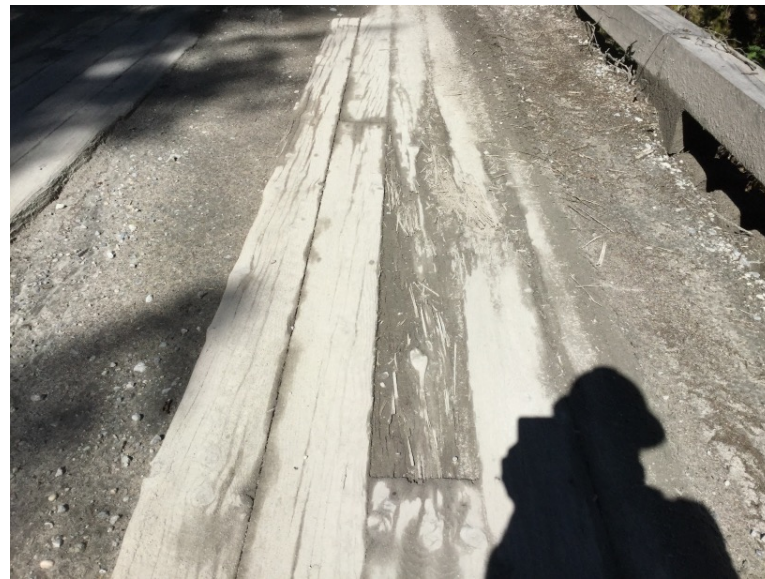
Wear plank condition

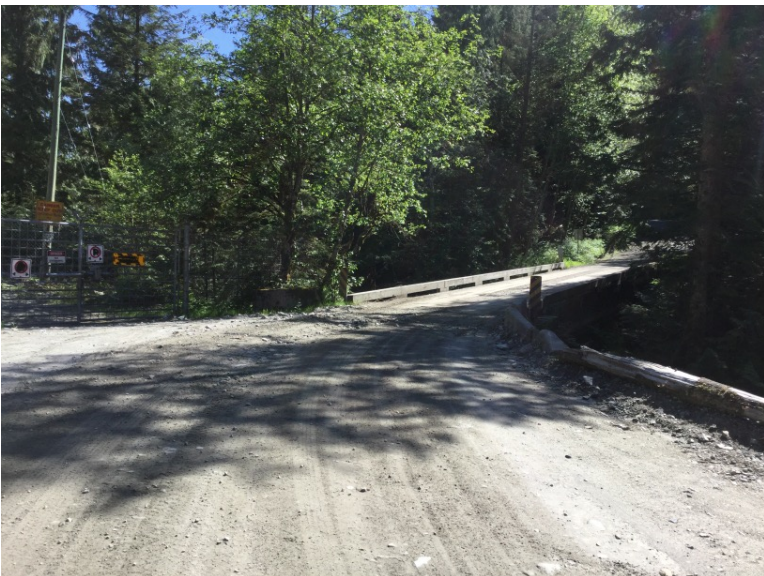
Right Bank Abutment when facing downstream

Caps or Sills Fair Single log sills at both abutments

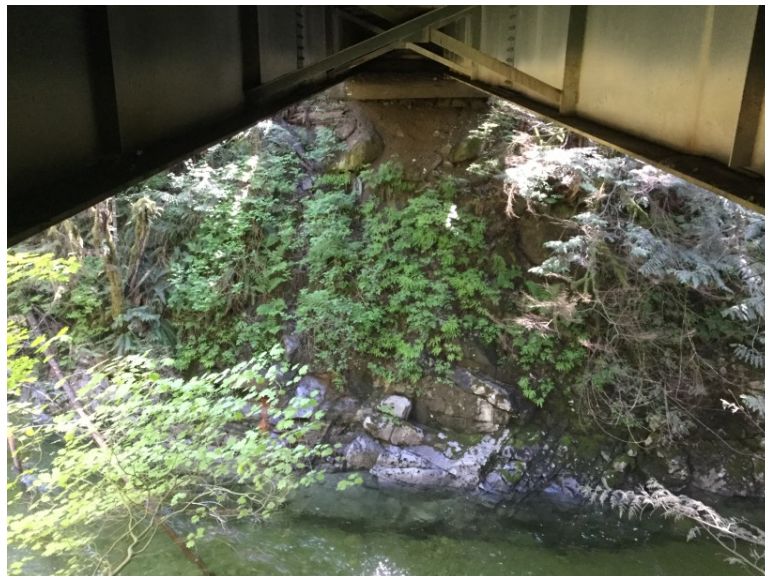
Left Bank Abutment when facing downstream

Fill Fair Ravelling under fill retention log at left bank

| Item | Monitor Description | Frequency |
|---|---|---|
| 1 | left bank erosion | Every Routine Inspection |

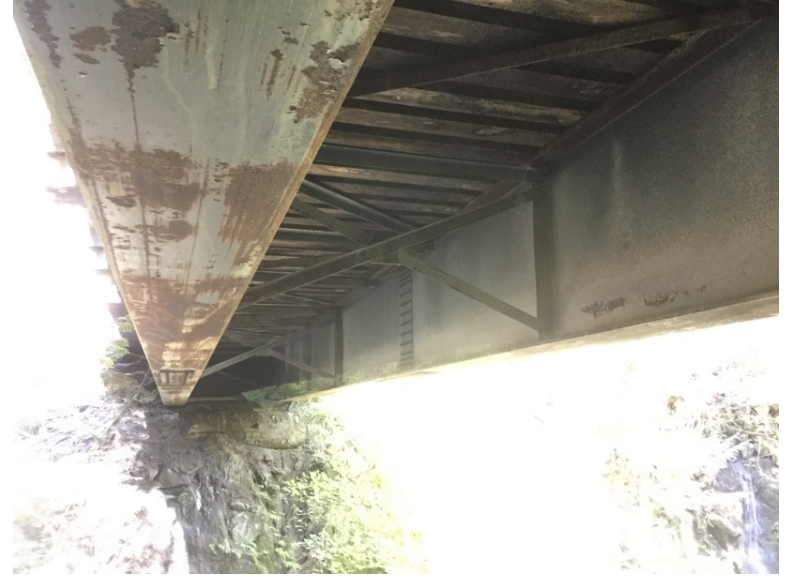
Superstructure

Girders Fair Painted

Diaphragms Fair 4 welded bays
