CK-2454  
CK-2454

NORRISH 8.4km

2020 Inspection

| Structure Class | Major Culvert |

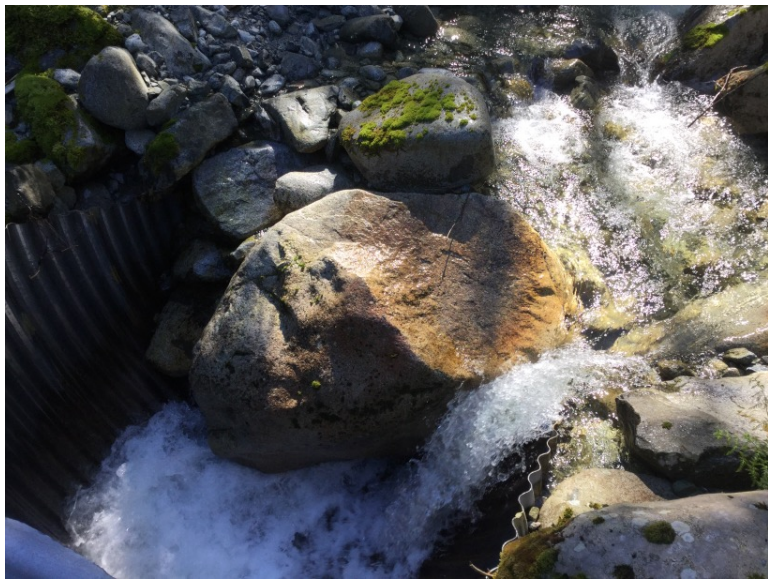
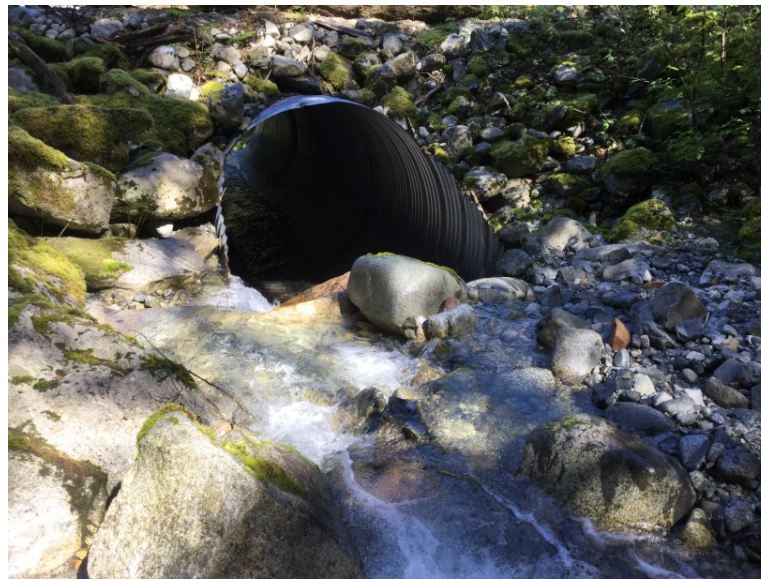
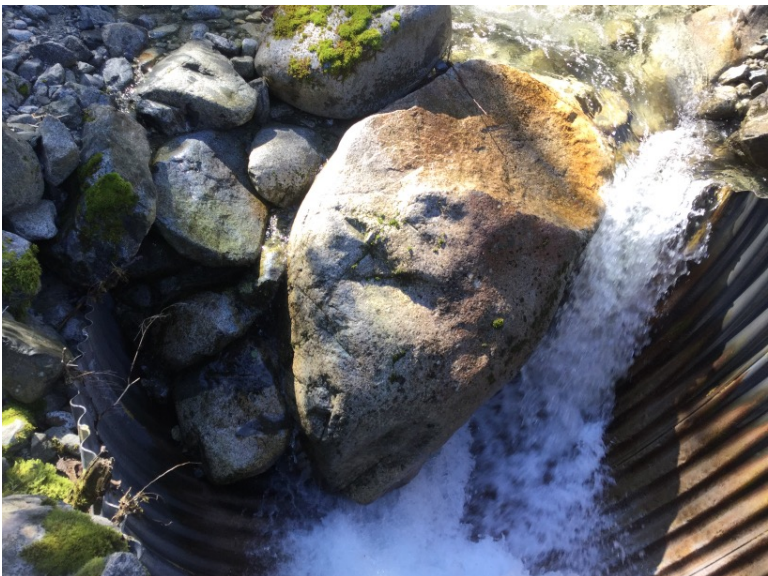
Inlet Poor Approx 50% end area blocked by aggraded material

Overall Fair Culvert is functioning but inlet 50% plugged

| Estimated Present Water Level Width (m) | 2.0 | Aggradation | <input checked="" type="checkbox"/> | Scour | <input type="checkbox"/> |

Remove the accumulated stream material at the inlet and dig a sump. The current load rating of L165 or 150 tonnes to continue.

| Repair Item | Repair Description |
|---|---|
| 1 Channel. Remove Aggraded Material. .<br>Priority:High | Remove aggraded material from inlet and create sump |

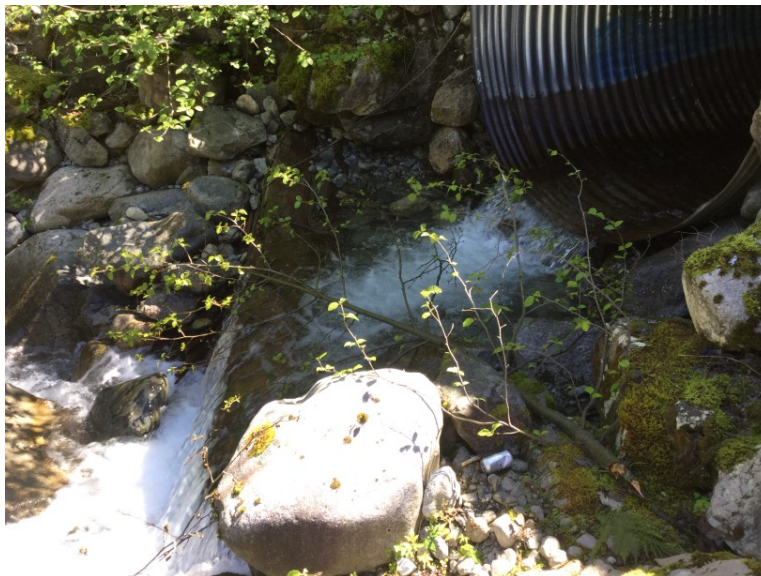
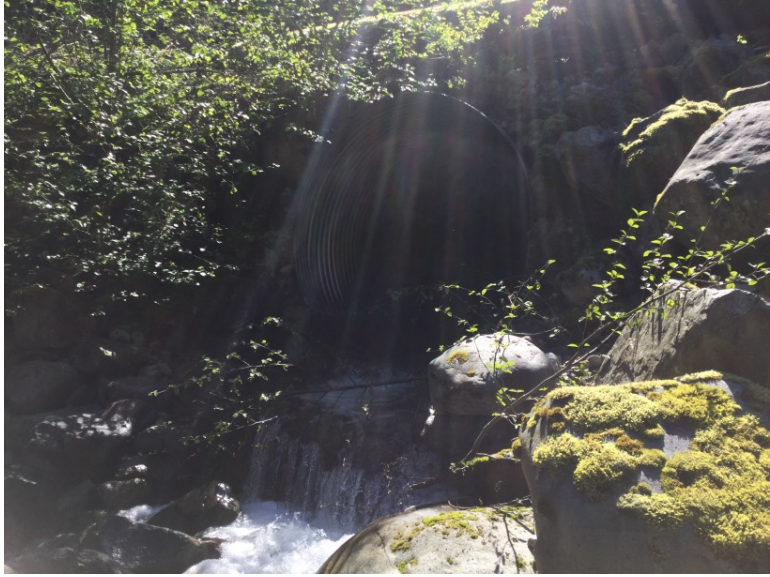
Outlet Good

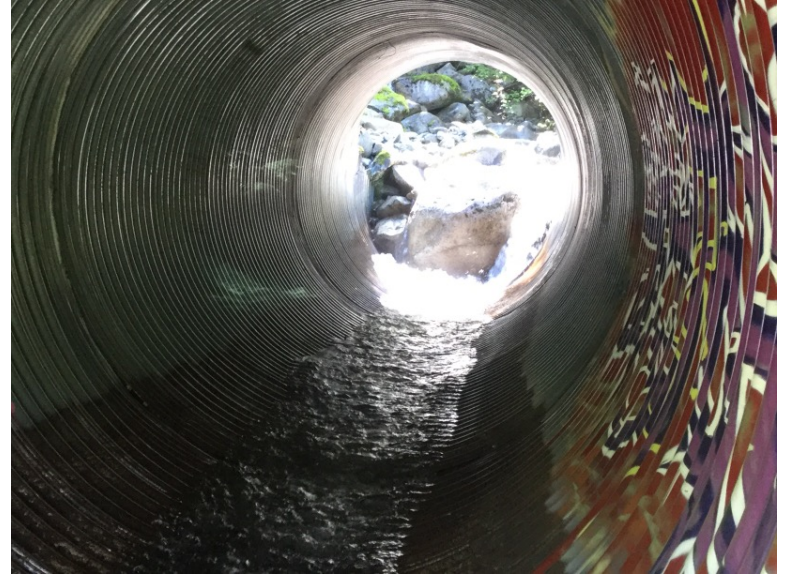
Looking through culvert from outlet

Floor Fair Minor corrosion
