CK-2456  
CK-2456

NORRISH 9.1km

2020 Inspection

| Structure Class | Major Culvert |

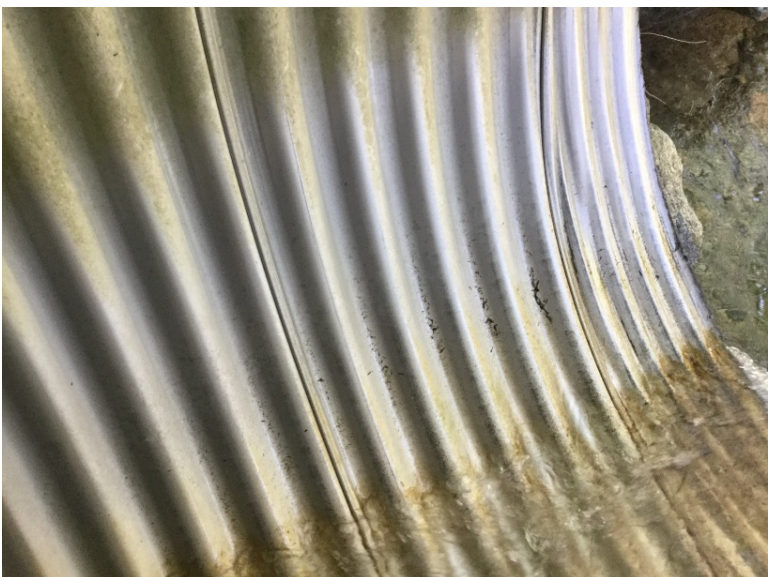
Aluminium?

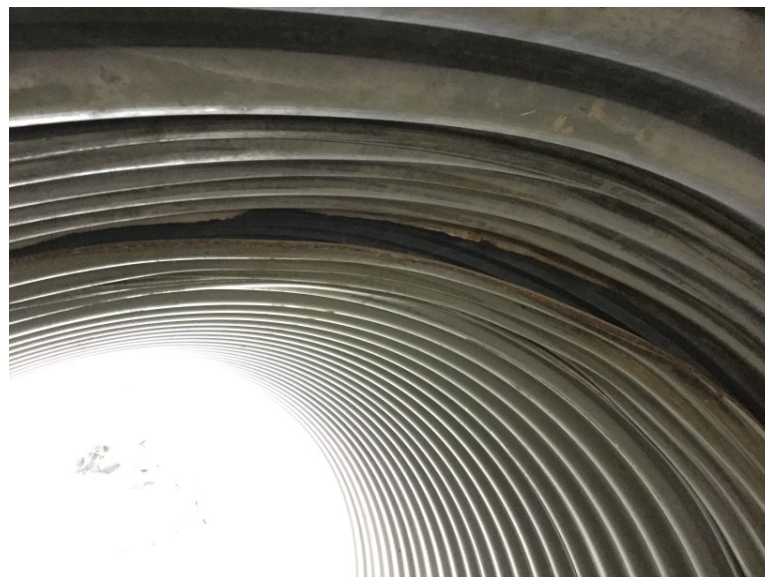
Coupled Connections      Fair      Slight separation in culverts at joint

Culvert connection
