CK-2457  
CK-2457

NORRISH 13.6km

2020 Inspection

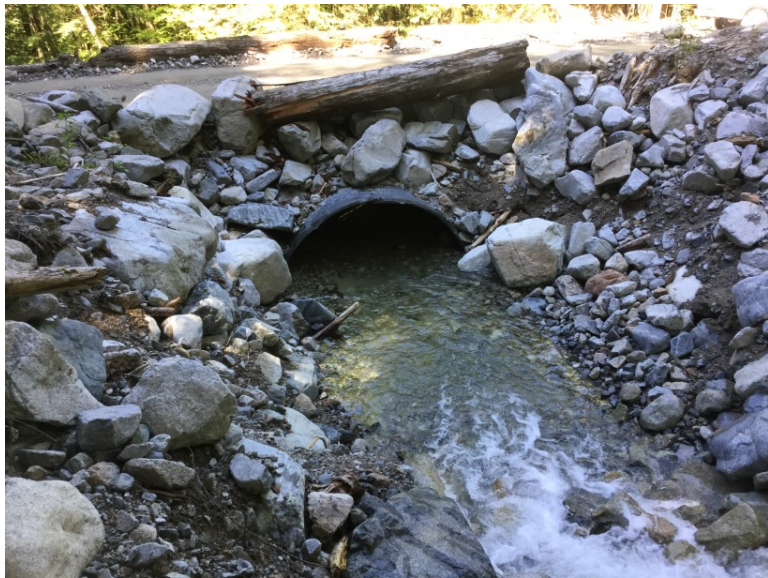
Embedment Materials      Poor      Inlet is +/- 60% filled and material aggrading within the culvert

Inlet      Fair      aggrading

Remove the accumulated material at the inlet and monitor. The stream continually aggrades at the inlet and within the culvert reducing culvert hydraulic capacity. Consider replacing the entire structure. The current load rating of BCL-625 or 63 tonnes to continue.

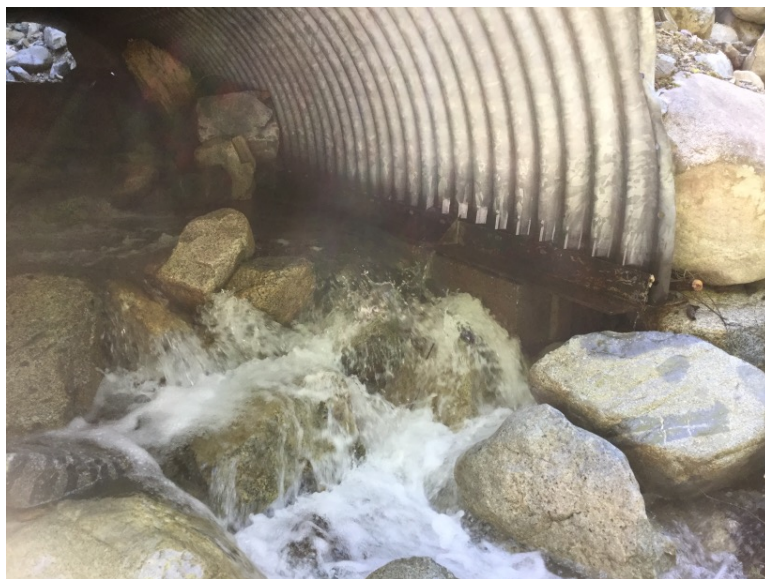
Footings exposed at outlet - left bank shown

1 Monitor aggradation at inlet and footing scour at outlet

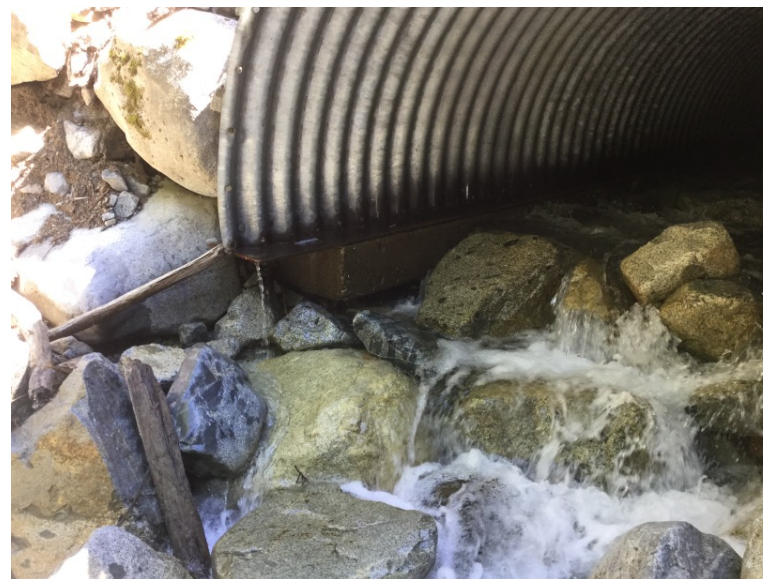
Footings exposed at outlet - right bank shown
