CK-2458  
CK-2458

NORRISH 19.9km

2020 Inspection

### Inspection

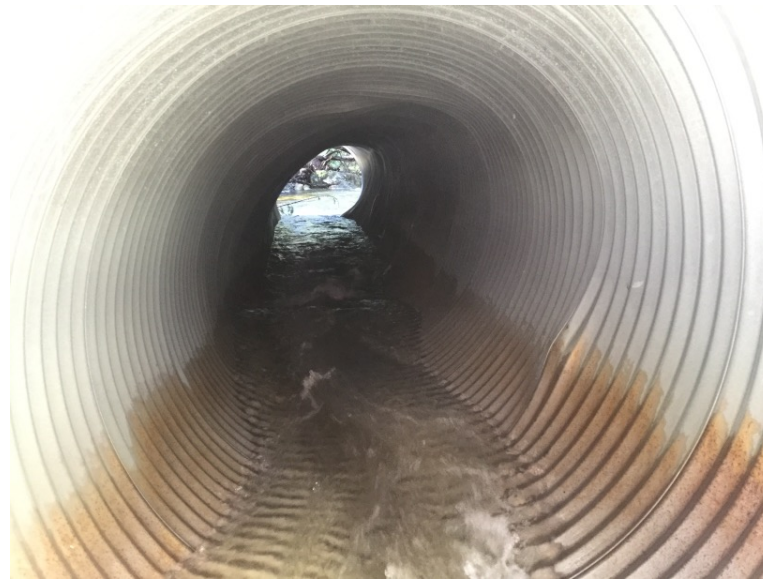
Looking through upchain culvert

Damage noted

Monitor the damage noted to the culverts. L100 or 91 tonnes load rating.
