CK-2459

HORNET 0.4km

2020 Inspection

| Structure Class | Temporary Bridge |

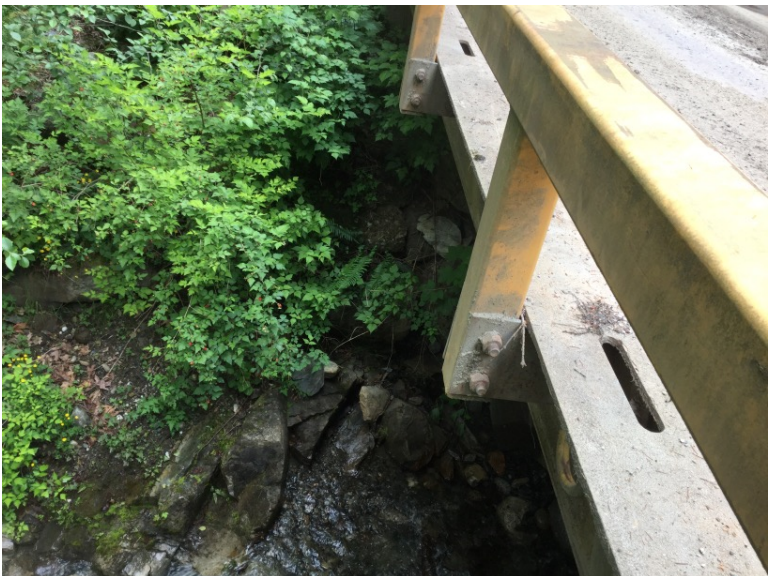
Missing rail hardware where deck damage noted

Guardrail connection

| Repair Item | Priority | Repair Description |
|---|---|---|
| 1 | Medium | Replace missing hardware for HSS rail at damaged deck location |

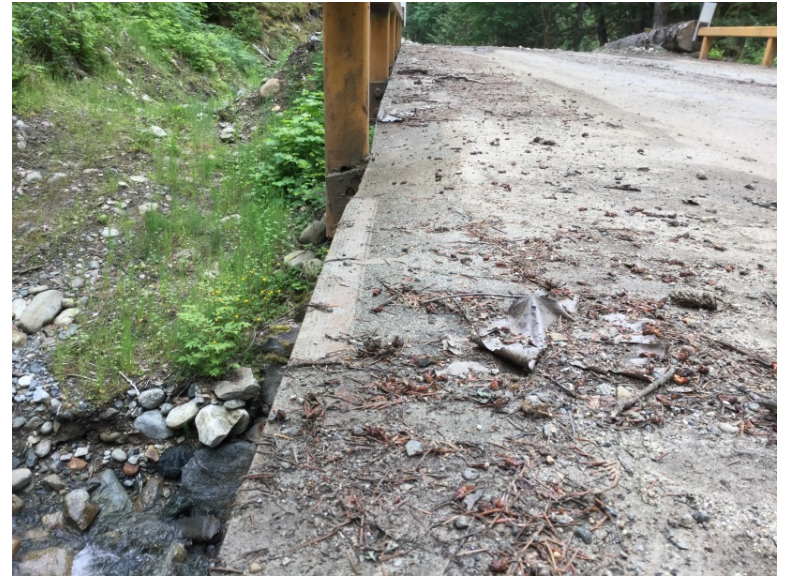
Damage noted to sections of both upstream and downstream girders at deck edges. Steel has deformed in these locations as noted in previous inspections

Damage noted to outside deck edge on upstream box girder

Replace missing HSS rail hardware and monitor the deck deformations noted at the edges.  
The current load rating of L75 or 68 tonnes to continue.

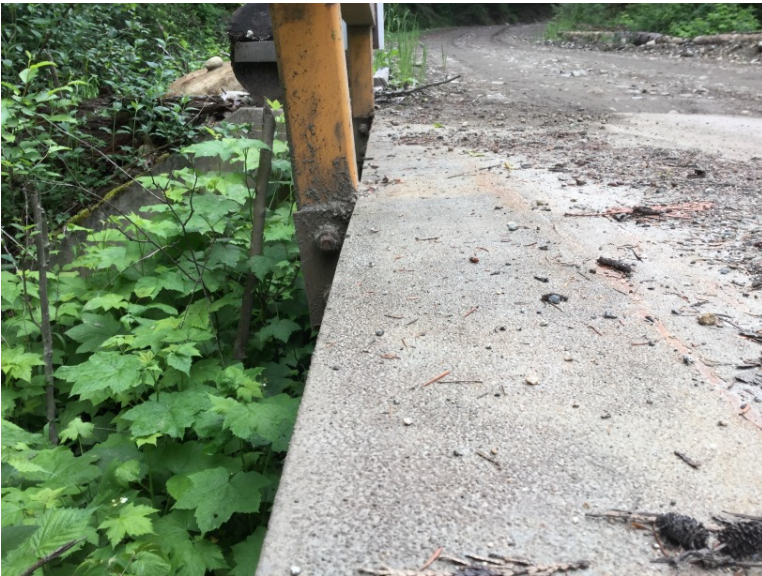
Damage noted to outside deck edge on downstream box girder

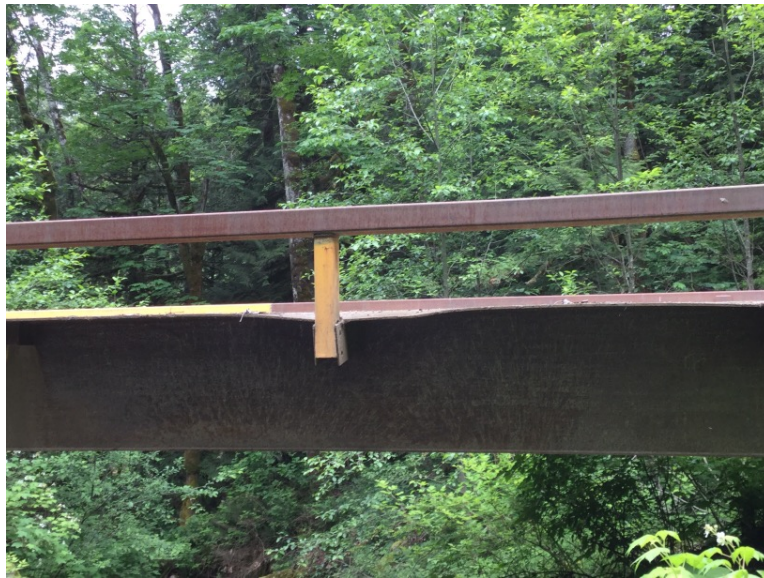
Damage to upstream box girder

| Item | Monitor Description | Frequency |
|---|---|---|
| 1 | Deck condition | Every routine inspection |

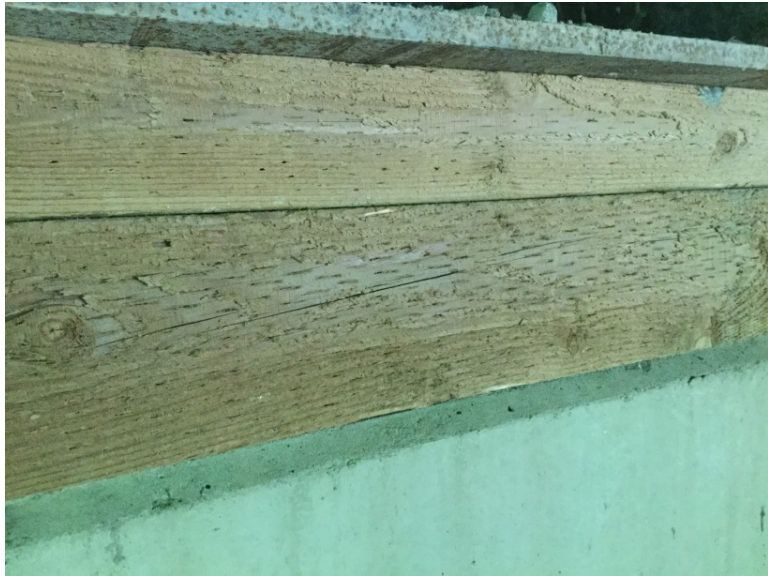
Caps or Sills Good Treated timbers on concrete integrated cap/wall

100mm thick timber on top of 150mm thick timber at both abutments

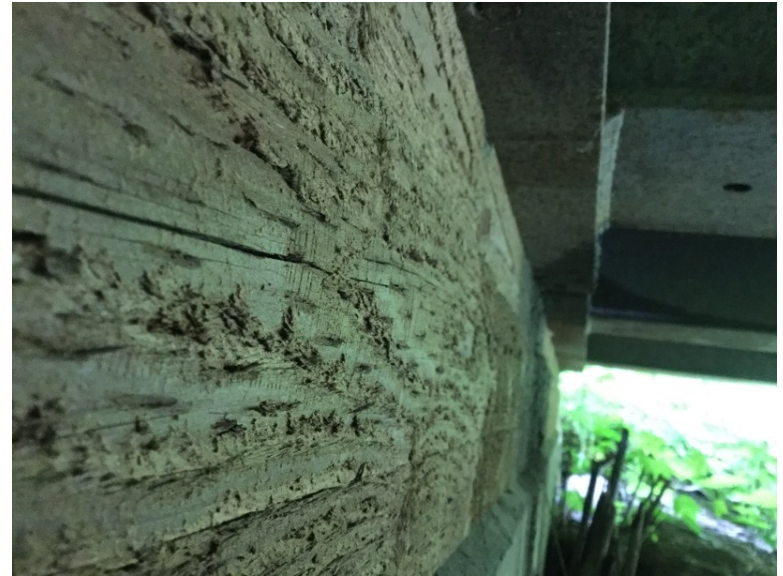
Bearings Fair bearing plate up 100mm off timbers - see photos

Bearing plate not completely on sill at right bank, up to 100mm off
