CK-2460  
CK-2460A

Hornet FSR 0.6km

2020 Inspection

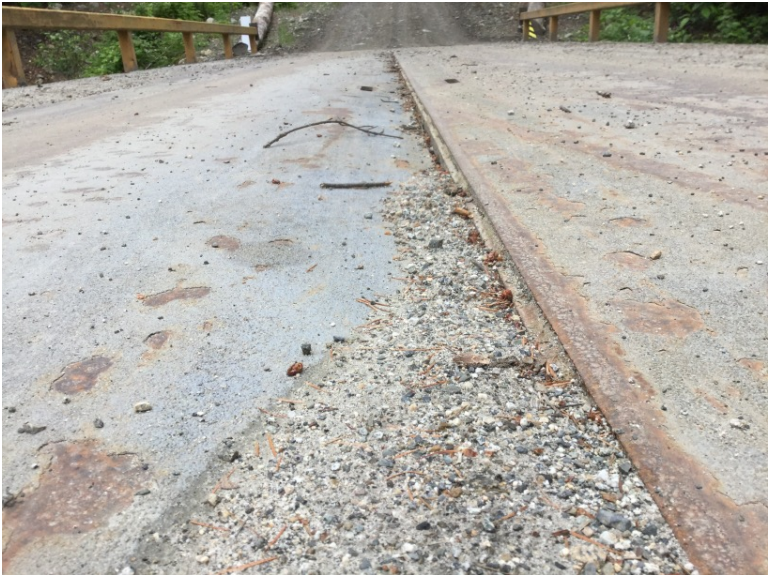
Deck deformation noted along both edges of downstream girder

Deformation of deck plate on downstream girder

| Item | Monitor Description | Frequency |
|---|---|---|
| 4 | Downstream girder deck edge deformations | Routine Inspection |

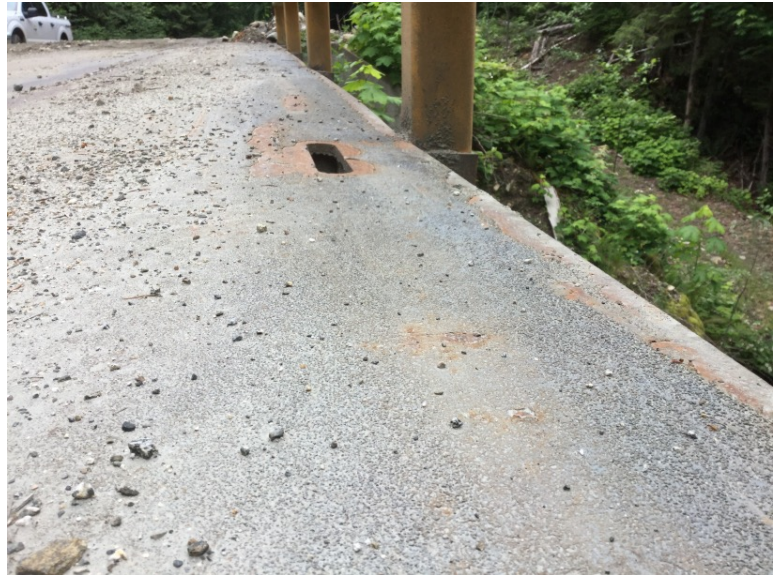
Deformation of deck plate on downstream girder

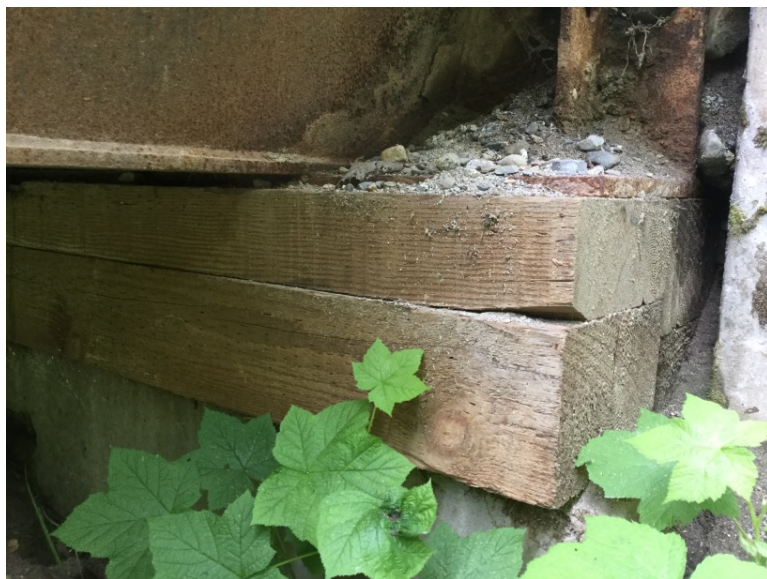
Treated timbers (150mm + 100mm) on top of concrete cap/wall

Timber sills stacked at right bank

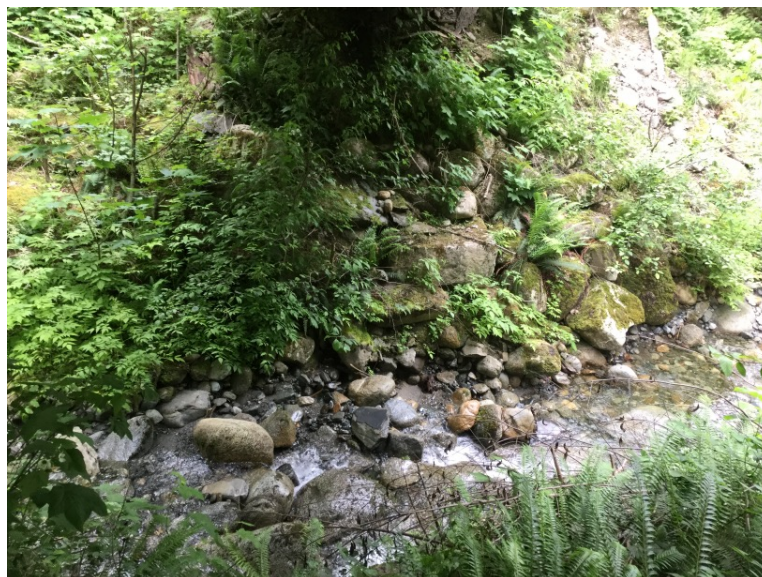
Large round boulders that have been scoured

Left bank riprap

| Item | Monitor Description | Frequency |
|---|---|---|
| 3 | Riprap condition | Routine Inspection |

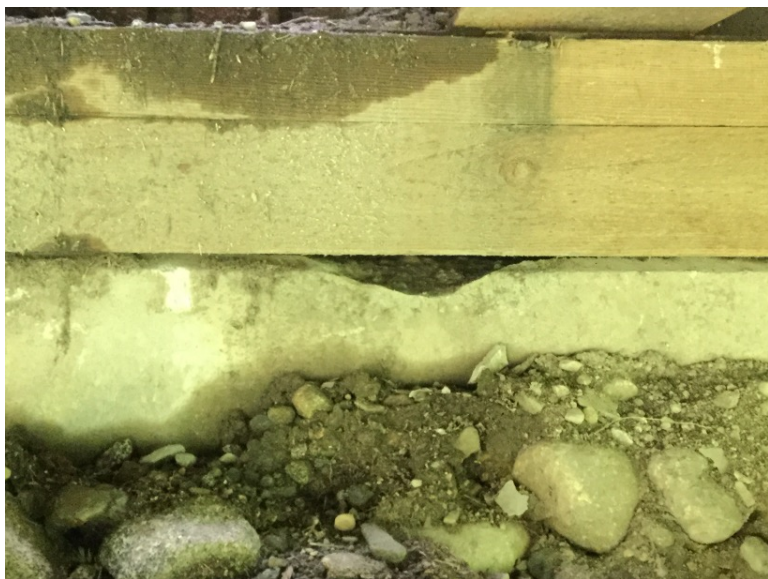
Minor damage noted to top of cap at right bank

Damage noted to right bank concrete cap

| Item | Monitor Description | Frequency |
|---|---|---|
| 2 | Concrete spalls at right bank | Routine Inspection |

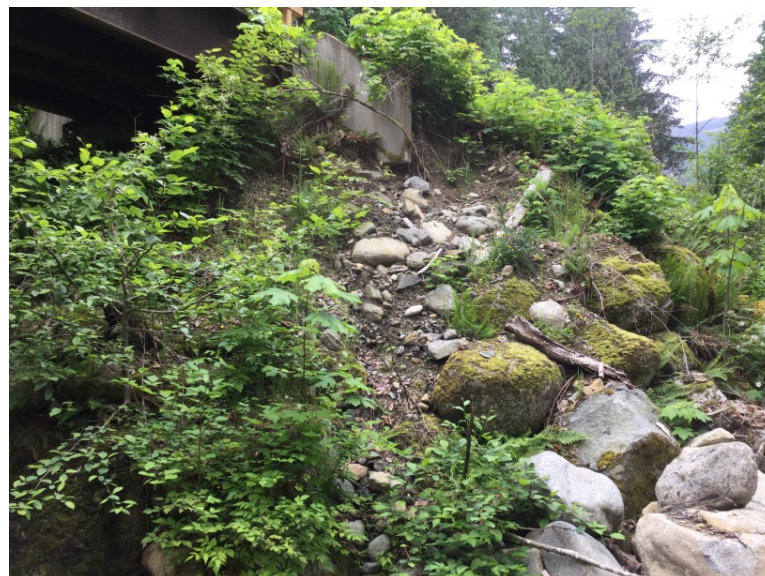
Over steepend and eroding at downstream left bank

Downstream left bank fill

| Item | Monitor Description | Frequency |
|---|---|---|
| 1 | Down stream left bank fill slope condition | Routine Inspection |
