CK-2462  
CK-2462A

Hornet FSR 3.0km

2020 Inspection

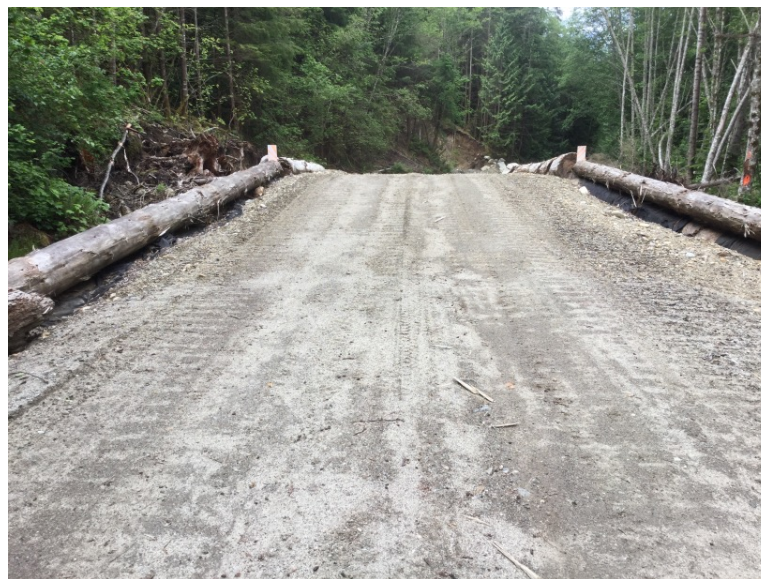
Overall Deck Condition      **Good**

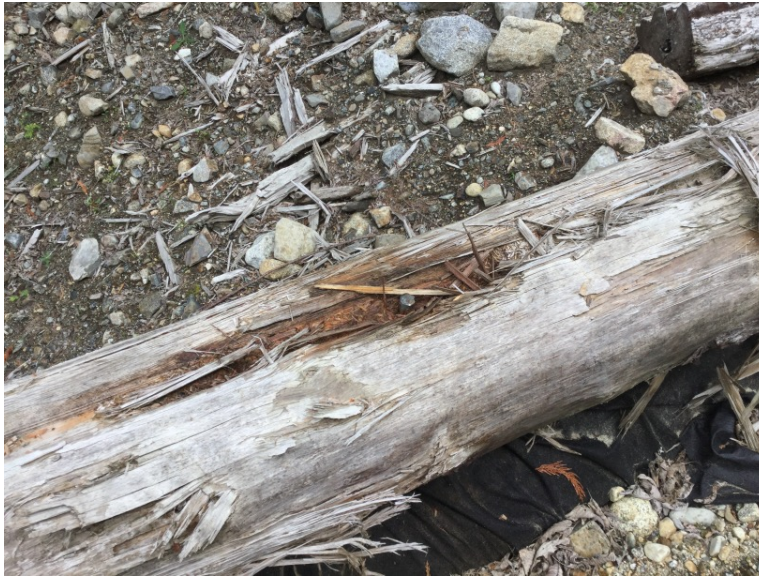
Guardrail pinned

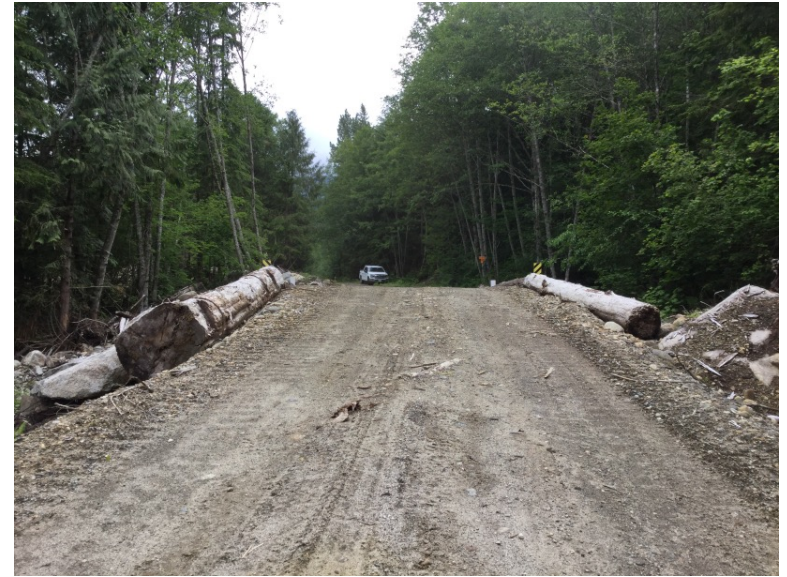
Approach from Left Bank when facing downstream

VC left approach limits visibility

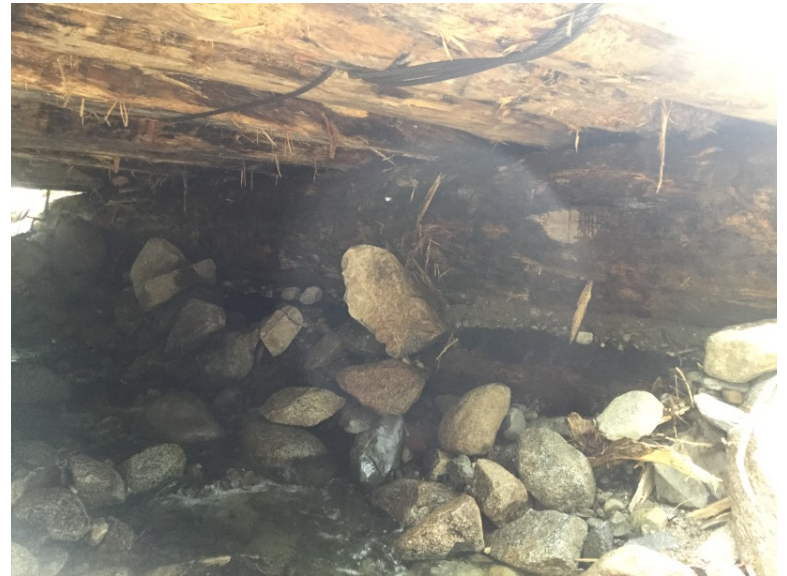
Left Bank Abutment when facing downstream

Large diameter sills sitting directly on top of old sills

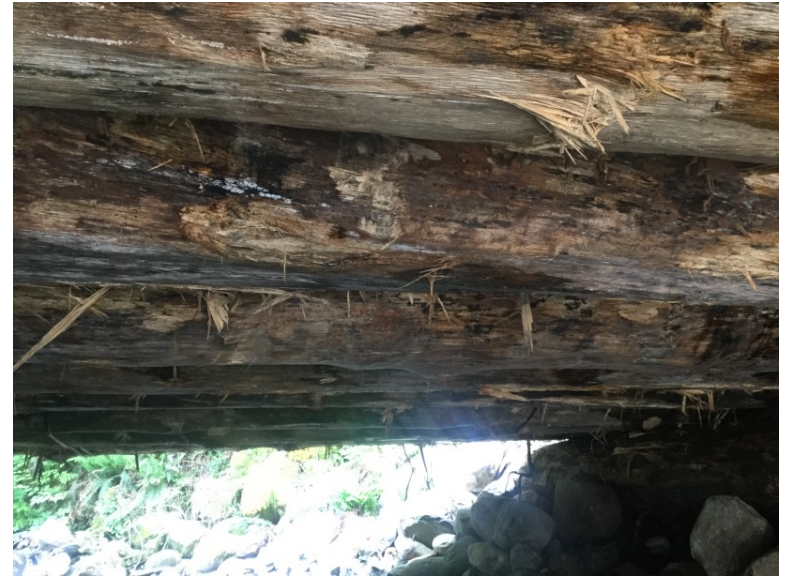
Stringers

8.5m span upstream  
8.0m span downstream
