CK-2471  
CK-2471

MAISAL 3.2km

2020 Inspection

| Crossing Name | Side Creek |

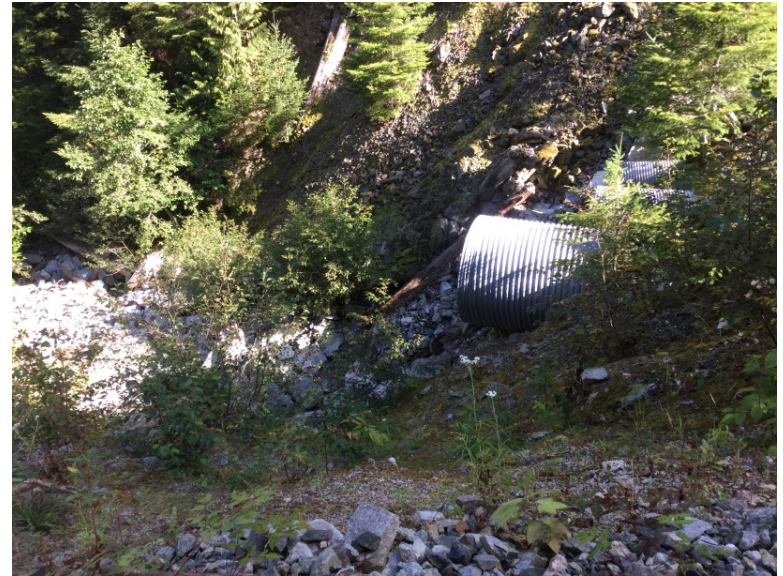
Outlet Fair Vertical drop but well armoured

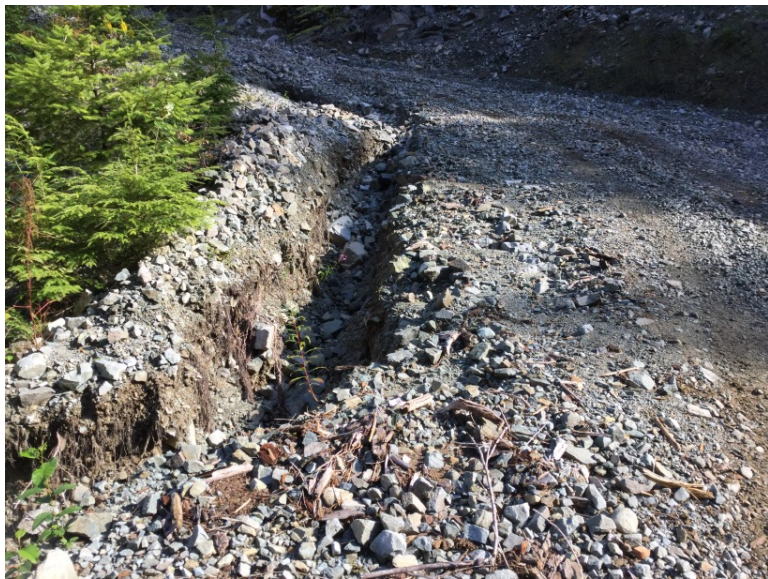
right approach surfacing and grading required

Running surface scour at right approach

| Repair Item | Repair Description |
|---|---|
| 1 Approach. Approach surfacing grading. m. Priority:High | Add surfacing and grade prior to activity |

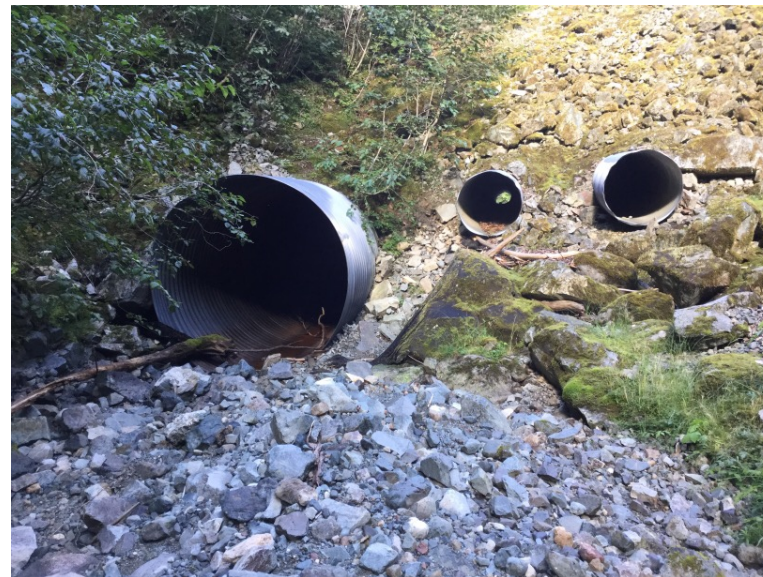
Inlet Good

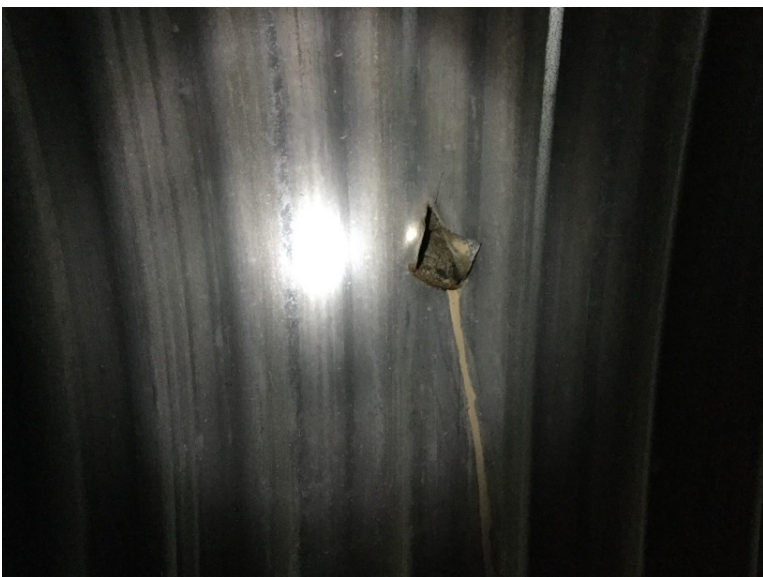
Culvert punctured from fill in 6 locations at left bank
